## Flooding in Slindon, Staffordshire

January 2024

Investigation under Section 19  
of the Flood and Water Management Act 2010

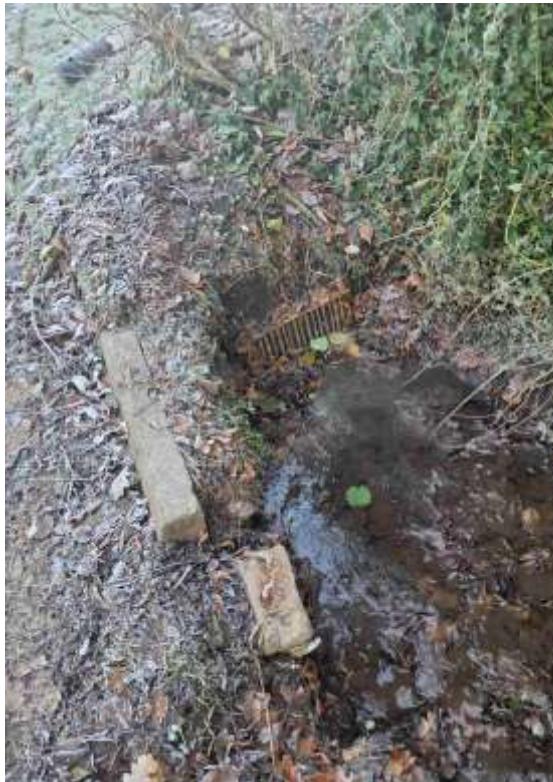
Figure 11: Trash screen on inlet to Aspley Lane pipe

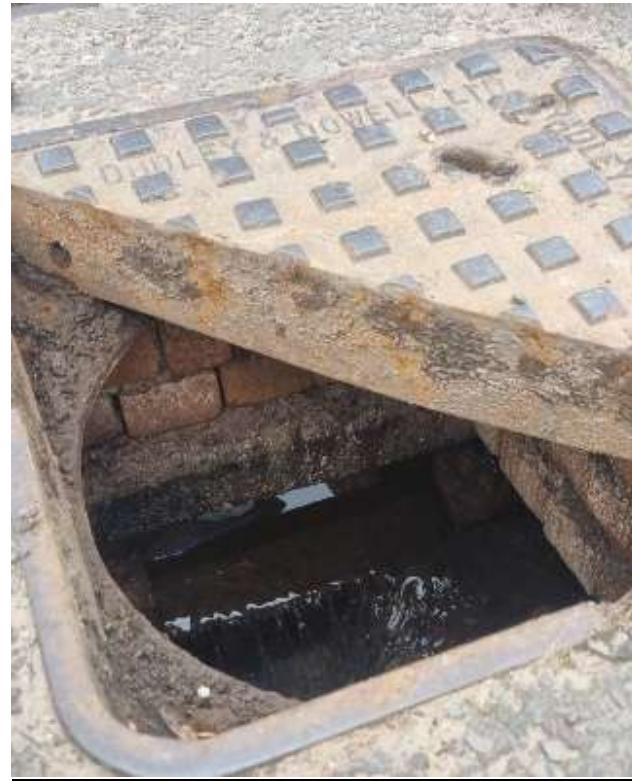
Figure 12: Weir in manhole at top of Villa Farm Lane

At the junction of the A519 and Villa Farm Lane, the Aspley Lane pipe passes through a manhole chamber with a weir (Figure 12). Under high flow conditions, once the capacity of the pipe from Aspley Lane has been exceeded, water will flow over the weir and enter the highway drainage network (Figure 10, yellow drainage route) which conveys surface water flows from the A519.

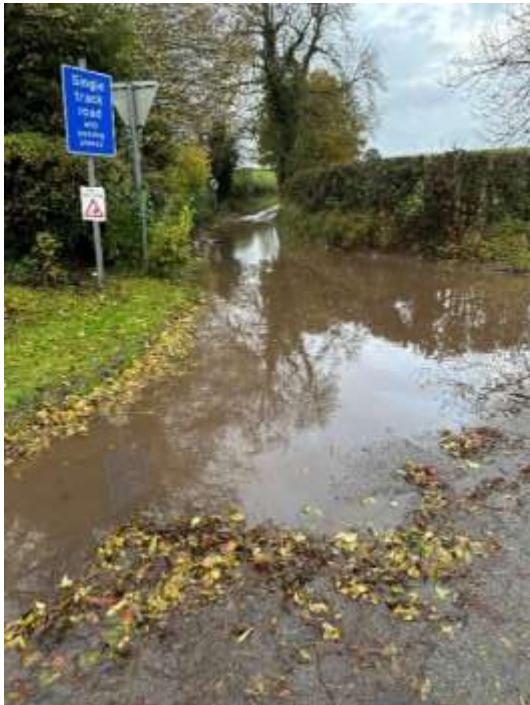
Floodwater initially began to accumulate in the highway at the junction of Aspley Lane and the A519 (Figure 23). Residents reported that the trash screen at the Aspley Lane pipe inlet was blocked with debris and silt washed from the upstream catchment (Figure 24). Topographical data shows that there is very little gradient in the ordinary watercourse and as a consequence, silt has been deposited over time which has significantly reduced the capacity of the channel to convey surface water flows from the village to Meece Brook. This resulted in the ditch quickly reaching capacity and spilling onto the highway. As the volume of water increased, this led to the lane becoming impassable and SCC Highways attended site to close the road.

Figure 23: Surface water accumulating at the junction of Aspley Lane and the A519 (Photo provided by resident)

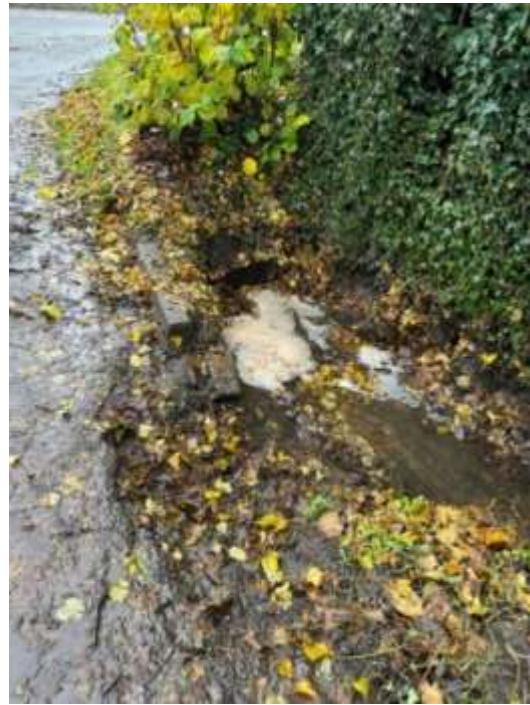
Figure 24: Blocked trash screen at Aspley Lane pipe inlet (Photo provided by resident)

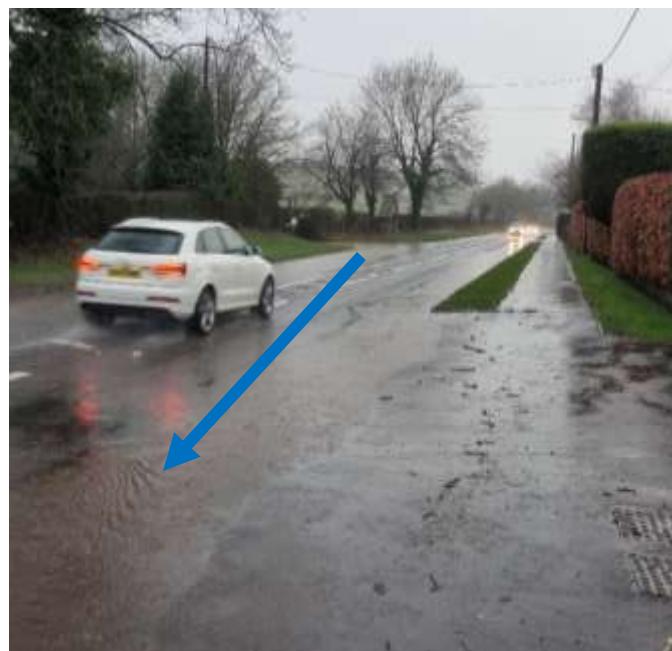
Surface water then began to quickly accumulate on both sides of the A519, and as the volume of water increased, the local highway drainage network became overwhelmed, with water following the prevailing topography, flowing in a southerly direction along the A519 (Figure 25).

Figure 25: Surface water beginning to accumulate at junction of Aspley Lane and A519 and starting to flow in a southerly direction (blue arrow) down the A519 (Photo looking in a northerly direction) (Photo provided by resident)

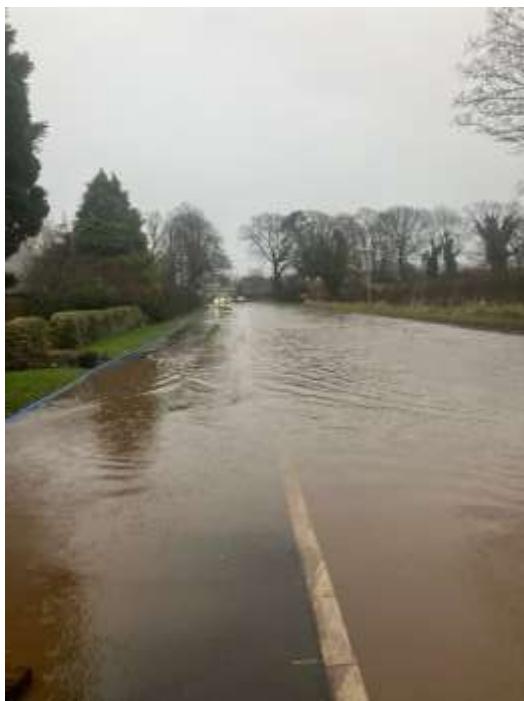
Surface water flows then continued to flow down the A519, impacting properties on the eastern side of the highway at around 14:30-15:00 (Location 4, Figure 22 and Figure 26). Residents reported that the highway drainage network became overwhelmed, with water observed to be bubbling out of the drain adjacent to the old telephone box. Surface water then flowed from the highway towards properties which are situated at a lower level than the highway. The flooding was exacerbated by bow waves from passing cars pushing water towards properties. Two properties reporting internal flooding to depths of between 4 and 5 inches, in addition to significant flooding to gardens and outbuildings.

Figure 26: Surface water along the A519, looking in a southerly direction (Photo provided by resident)

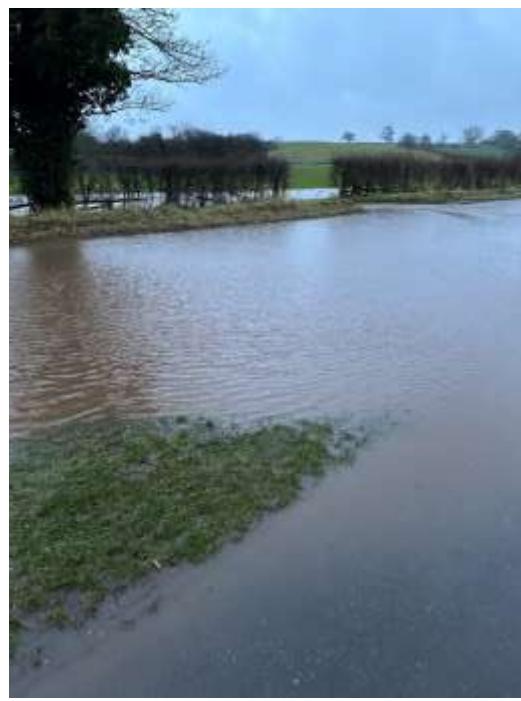
Figure 27: Surface water flowing onto western side of A519 and into adjacent field (Photo provided by resident)

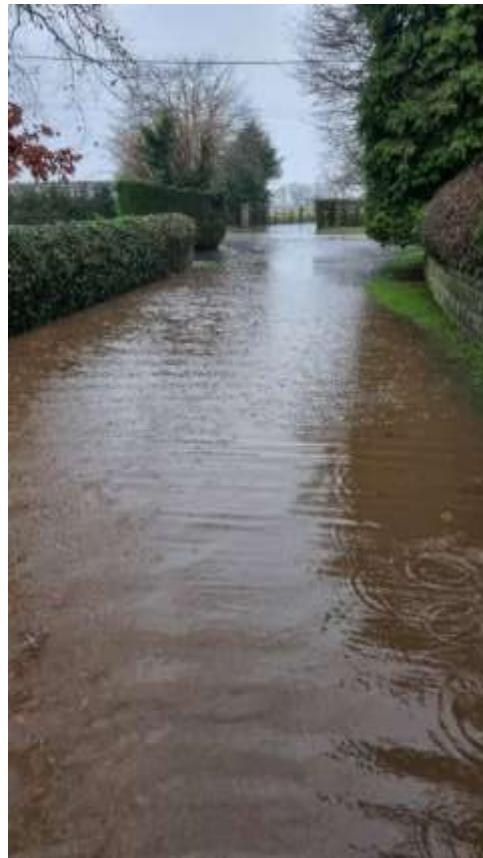
At the northern extent of the village, flooding was also experienced along Villa Farm Lane (Location 6, Figure 22). Residents described how water emerged rapidly from a manhole cover situated along the private lane. Since the lane is below the main A519 road surface level, water accumulated along the lane (Figure 28). As the volume of water on the A519 increased, this also flowed onto the lane, resulting in floodwater reaching depths of approximately 30cm. Whilst no internal flooding to property was reported, access to property was significantly restricted, with some residents also reporting issues with septic tanks and private drainage.

Figure 28: Flooding along Villa Farm Lane (Photo provided by resident)

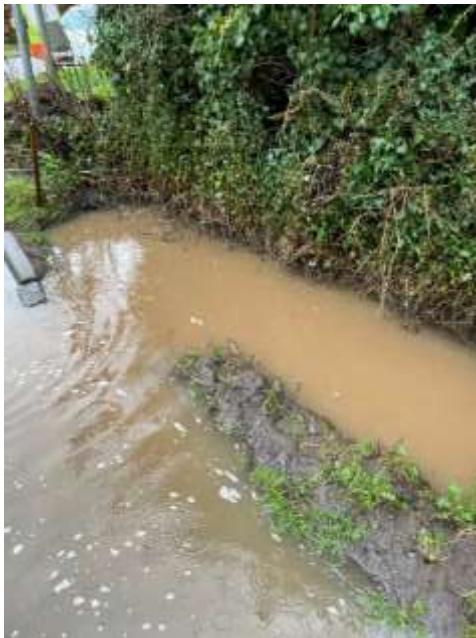
Site inspection found the roadside ditch at Aspley Lane was at capacity, and water was spilling from the ditch on to the highway (Figure 29). Surface water runoff was also observed flowing from adjacent fields onto the highway along Aspley Lane and into the ditch (Figure 30). Whilst the inlet pipe at the downstream end of the ditch was submerged, it was evident that some water was still flowing through the pipe following clearance of debris by SCC Highways. On site it was noted that at around 13:00 the rainfall had eased and water within the ditch at Aspley Lane had started to clear.

Figure 29: Ditch and pipe inlet at junction of Aspley Lane and A519, observed on 22<sup>nd</sup> February 2024.

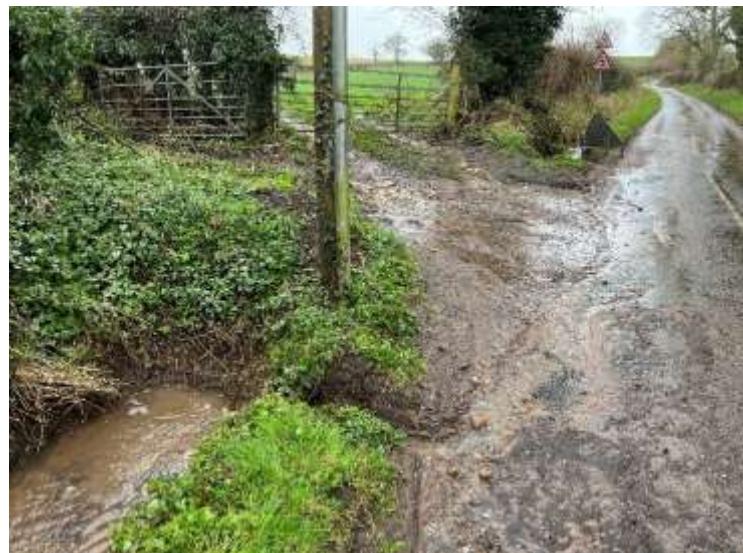
Figure 30: Surface water runoff from fields adjacent to Aspley Lane, observed on 22nd February 2024

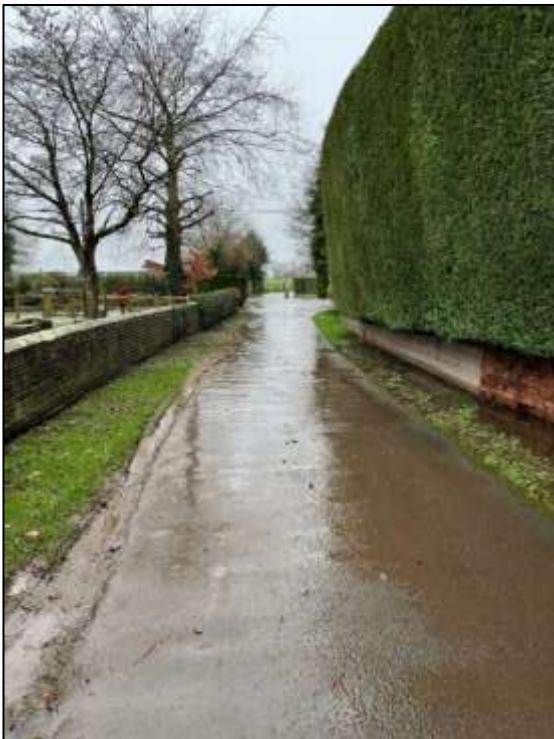
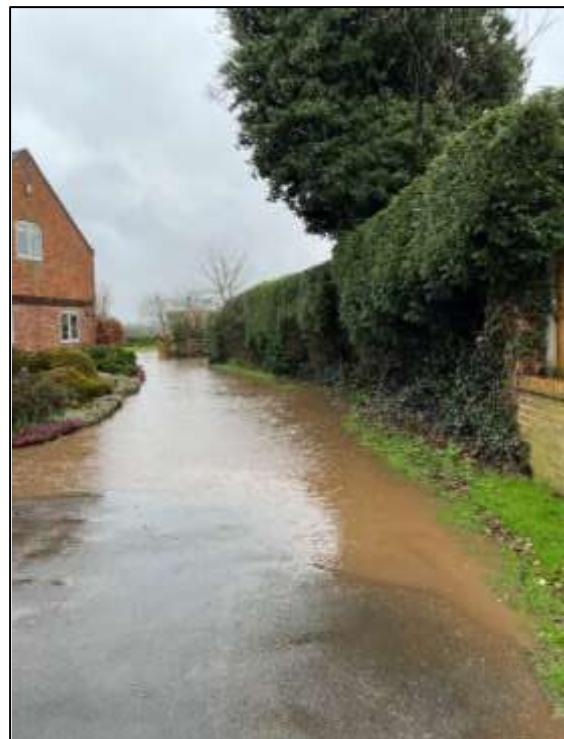
Flooding was also observed along Villa Farm Lane (Figure 31). Discussion with residents on site confirmed that water initially spilled from the manhole at the entrance to the drive before accumulating along the private road, restricting access to property along the road. No internal flooding to property was reported along Villa Farm Lane on this occasion.

Figure 31: Photographs of floodwater along Villa Farm Lane as observed on 22<sup>nd</sup> February 2024

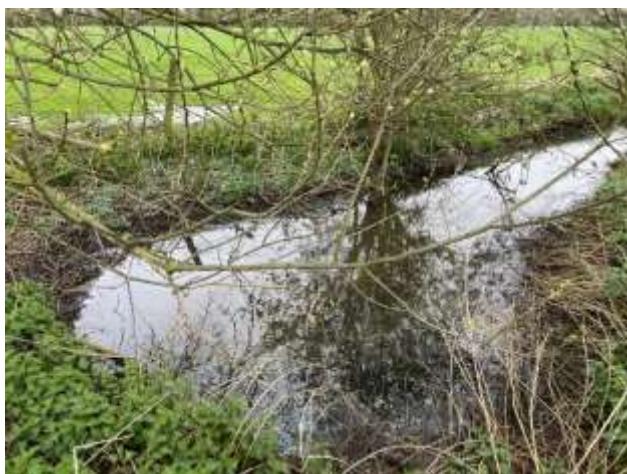
A walkover of the riparian owned ditch from Aspley Lane was undertaken from the point at which the pipe enters the open channel to the point at which it enters the Millmeece Drain South. The channel was found to be heavily silted with significant vegetation growth in several places. The outlet pipe from the Aspley Lane was found to be submerged, and the water level in the channel was almost at bank full in several places (Figure 32 and Figure 33).

Figure 32: Discharge point of Aspley Lane pipe into open ditch to east of Slindon (Photograph taken 10<sup>th</sup> April 2024)

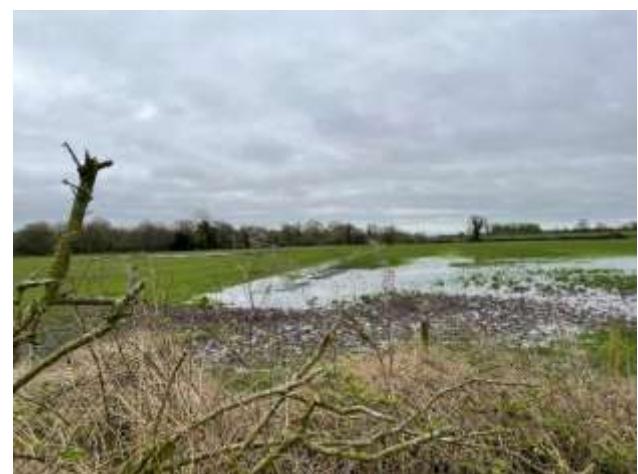
Figure 33: Open watercourse leading to Millmeece Drain South (Photograph taken 10th April 2024)

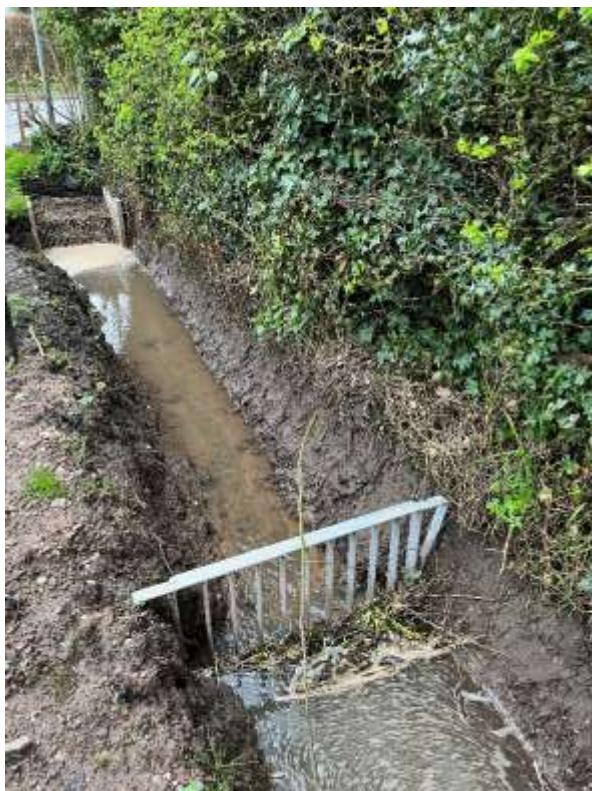
Site observations have shown that both trash screens have been working effectively in preventing debris washing from the upstream catchment and entering or blocking the pipe inlet. However, residents have reported that during heavy rainfall events, the roadside ditch continues to reach capacity quickly with downstream flow restricted. This is likely due to the condition of the downstream channel and potential build-up of silt within the pipe as observed during site inspections.

Figure 34: Two-stage trash screen installed along roadside ditch pipe inlet at Aspley Lane/A519 in February 2024

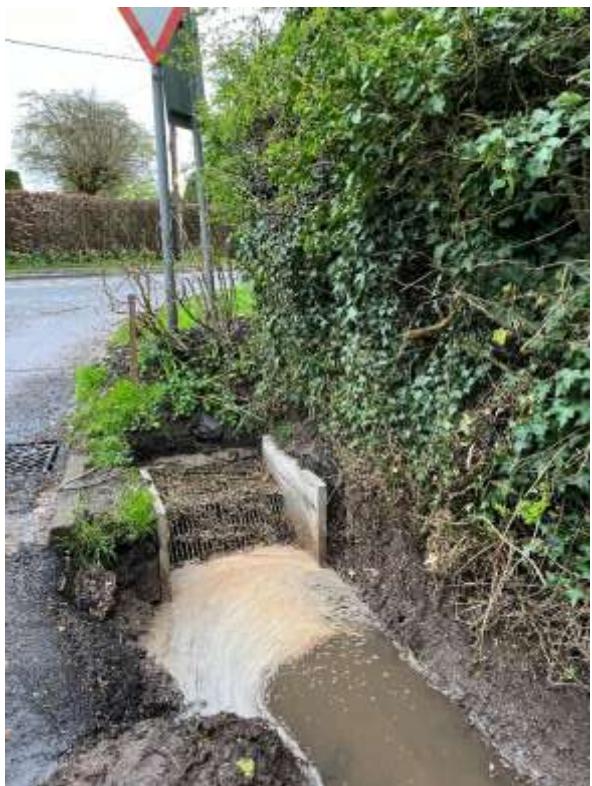
Figure 35: Aspley Lane inlet pipe and new trash screen following heavy rainfall February 2024.

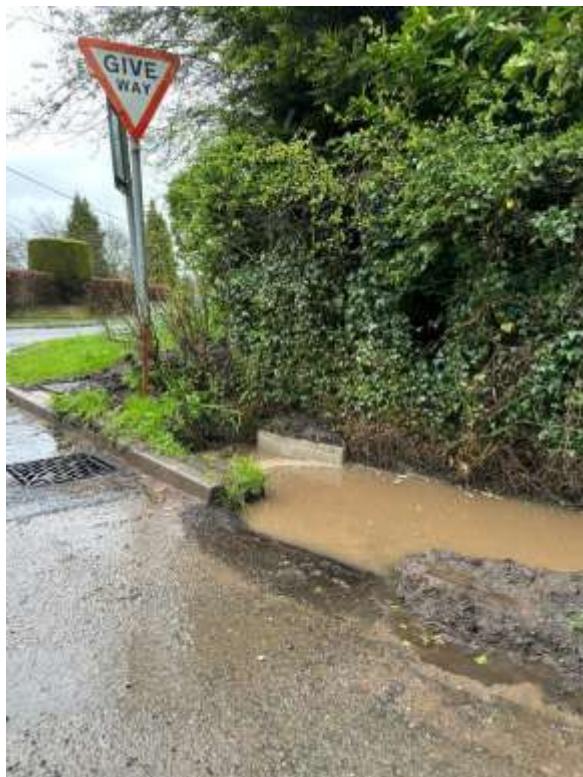
Figure 36: Roadside ditch at capacity following rainfall experienced April 2024

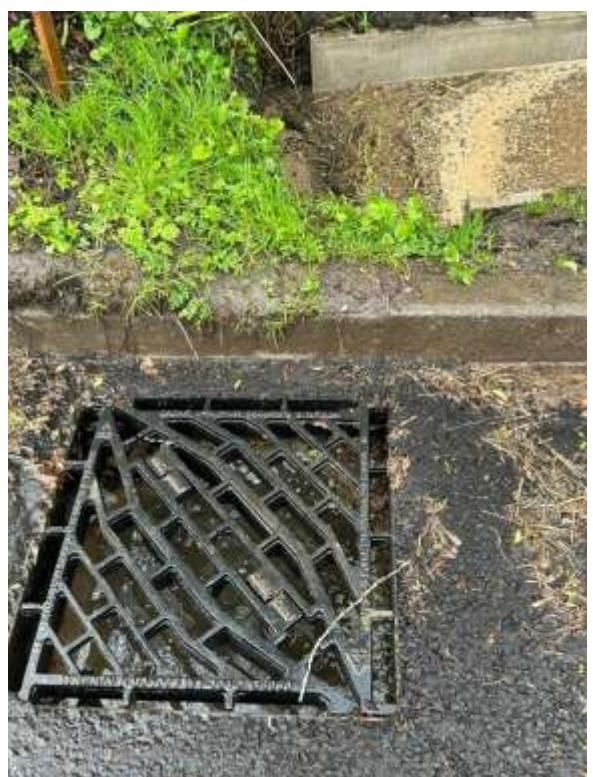
Figure 37: Gully adjacent to Aspley Lane ditch almost at capacity following rainfall April 2024
