Flooding in Cranberry, Staffordshire

January 2024

Investigation under Section 19
of the Flood and Water Management Act 2010

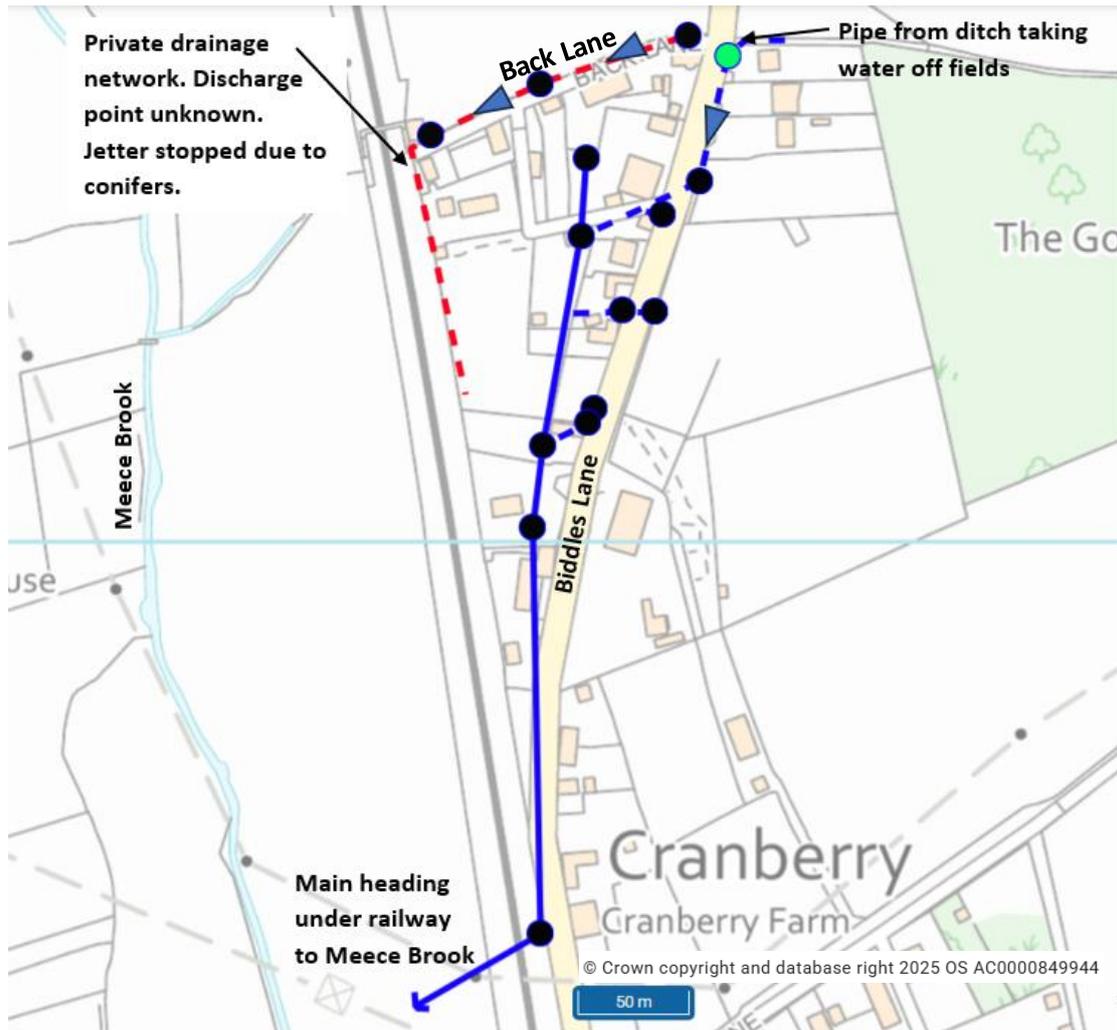
Figure 10: Local drainage networks identified in Cranberry from previous investigations (Note: locations are approximate, and further investigation is required to determine exact locations and connectivity of the drainage network)

Surface water runoff from Back Lane discharges into a 150mm diameter pipe (Figure 10, red dashed line) that flows in a westerly direction towards the West Coast Mainline. Previous investigations have been undertaken by SCC Highways to determine where this drainage pipe discharges, however, this was inconclusive and not investigated further as the road is classified as a private highway and does not fall under the responsibility of SCC Highways.

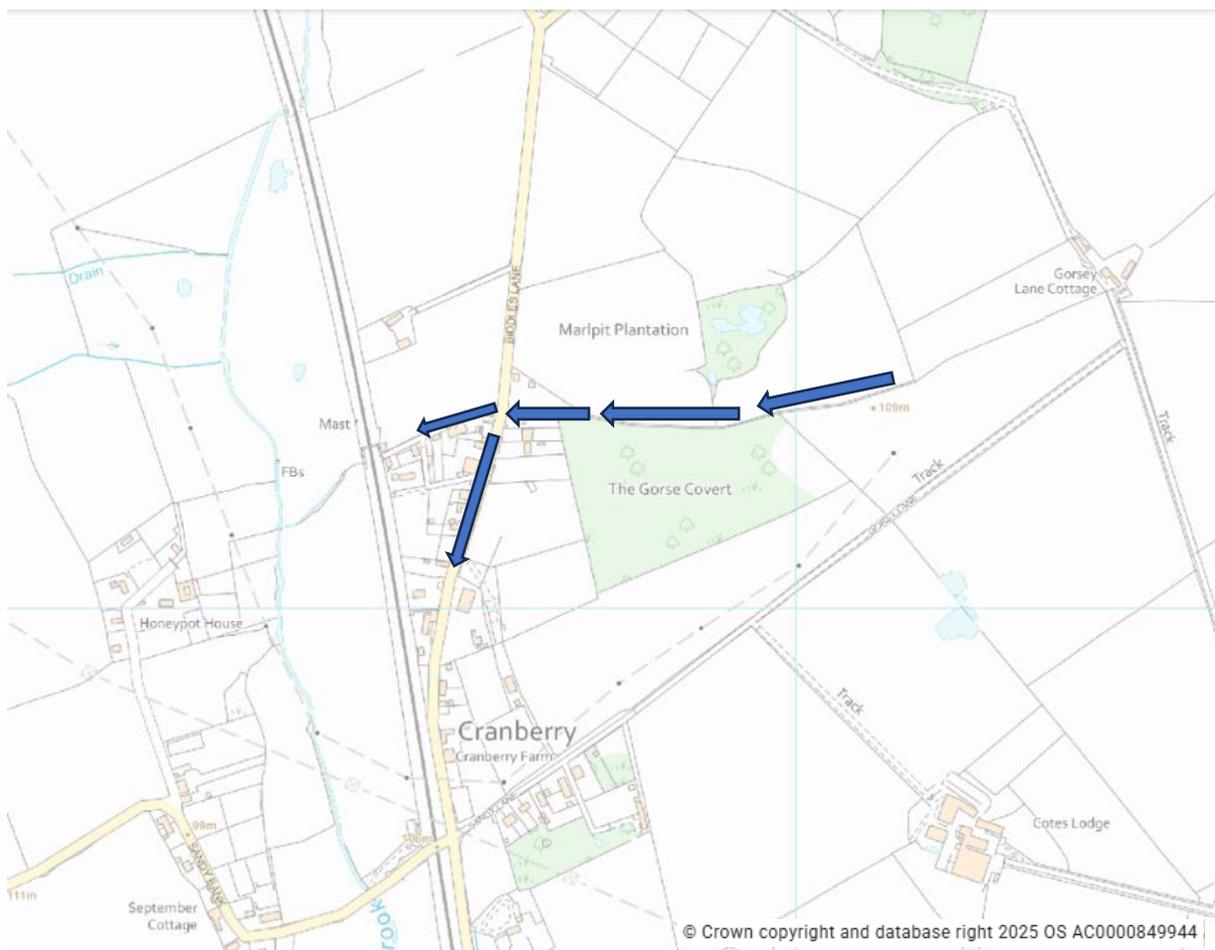
Figure 17: Surface water flow routes observed by residents on 2nd January 2024

Residents described how water flowed from agricultural land to the east of the village towards the small ditch that is situated adjacent to the footpath alongside The Gorse Covert. Once the capacity of the pipe inlet at the downstream end of the ditch adjacent to the footpath was exceeded, water spilled onto the footpath adjacent to the ditch and flowed westerly towards Biddles Lane and Back Lane (Figure 17).

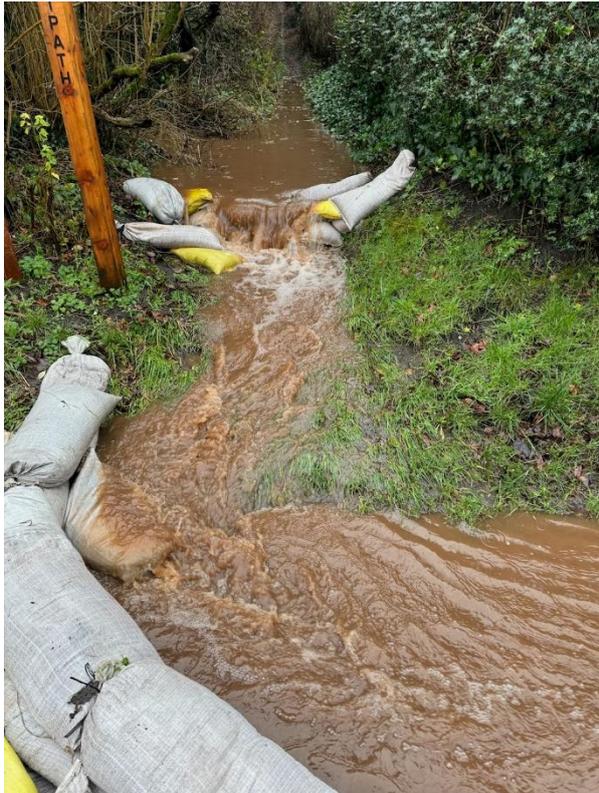
SCC Highway Authority attended site and provided sandbags to residents who placed them across the entrance to the footpath adjacent to The Gorse Covert in an attempt to prevent water spilling onto the highway (Figure 18). Unfortunately, the volume of water was too significant, and water flowed over the sandbags towards the highway.

Figure 18: Surface water flowing from Gorse Covert footpath (Photos provided by resident)

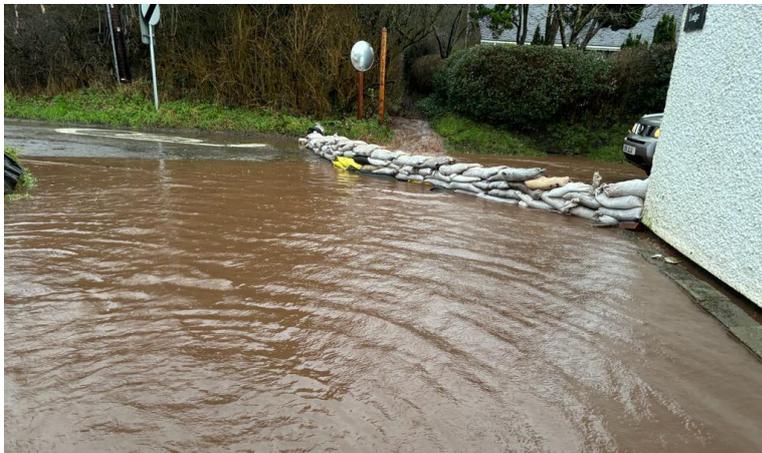
Additional sandbags were also placed across the highway between Biddles Lane and Back Lane to divert the flow of water in a southerly direction through the village (Figure 19).

Figure 19: Sandbags placed between Biddles Lane and Back Lane to divert water away from properties on Back Lane during Storm Henk (Photo provided by resident)

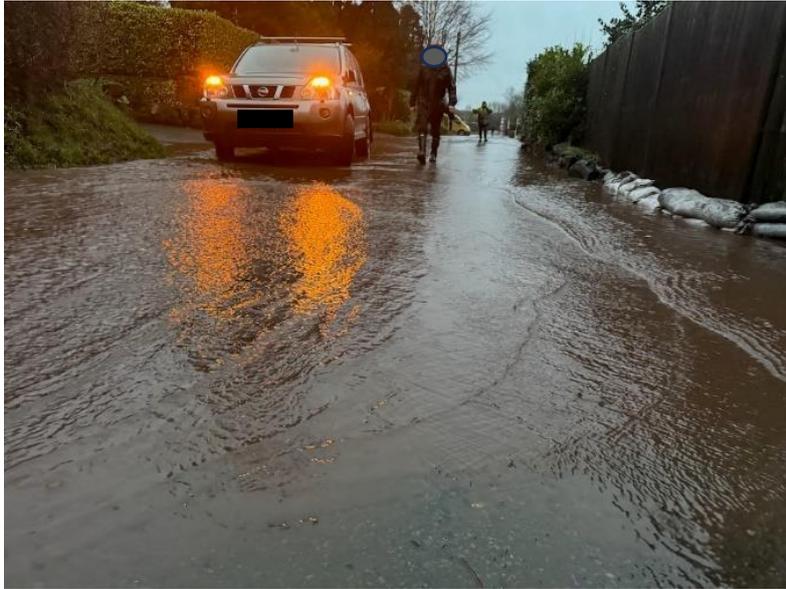
Figure 20: Water flowing in a southerly direction along Biddles Lane during Storm Henk (Photo provided by resident)
