2020 Flood Events:
Flood and Water Management Act
Section 19 – Investigation,
Barton-under-Needwood

This report focuses on flooding associated with Storm Dennis that internally affected properties in Barton-under-Needwood on the 16th February 2020. This investigation undertaken has been summarised, outlining the flood extent and flow routes reported, the most likely cause of flooding, and the relevant actions that have been completed or are to be undertaken in the future.

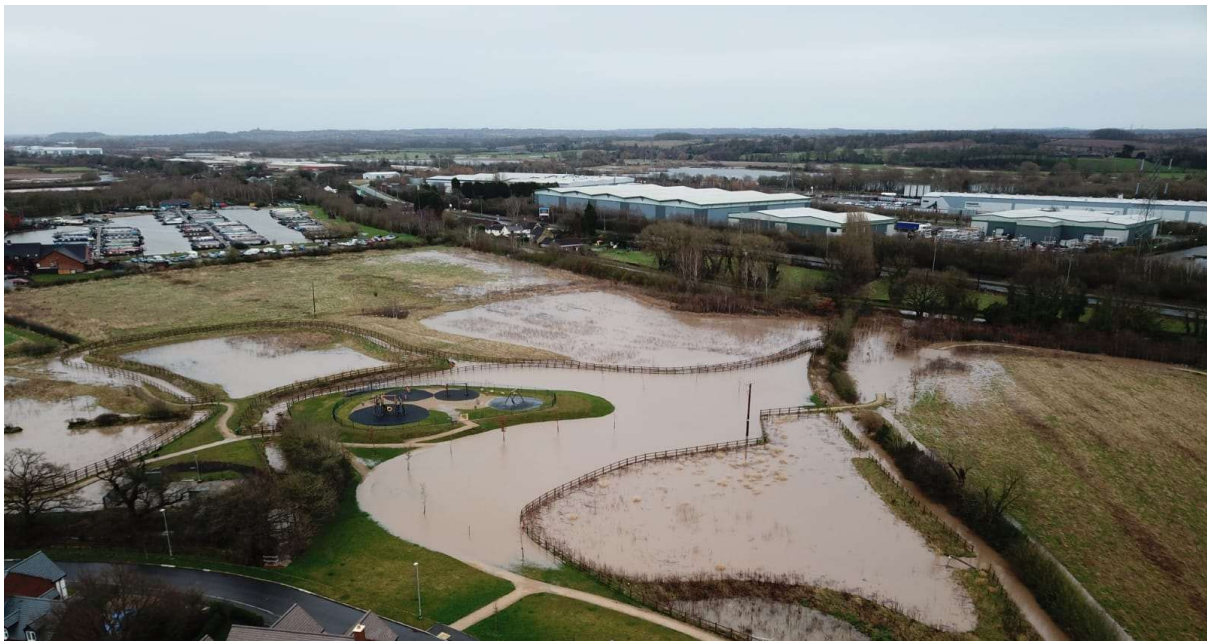
Figure 1: Flooding in Barton-under-Needwood after the February 2020 event – supplied by the Barton-under-Needwood Parish Council

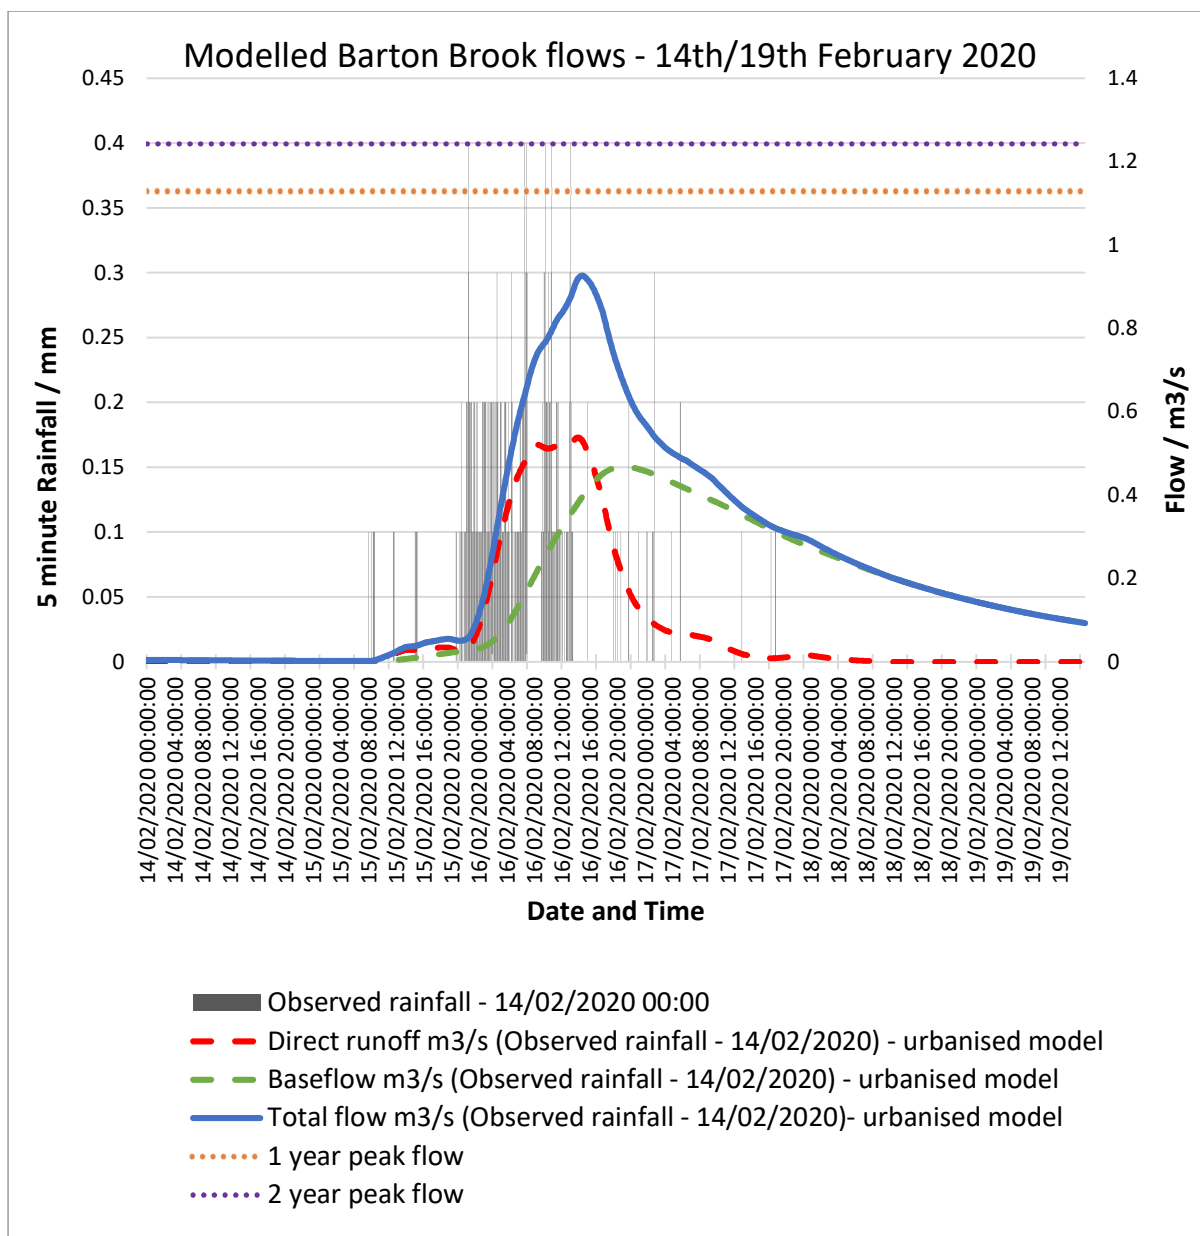
Figure 13: ReFH design flood hydrograph for Barton Brook overtopping event on February 16th following the Storm Dennis rainfall event on 15th-16th February 2020. The modelled return period of flows has been calculated as less than a 1-year peak event (Data Source: Hydromaster and ReFH)

Figure 13 and **Figure 14** demonstrate the main Barton Brook flow routes observed on February 16th. High Barton Brook levels were reported as it first discharges into Barton-under-Needwood around Park Road. The first observed incident of overtopping at the footbridge between Fallowfield Drive to Brookside Road (**Figure 13, number 1**) that caused internal flooding to several properties on Brookside Road. Once out of bank, flows continued eastward through Brookside Road gardens, subsequently knocking over fence panels with the force of flows and inundating further Brookside Road properties. This flow remained out of bank and accumulated behind the Wales Lane culvert (**Figure 13, number 2**), up to a recorded depth of approximately 450mm (>17 inches) at the culvert

entrance. These flows damaged further garden fence panels and a front gate, before discharging across Wales Lane to internally flood properties on Wales Lane and Collinson Road to depths ranging from 50mm (2 inches) to 450mm (>17 inches) inside affected properties, garages, and outbuildings. Flows remained out of bank around the footbridge between Wales Lane and Collinson Road, with flows potentially overtopping the southern bank and discharging across Collinson Road rather than through the culvert. Out of bank flows left recorded flow marks of flood depths approximately 300mm 21 meters away from footbridge around properties on Church Lane (**Figure 11, number 3**). Gardens also flooded, with floodwater up to the thresholds of several additional properties.

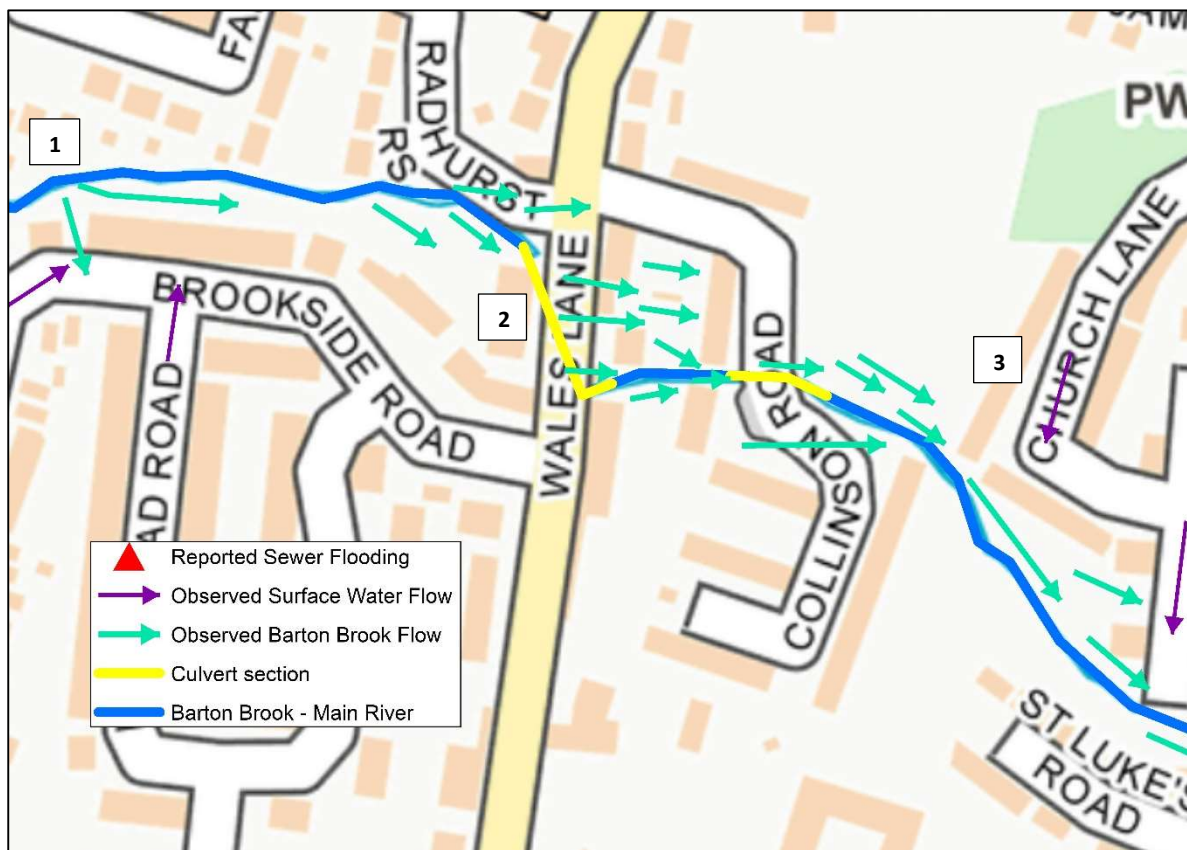
Figure 14: Observed Barton Brook (blue arrows) and surface water flow (green arrows) routes, between Brookside Road and Church Lane. 1: First reported overtopping at footbridge. 2: Accumulation of flows behind Wales Lane culvert that discharged as overland flow across Wales Lane. 3: Overland flow up to 300mm 21m from the Barton Brook footbridge. Data from residents, the Parish Council and Flood Action group.

Barton Brook flows that would normally discharge under St James' Road culvert reportedly pooled at the south end of Church Lane (**Figure 14, number 1**), up to depths of 450mm (>17 inches) in internally affected properties, before discharging as overland flow across St James' Road and through allotment gardens surrounding an open channel section. During this open channel section between St James' Road and Efflinch Lane (**Figure 14, number 2**), flow is reported to have overtopped the left bank at several places to inundate properties on both roads. This overtopping may have been caused by flows exceeding the channel capacity, particularly at right angle bends in

this section of the channel, or the potential of fallen vegetation in channel that obstructed or impeded discharge and caused out of bank flows. Flow exceeded the culvert capacity under Efflinch Lane, with reports levels were above the crown of the culvert at maximum flood level and continued as overland flow from the northern side of the channel, across Efflinch Lane (**Figure 14, number 3**), to internally inundate properties on Efflinch Lane and the south of Meadow Rise. A dwarf garage wall was also knocked over by the force of flows in this area. Reports indicate levels remained high adjacent to Potters Way, with the soffit level of the footbridge between Potters Way and Meadow Rise exceeded, that caused floodwater on Potters Way, the sports fields, and overflowing the fishing pond.

Combined sewer network surcharge was also observed on Efflinch Lane, with a manhole 'fountaining' to a height of 600mm (>23 inches) and flowing onto drives of properties on the East side of Efflinch Lane (**Figure 14, red triangle**). Sewer flooding further south along Efflinch Lane that potentially impacted properties was also reported during the flood incident. This is further confirmation that river flows may have overwhelmed the sewer system in some areas. Severn Trent Water have been made aware of these incidents and are investigating the issue further.

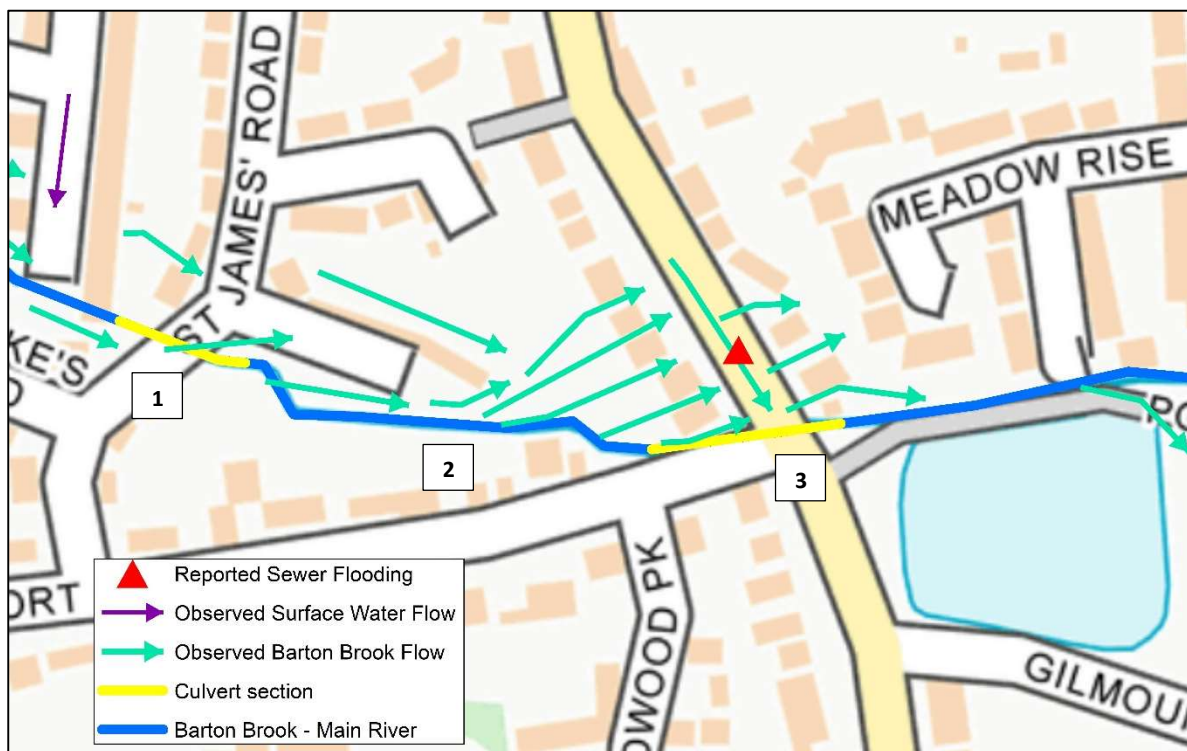
Figure 15: Observed Barton Brook (blue arrows) and surface water flow (green arrows) routes, between Church Lane and Potters Way. 1: Flows accumulated at St James’ Road culvert entrance and south of Church Lane. 2: Open channel section that experienced overtopping of the left bank. 3: Efflinch Lane culvert that was exceeded by Barton Brook flows which resulted in overland flow across the highway. Data from residents, the Parish Council and Flood Action group.

The Barton Brook is a heavily culverted watercourse with several additional footbridges across the channel. Thus, flows could potentially be restricted in many areas by these assets, with flows potentially backing up against these structures to spill out of channel. Flood flows are first reported to have overflowed the channel at the footbridge between Brookside Road and Fallowfield Drive, however no notable blockages around this footbridge were reported during the event. The culvert sections under Wales Lane, Collinson Road, St James’ Road and Efflinch Lane may also have experienced blockages or exceeded capacity. The Wales Lane box culvert turns approximately 90°

twice when passing under the highway and discharging into a narrow channel. Losses at the bends and the restricted channel at the outlet may force flood waters to mount the banks at the culvert entrance. This was experienced during the event with observed floodwater depths of approximately 450mm (>17 inches) at the Wales Lane entrance that internally affected surrounding properties. Constrictions of the channel by the additional culverts from potential blockages or flows exceeding capacity of the structures are also observed.

Overland flow routes around Collision Road and St James' Road indicate an inability to discharge through the culverts normally. Floodwater levels were also observed to be above the culvert crown and soffit levels of the Efflinch Lane culvert and Potters Way footbridge respectively. An additional blockage by building debris that had blown off a neighbouring plot during the event was also reported at the east end of Short Lane, that runs adjacent to the open section prior to Efflinch Lane. This blockage was cleared before the Environment Agency field team deployed during the event were present to action work to clear it. However, this may have been a factor in disrupting flows out of the channel and resulted in these discharging toward properties on Efflinch Lane. There is further potential that the steep 90° bends in this section of the channel could have constricted high flows, in addition to any vegetation that could have fallen in the channel in this area to impede flows and cause overtopping. Maintenance of the Barton Brook channel is undertaken annually by the Environment Agency to reduce the potential of blockages in the multiple culverts throughout Barton-under-Needwood. However, the general condition of the Barton Brook channel may have been reduced following Storm Ciara the preceding week.

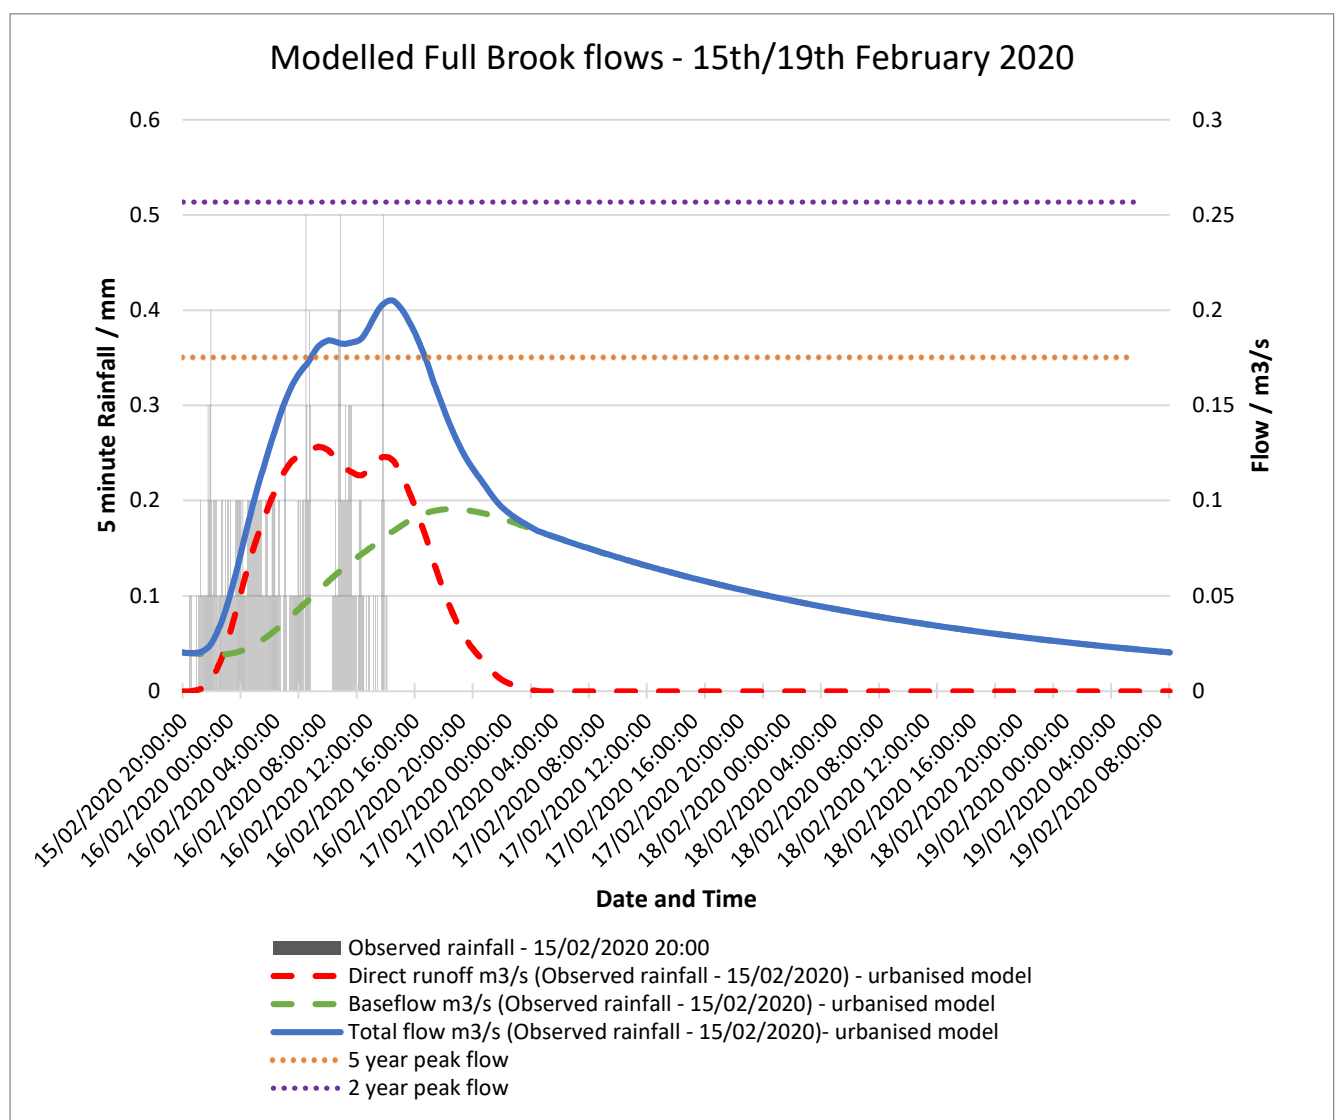
Figure 16: ReFH flood hydrograph for the full Brook ordinary watercourse overtopping event on February 16th following the Storm Dennis rainfall event on the 15th-16th of February 2020. The modelled return period of flows has been calculated as between a 2-year and 5-year peak event (Data Source: Hydromaster and ReFH).

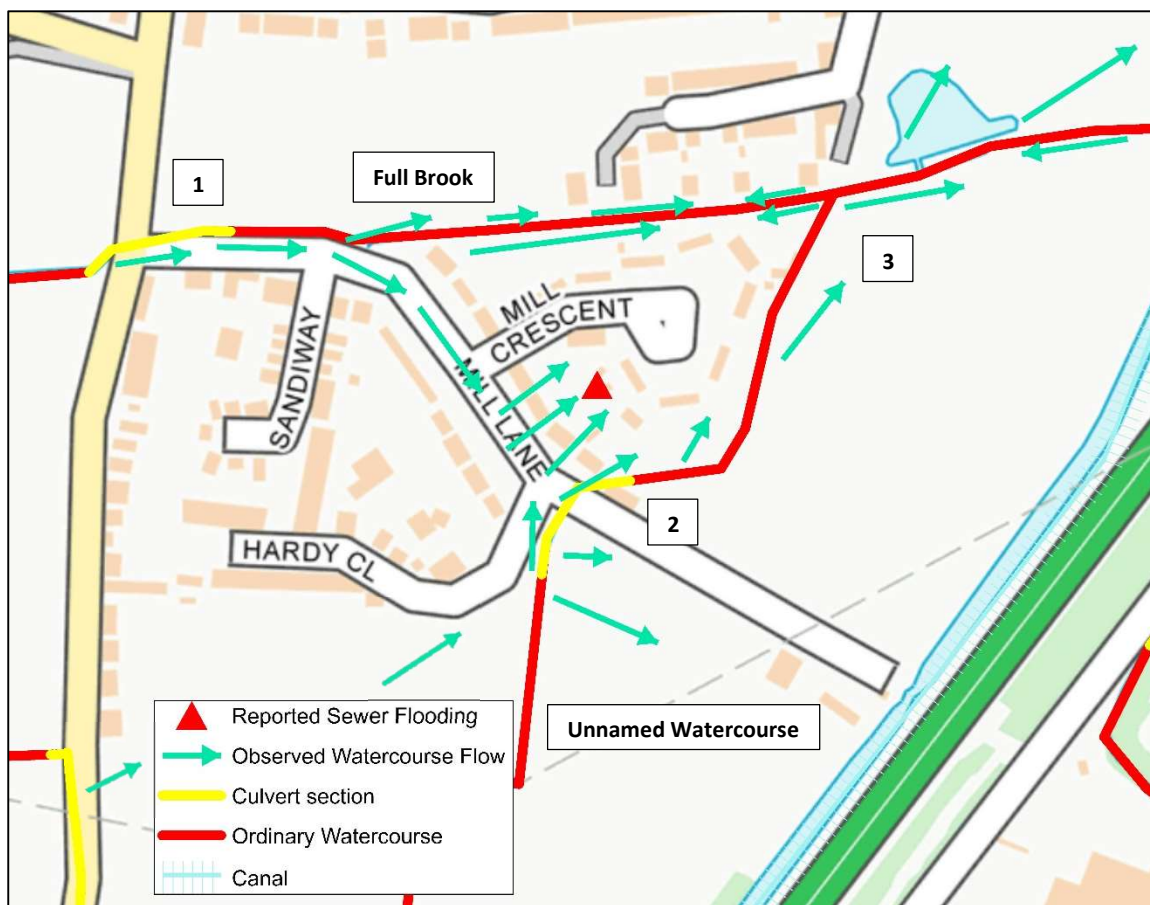
Figure 16: Route of overtopped flows from the Full Brook and unnamed watercourse that resulted in flooding along Mill Lane and Mill Crescent. 1: Flows overwhelming Efflinch Lane/Mill Lane culvert. 2: Flows overwhelming Mill Lane culvert. 3: Flows from both watercourses collected in open land east of Mill Crescent.

Figure 16 illustrates the observed flow routes from the Full Brook on February 16th. Flows initially overtopped the Full Brook at Efflinch Lane, with in bank flows unable to pass through the culvert beneath Efflinch Lane and Mill Lane due to a partial blockage. Full Brook flows unable to enter the culvert overtopped the bank and flowed across Efflinch Lane (**Figure 16, number 1**), and across drives of properties along Mill Lane. Flows continued southeast along Mill Lane, which acted as a path for directing flood flows.

Flood flows also overtopped the unnamed watercourse further southeast along Mill Lane, that discharges into the Full Brook northeast of Mill Lane and Mill Crescent. The culvert under Mill Lane (**Figure 16, number 2**) was also overwhelmed, resulting in flows bypassing and overtopping at the culvert entrance. The prevailing topography of the area directed these flows south to Hardy Close and agricultural land south of Mill Lane, and north of the culvert to inundate an area of Mill Lane that resulted in internal and external flooding to properties. This was exacerbated by the culvert condition, and in-channel blockages downstream of the culvert. Ingress of watercourse flows into

Out of bank flows from the Full Brook joined with those out of bank from the unnamed watercourse to collect in an area of open land and lower topography behind properties on Mill Crescent (**Figure 16, number 3**). As previously noted, local volunteers acted to direct flood waters away from properties where flood flows had collected from both the Full Brook and the unnamed watercourse. This allowed floodwater to drain into open land to the east and reduce pressure of floodwater in the around surrounding Mill Crescent. Other remedial work undertaken since includes the clearance of blockages from under both Efflinch Lane and Mill Lane culverts by Staffordshire County Council Highways, clearance of in-channel blockages upstream of the unnamed watercourse Mill Lane culvert, and clearance work undertaken by the Barton-under-Needwood Parish Council, supported by Staffordshire County Council, along the Full Brook channel adjacent to Mill Lane to improve capacity.

Reports that further sewer flooding from the foul sewer system occurred to rear gardens in Mill Lane and Mill Crescent (**Figure 16, red triangle**) have also been passed to Severn Trent Water. This was also most likely caused by ingress from watercourse flows into the sewer system. Severn Trent Water are investigating this flood incident further.
