Flooding in Marchington, East Staffordshire

October 2023

Investigation under Section 19
of the Flood and Water Management Act 2010

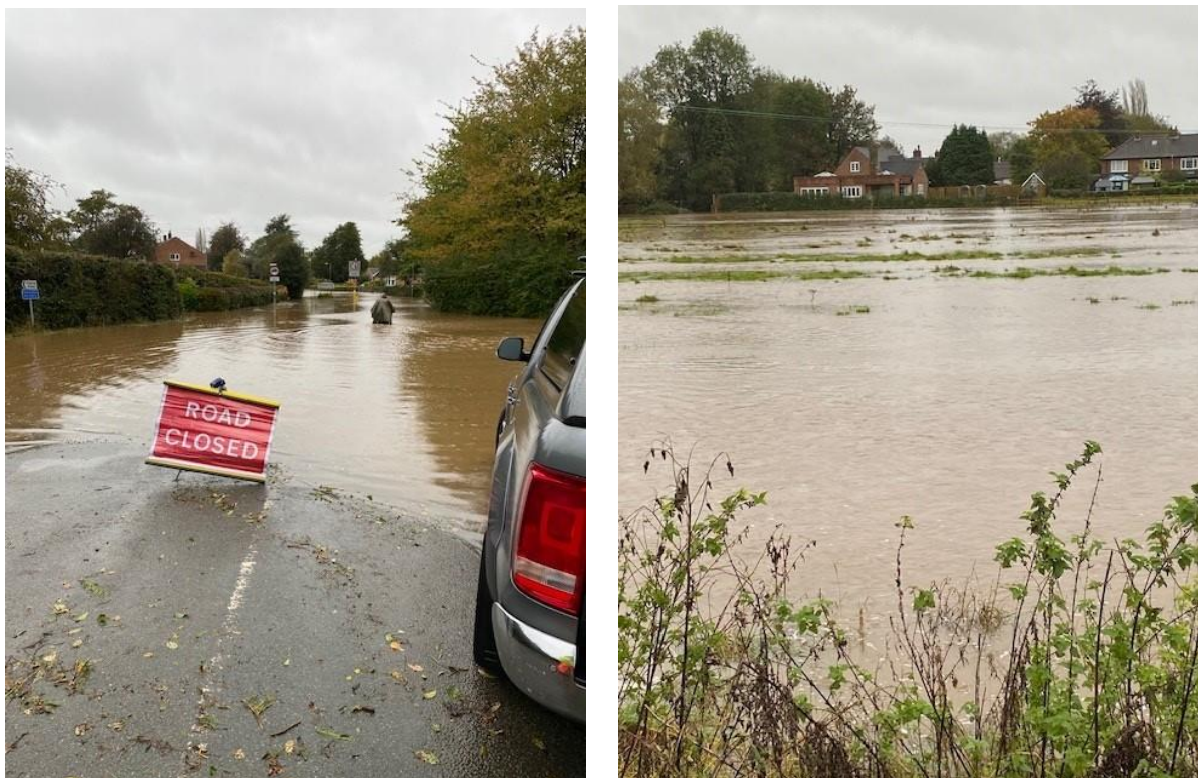
Figure 1 – Flooding in Marchington during Storm Babet, October 2023. Photos copyright of the Environment Agency.

The primary cause of flooding was found to be heavy and persistent rain from Storm Babet that overwhelmed the capacity of the main river channel. However, several specific actions were identified where improvements can be made to reduce potential flooding impacts in the future.

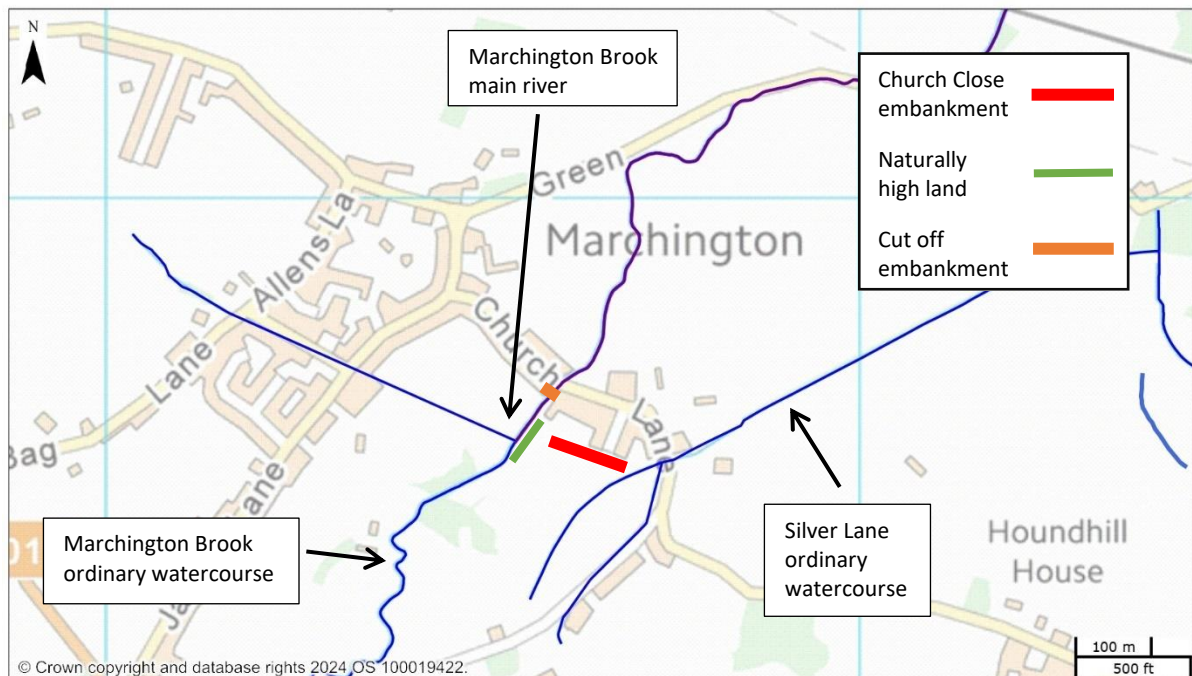
Figure 12: Map showing the Marchington Brook as main river and ordinary watercourse and the Silver Lane ordinary watercourse and the location of the Church Close embankment (red line); naturally high land (green line); and cut off embankment to hold water off road (orange line)

This historic flooding is primarily from Marchington Brook levels exceeding the capacity of the culvert under Church Lane, as well as coming out of bank further upstream of the village and flowing towards the Silver Lane ordinary watercourse. A combination of out of bank Marchington Brook levels, overland flows and road drainage issues have also previously been identified as a cause of extreme flooding in the village (for example, during the 2012 event).

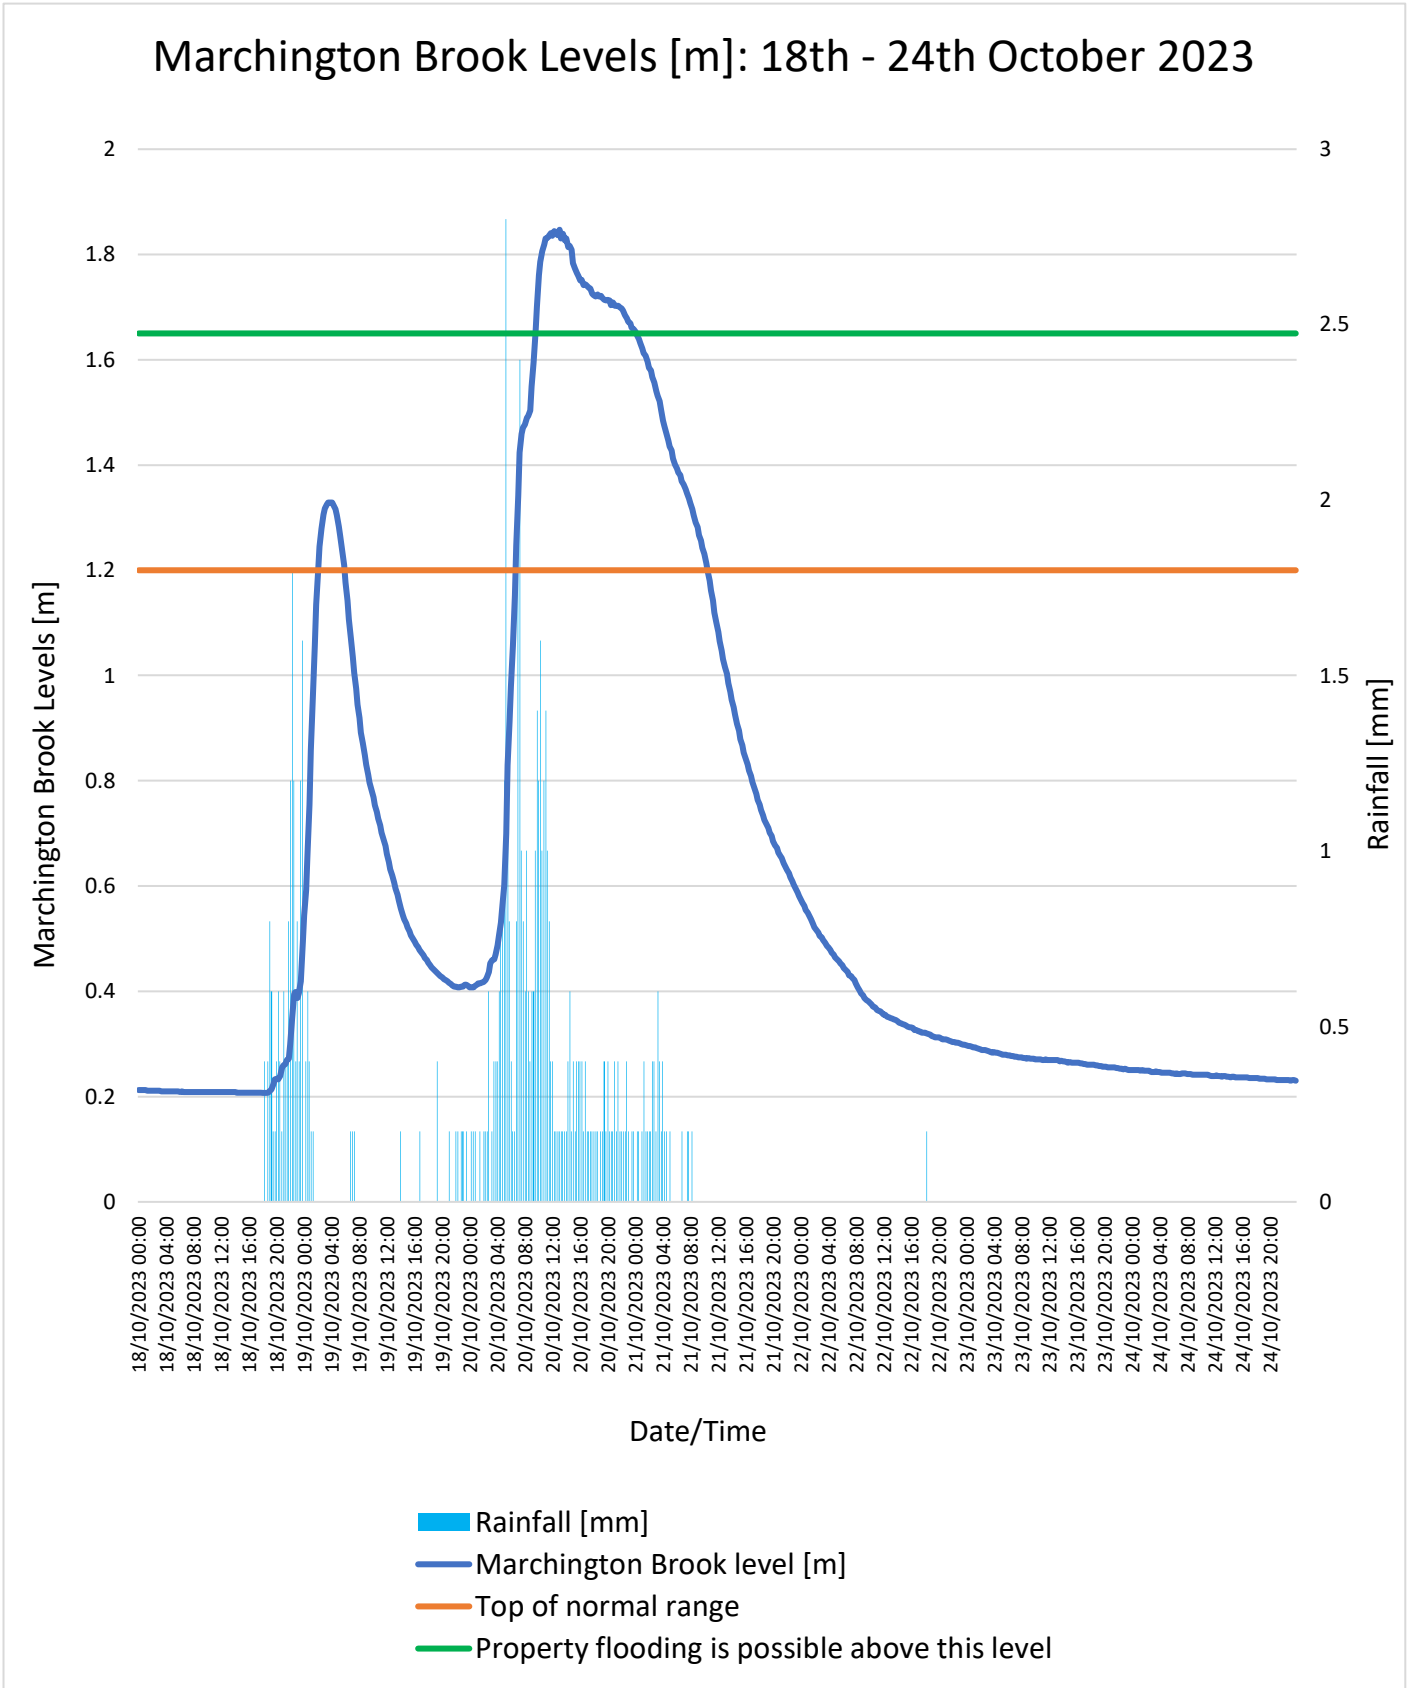
Flow within the Marchington Brook responded quickly to both the smaller rainfall event between 18 – 19 October and the heavier, more persistent rainfall between 19 – 20 October. This heavy rainfall resulted in a peak flow of approximately 6.1m³/s. The modelled hydrograph indicates this peak flow is equivalent to between and 1 and 2-year return period. This is larger than Marchington Brook flows during the previous Storm Dennis event in February 2020, than resulted as less than a 1-year return period

Figure 13: Marchington Brook levels between 18 and 24 October 2023, showing highest record level of 1.85m, alongside Uttoxeter rainfall gauge data for the same period

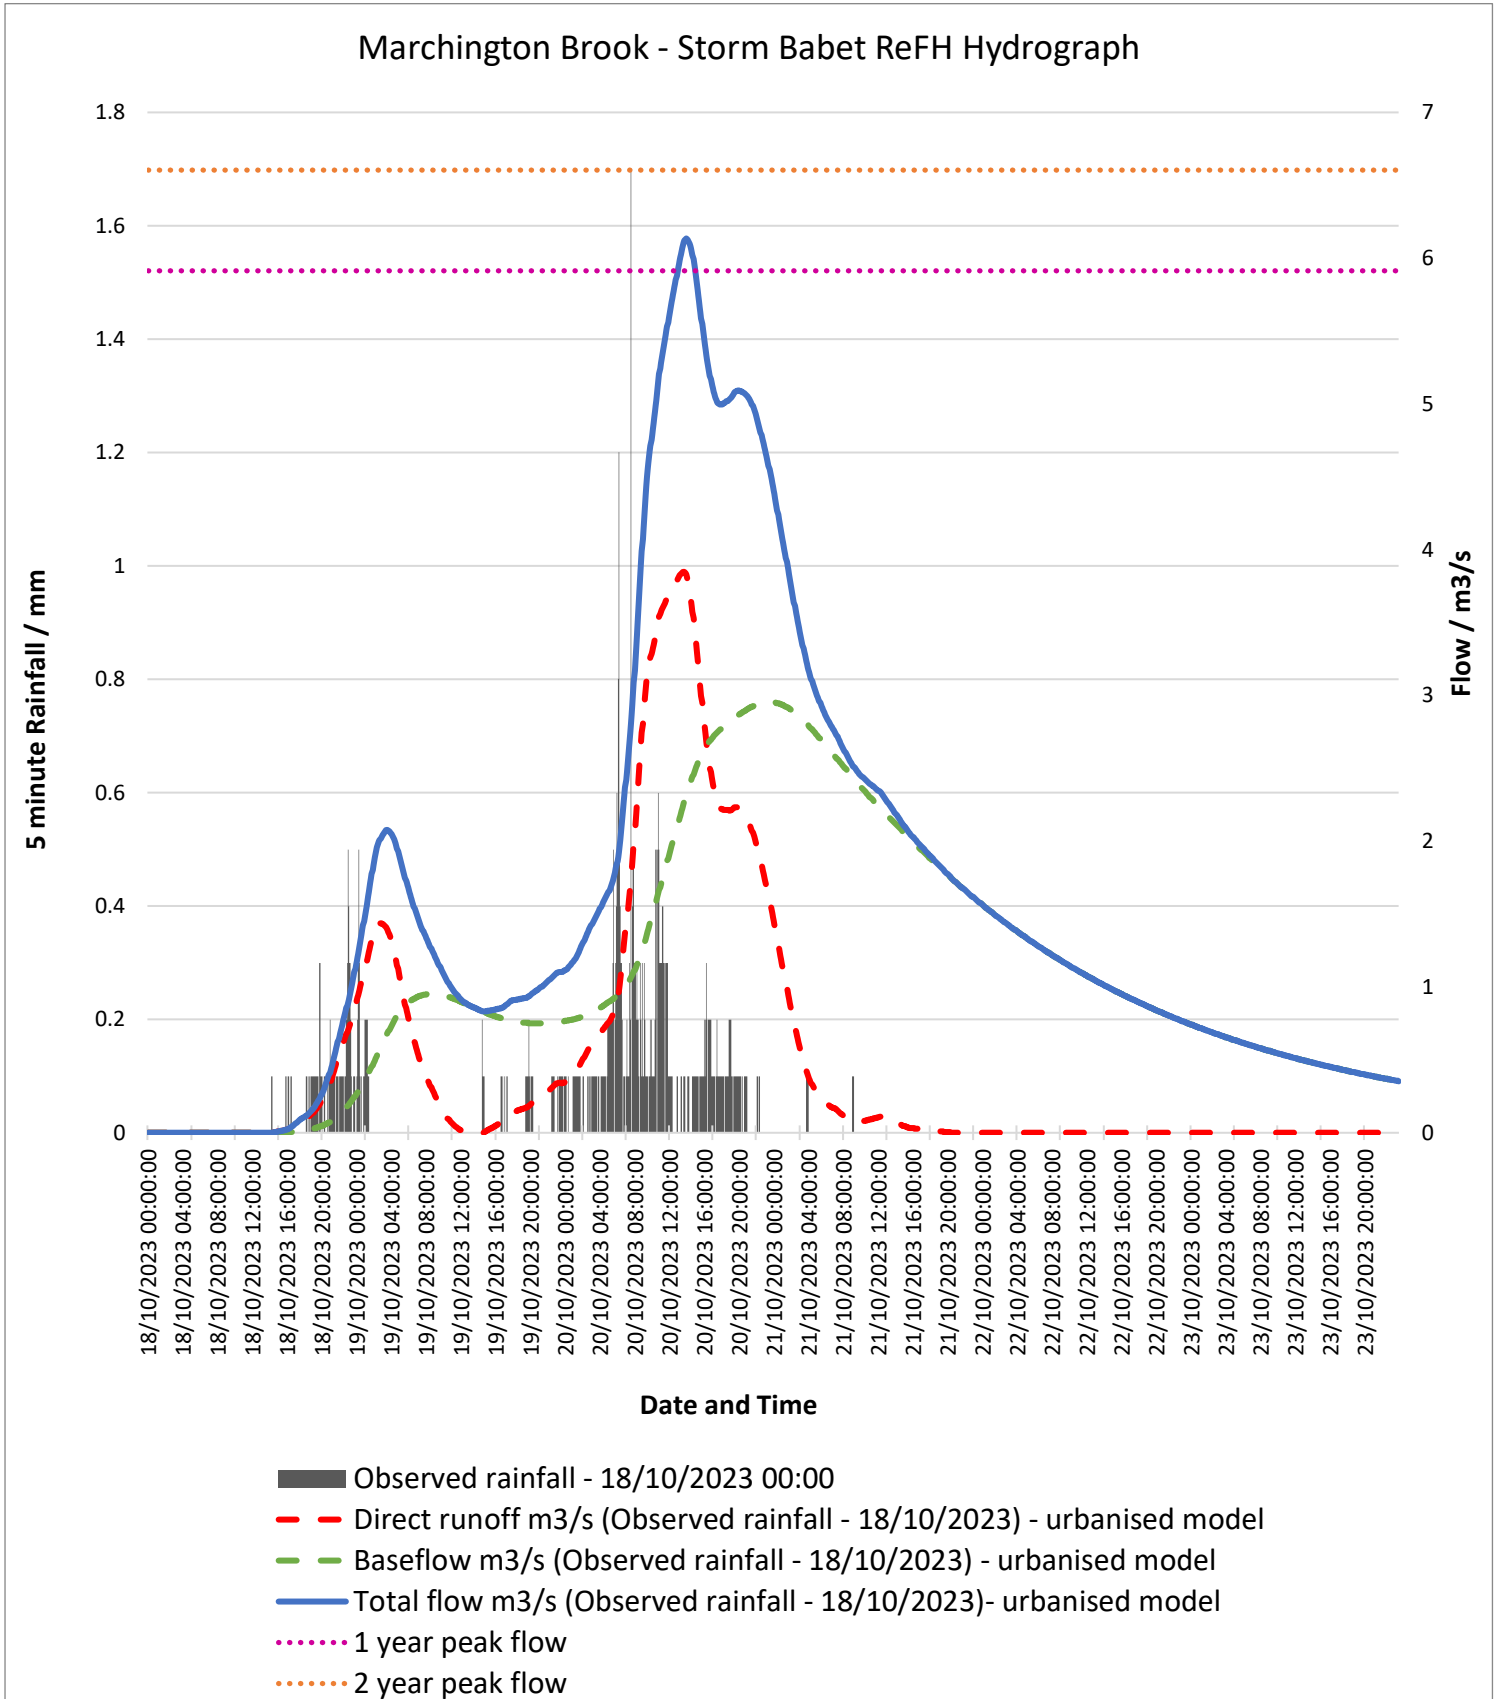
While the Marchington Brook gauge records river levels, it does not record the amount of flow. ReFH (Revitalised Flood Hydrograph) software has been used to create a hydrograph from the observed rainfall that fell during Storm Babet event (included in Figure 7 in section 4.2), the antecedent rainfall conditions for three months prior to the event, and the FEH catchment characteristics, along with a series of uncalibrated modelled hydrographs for design storms of different return periods. Comparison of peak flows enable the flow return period to be estimated (Figure 14).

Figure 14: ReFH design flood hydrograph for the Marchington Brook during the Storm Babet rainfall event (18 to 23 October 2023)

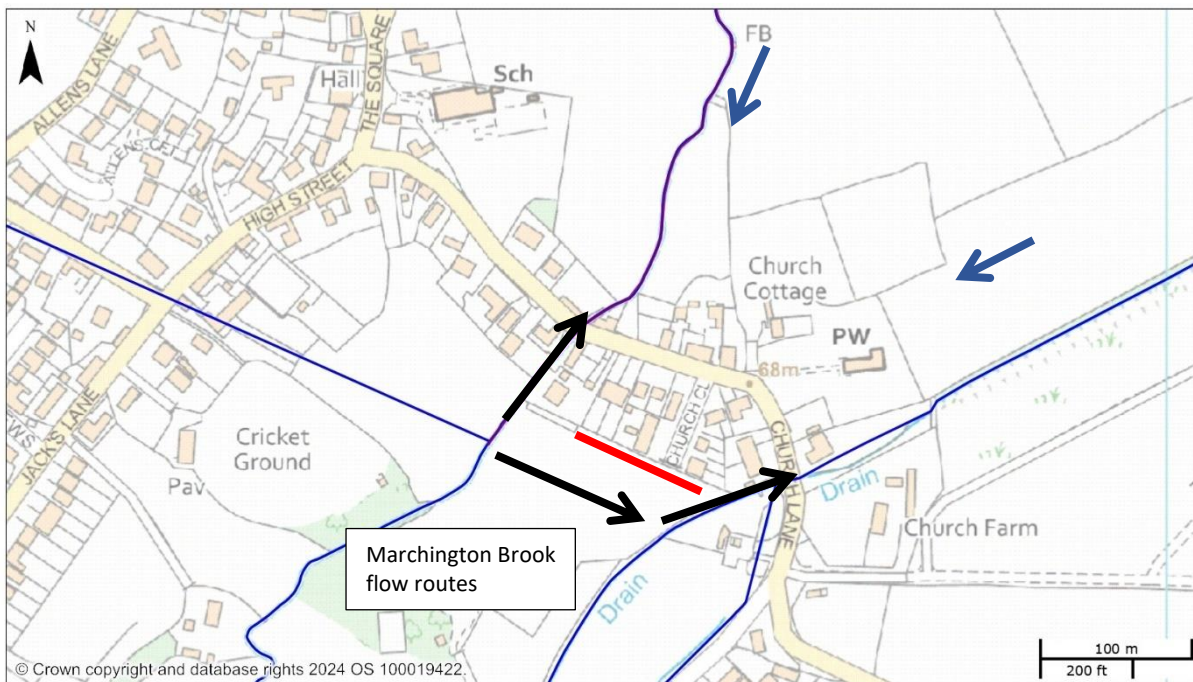
The high Marchington Brook levels exceeded the capacity of the Church Lane road bridge culvert and caused out of bank flows to spill onto Church Lane. Floodwater from the Marchington Brook also enters the Silver Lane ordinary watercourse upstream of Church Lane, Church Close and the Church Close embankment. This increased flow in the Silver Lane ordinary watercourse caused the watercourse to also exceed its culvert capacity under Church Lane and caused further floodwater to spill onto Church Lane (Figure 15). Floodwater also exceeded culverts along the Silver Lane ordinary watercourse further downstream of the village. Flood flows from the back of properties may have further exacerbated flooding in the village.

Figure 15: Flow mechanisms from Marchington Brook and Silver Lane ordinary watercourse (black arrows) where flood flows continued along Marchington Brook but also joined the Silver Lane ordinary watercourse behind the Church Close embankment (red line). Flows from the back of properties (blue arrows) may have further exacerbated flooding in the village.
