2020 Flood Events:  
Flood and Water Management Act  
Section 19 - Investigation  
Lichfield Road, A38, Branston

<b>Document Ref:</b>			<b>2020 Flooding: Section 19 Flood Investigation for Lichfield Road, Branston</b>		
<b>Revision</b>	<b>Date</b>	<b>Description</b>	<b>Originated</b>	<b>Checked</b>	<b>Authorised</b>
1	April 2022	Draft 1	Lucinda Capewell	Jamie Cooper	
2	May 2022	Draft for Partners	Lucinda Capewell	Chris Archer	
3	Dec 2022	Draft for Division	Lucinda Capewell	Chris Archer	Jamie Cooper

This report focuses on flooding associated with Storm Dennis that internally affected several properties on Lichfield Road, south of the village of Branston, on the 17<sup>th</sup> of February 2020. The investigation undertaken has been summarised, outlining the flood extent and flow routes reported, the most likely cause of flooding, and the relevant actions that have been completed or are to be undertaken in the future.

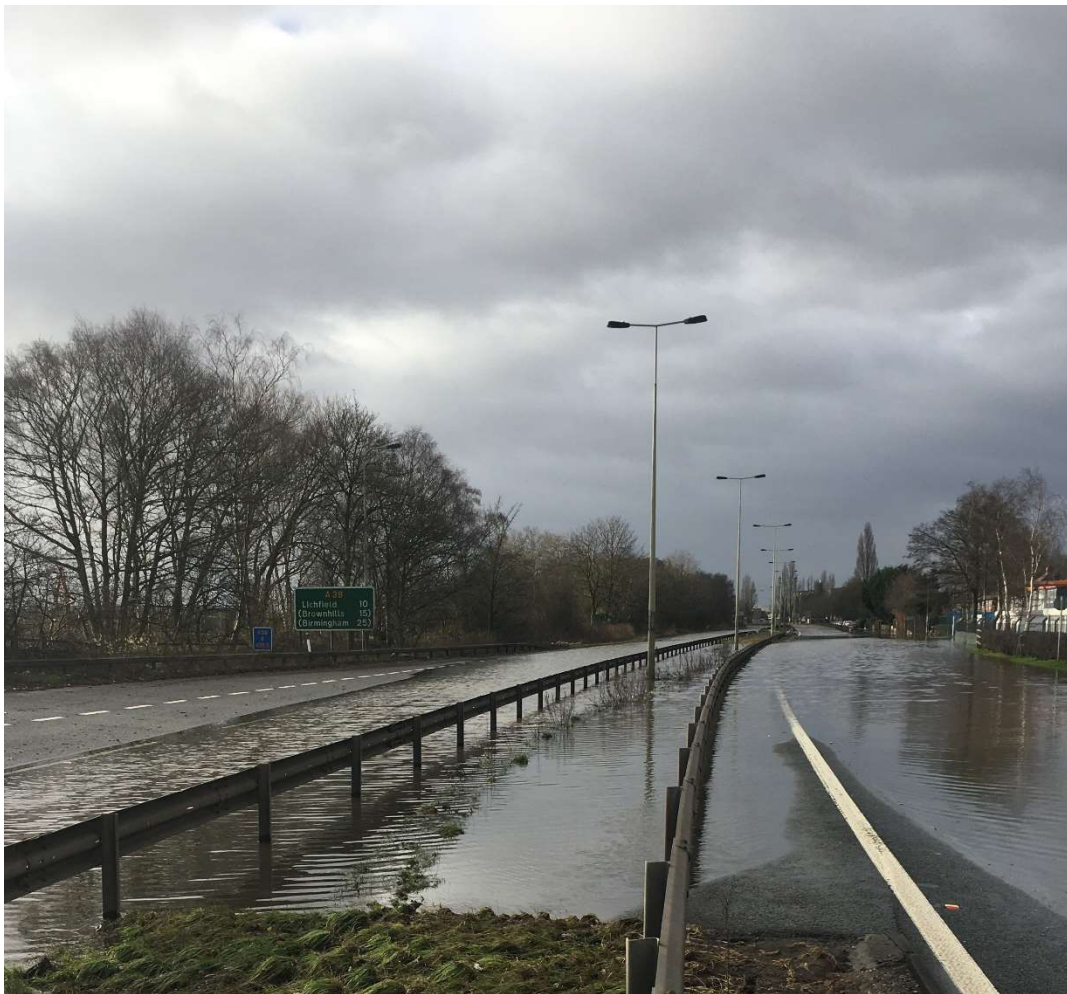
**Figure 1:** Flooding on the Lichfield Road section of the A38 (image source and rights belong to the Environment Agency)

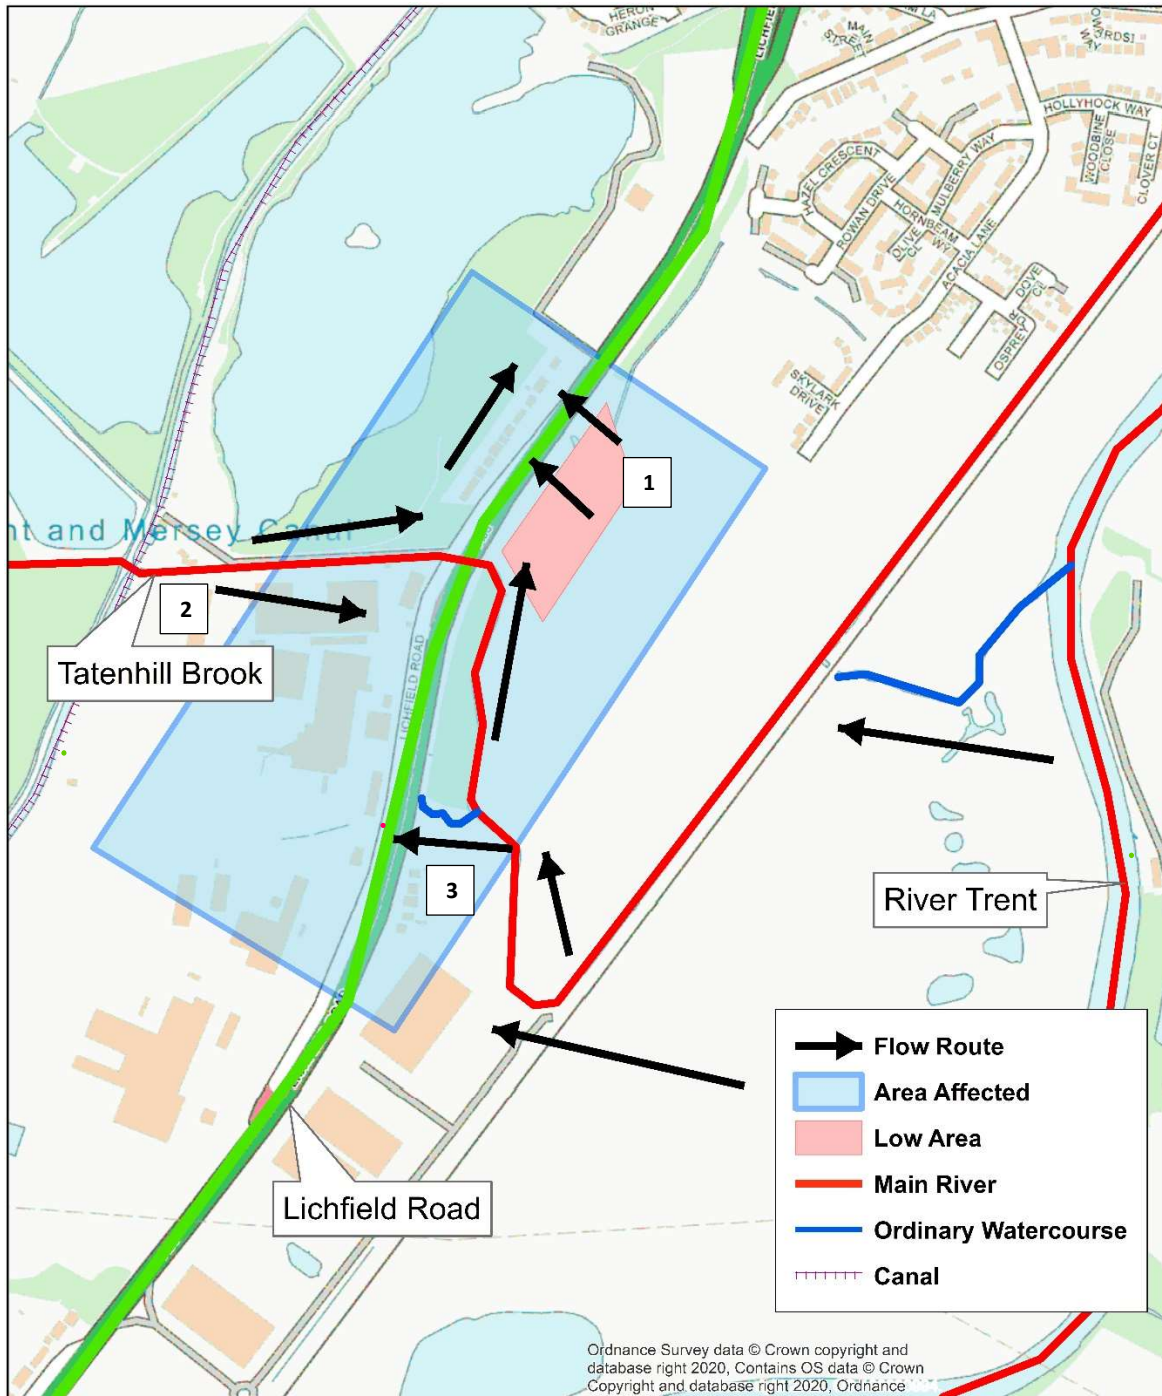
Communication from the Environment Agency on flood mechanisms and hydraulic modelling confirm the main factor causing flooding along the Lichfield Road is high River Trent levels backing up along the Tatenhill Brook and stopping flow discharging into the River Trent as it usually would. **Figure 15** shows this route of flows from the River Trent along the Tatenhill Brook to the Lichfield Road. Overtopped flow from the Tatenhill Brook on the east side of the Lichfield Road highway is subsequently redirected into an identified low spot and across the highway to inundate properties (**Figure 15, number 1**). While this is the first instance of water overflowing from the Tatenhill Brook channel, a second flood route is identified by discharge that remained in channel and continued backing up under the Lichfield Road culvert and towards the Branston Water Park area (**Figure 15, number 2**). Here, this flow overtops the channel and floods the rear of properties, exacerbating the inundation of properties.

A further route of River Trent flows backing up along the Tatenhill Brook and an unnamed ordinary watercourse (**Figure 15, number 3**) to flood the Lichfield Road around several industrial units and businesses is also identified by the Environment Agency. These flood flows can result in ingress of river flows into the Severn Trent Water foul sewer system, as well as by manholes and drains for sewage systems and highway drainage.

**Figure 15:** Map of the area on Lichfield Road that was affected by flooding on the 16th and 17th of February 2020 primarily due to Tatenhill Brook flow backing up from high River Trent levels and entering a low area, and some potential overtopping

To reduce this flood risk, an Environment Agency scheme for the Lichfield Road and Branston area, working in partnership with the relevant RMAs, has been incorporated into the improvement works for the Burton Flood Alleviation Scheme. The scheme is designed to hold high River Trent flows in the Tatenhill Brook channel and reduce overtopping in two areas with sheet piling walls (**Figure 15, numbers 1 and 2**), and to stop ordinary watercourse flows discharging onto the highway (**Figure 15,**

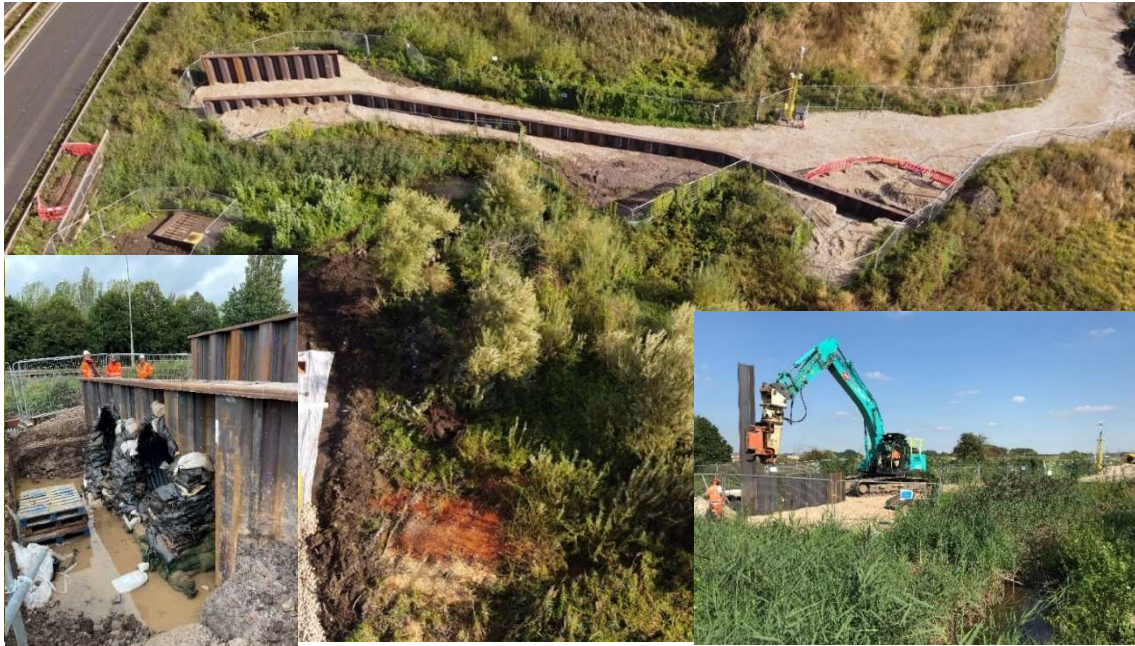
**Figure 16:** Construction of the scheme in area one, the low spot on the east of the Lichfield Road highway (image source and rights belong to the Environment Agency)

Construction for this phase of the scheme began in July 2021, with the area around the Tatenhill Brook low spot and the majority of sheet piled flood protection walls completed by winter 2021-2022. The whole scheme was completed in June 2022.

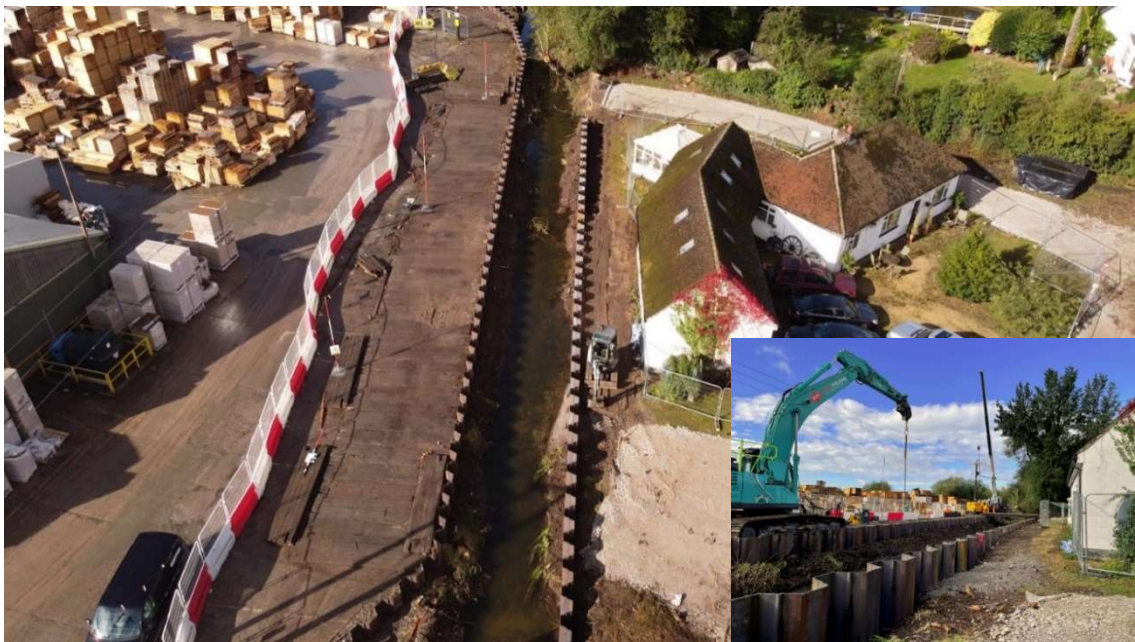
**Figure 17:** Construction of the scheme in area two, alongside the Tatenhill Brook (image source and rights belong to the Environment Agency)

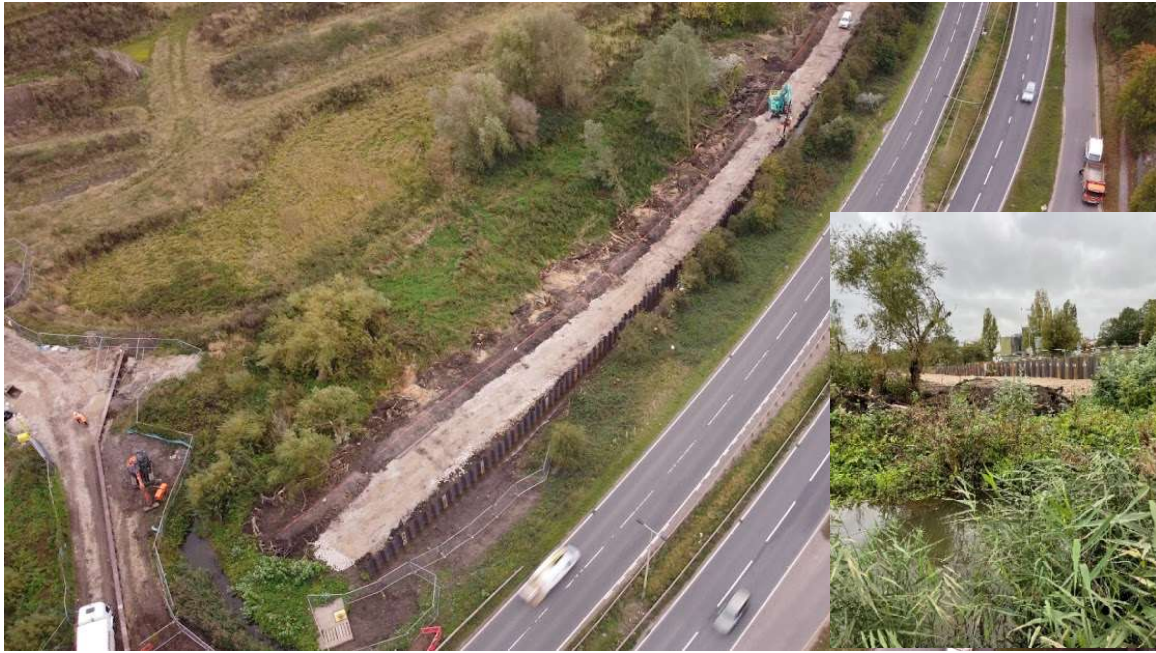
**Figure 18:** Construction of the scheme in area three, alongside the east of the Lichfield Road/A38 (image source and rights belong to the Environment Agency)
