2020 Flood Events:
Flood and Water Management Act
Section 19 - Investigation
Church Lane, Marchington

Flooding at Church Lane road bridge, Marchington

This report has been prepared by Staffordshire County Council as Lead Local Flood Authority for Staffordshire County, under Section 19 of the Flood and Water Management Act 2010, with the assistance of the Environment Agency and Severn Trent Water.

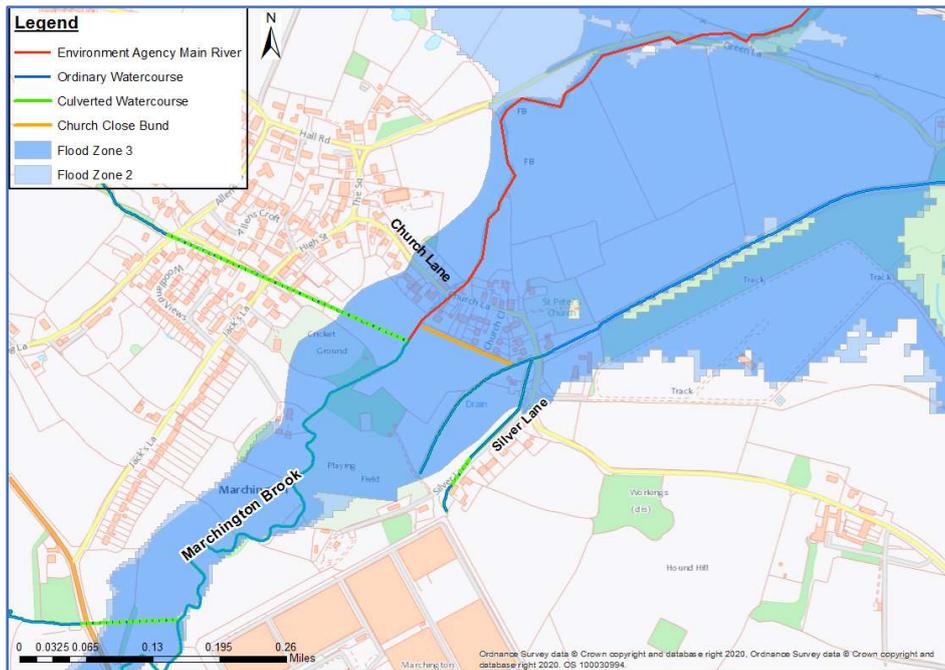
Figure 8: Environment Agency Risk of Flooding from Rivers and Sea (RoFRS) map demonstrating Flood Zones 2 and 3 at Church Lane, Marchington

Church Lane is at risk of flooding from multiple sources. Figures 8 and 9 below demonstrate the Environment Agency's Flood Zones from Rivers and Sea (RoFRS) and the Risk of Flooding from Surface Water (RoFSW) maps for Church Lane, Marchington.

The Environment Agency's Flood Zone map clearly shows the risk of flooding to Church Lane from Marchington Brook, with large parts of the road located within both Flood Zones 2 and 3 (Figure 8). Areas both upstream and downstream of Church Lane are also shown to be at risk.

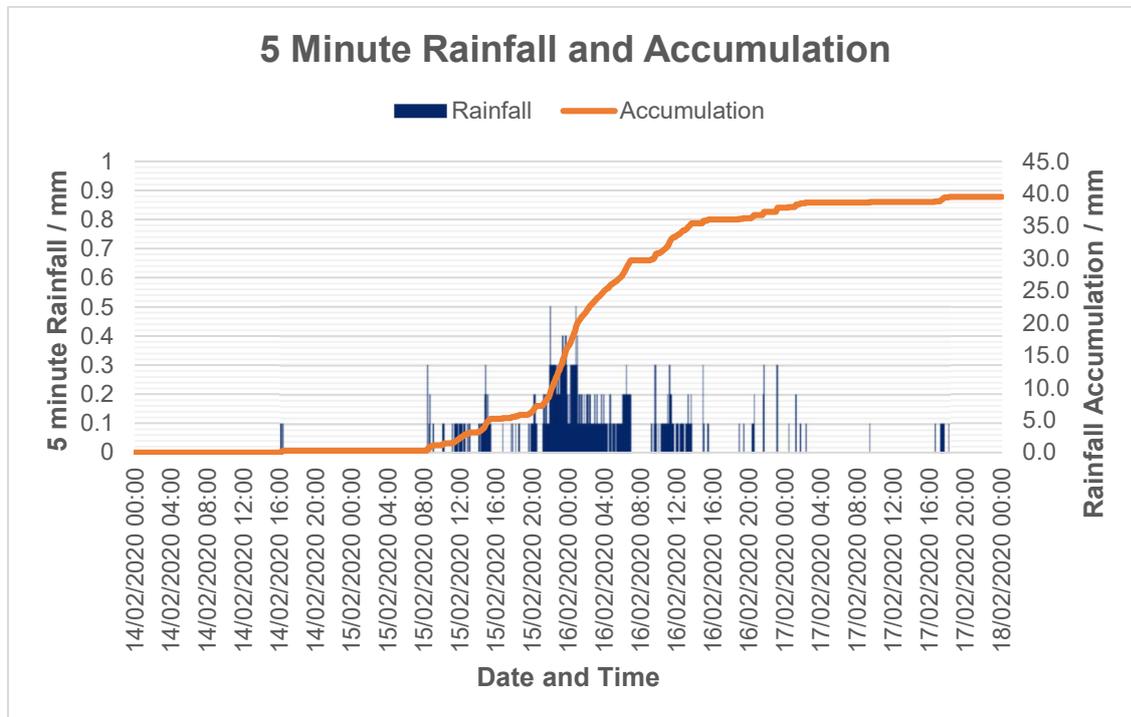
Figure 10 shows the recorded 5-minute HydroMaster rainfall data for Marchington. A total of 37.5mm of rainfall was recorded over the 24 hour time period 15th February 2020 to 16th February 2020. There were several shorter periods of rainfall prior to a more significant period of rainfall which started around 21:10 on the 15th February. Of the total rainfall recorded during the event, 22.5mm was recorded during a 17-hour period between 21:10 on February 15th and 07:00 on 16th February 2020 demonstrating that the storm was intense with rainfall falling continuously throughout the duration of the storm.

The intense period of rainfall prior to the flooding incidents that occurred across the County resulted in significant volumes of surface water flowing over what was already saturated ground.

Analysis of rainfall data in HydroMaster has estimated the rainfall return period of the February 2020 event to be between a 1 and 2 year event (Table 1) and calculations undertaken by the Environment Agency have suggested that the rainfall event equates to a 3 year rainfall event. Whilst this appears relatively insignificant, historic average annual rainfall data from the MET Office shows that for the nearest rain gauge to Marchington (Denstone), the average annual rainfall for the month of February is 62.05mm (based on the baseline climate period 1981 to 2010). Therefore, more than 50% of the monthly rainfall fell over the Marchington area in the two day period between 15th February 2020 to 16th February 2020, making it significant to the area.

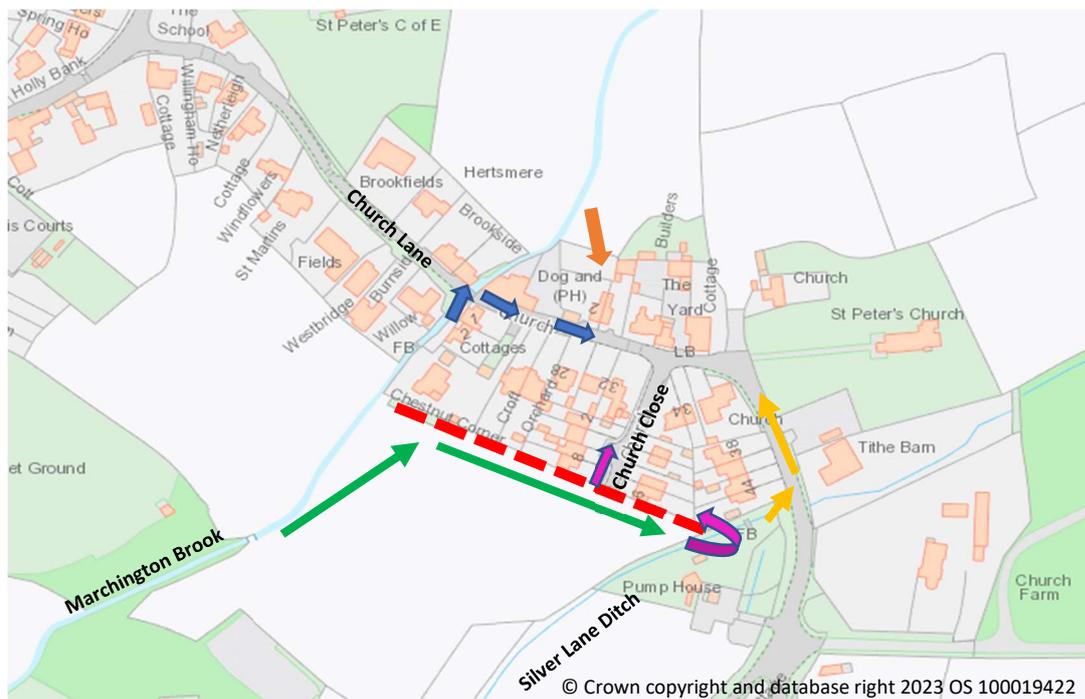
Figure 11: Observed flow routes at Church Lane, Marchington

Figure 11 demonstrates the main observed flow routes at Church Lane with the following sections describing these in more detail.

During the February 2020 event, flooding to property situated towards the eastern edge of the village was also reported. Floodwater was observed spilling from the left bank of Silver Lane ditch onto the road, flowing down the road towards the village (Figure 11, yellow arrow). The ditch receives surface water flows from Marchington Industrial Estate, situated to the south. Flows from the Industrial Estate enter the ditch via a 900mm culvert pipe and then flow parallel to Silver Lane. The ditch is then culverted through two 900mm circular culverts beneath Silver Lane/Church Lane. Flooding to properties at this location occurred as a result of the high volume of water in the channel that backed up behind the culverts, spilling onto adjacent land and following the prevailing topography down Church Lane towards the lowest point in the village at the Post Office. Past site investigations have shown that the ditch course is unmaintained and open to livestock through its length, leading to some parts of the bank collapsing.

A further identified flow route is downstream of Church Lane road bridge. Anecdotal reports from residents also describe water spilling from the right bank of Marchington Brook downstream of Church Lane bridge. Water was observed flowing across the fields towards the Dog and Partridge public house into the gardens behind properties on Church Lane (Figure 11, orange arrow). The prevailing topography directs flood water from the brook towards the gardens of properties on Church Lane and onto the road itself.

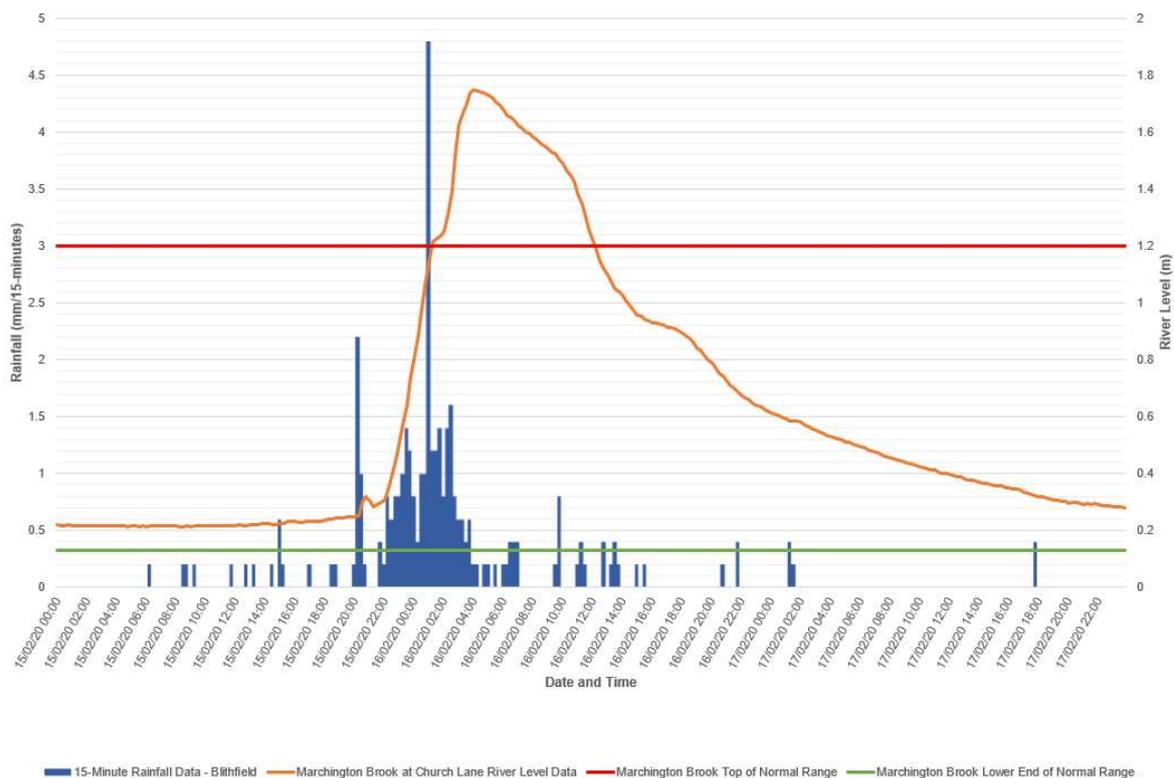
Figure 12: Recorded river level data for the Marchington Brook during the Storm Dennis event on 15th and 16th February 2020 (Data Source: Environment Agency)

Figure 12 overleaf shows that there were two 15 minute periods of exceptionally intense rainfall on 15th February at 20:00 and 01:45 on 16th February. The Environment Agency has a continuous water level gauge on the Marchington Brook located directly upstream of Church Lane. Environment

Agency recorded river level data show that these two intense periods of rainfall triggered a rise in Marchington Brook levels, and at 04:00 on the 16th February, the river gauge at Marchington recorded the third highest level since the installation of the river gauge in 2000, peaking at a level 1.75m (Figure 12). The water from the brook, combined with the accumulation of surface water resulted in flooding to properties along Church Lane. In addition, given the high water levels in the brook, the local surface water drainage system was unable to discharge into the river, resulting in surcharging of drains and surface water flooding to the highway.

Discussions with representatives from the Environment Agency indicate that modelling work undertaken following the storm has estimated that the event corresponded to an event with a 3.33% Annual Exceedance Probability (AEP), or a 1 in 30 year chance of occurring.
