**2020 Flood Events:**

**Section 19 - Investigation**

**Mead Crescent & Manor Crescent,  
Stapenhill, Burton-Upon-Trent**

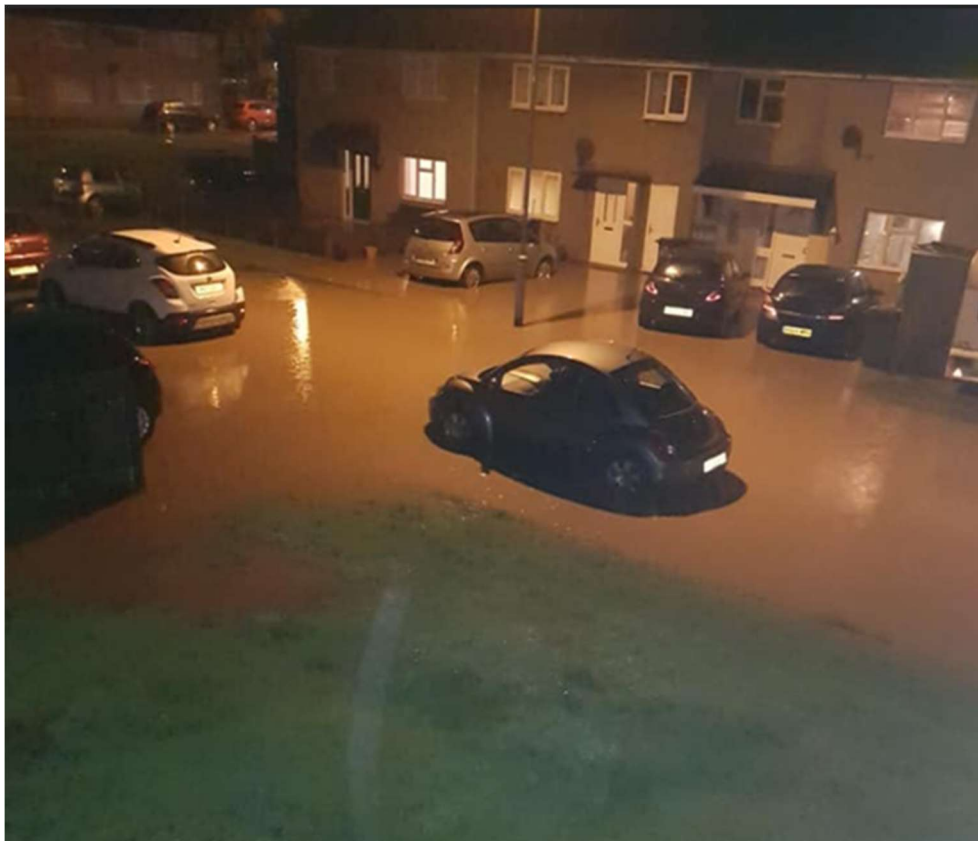
Figure 1: Flooding at Mead Crescent in February 2020 (Image provided by the Housing Association)

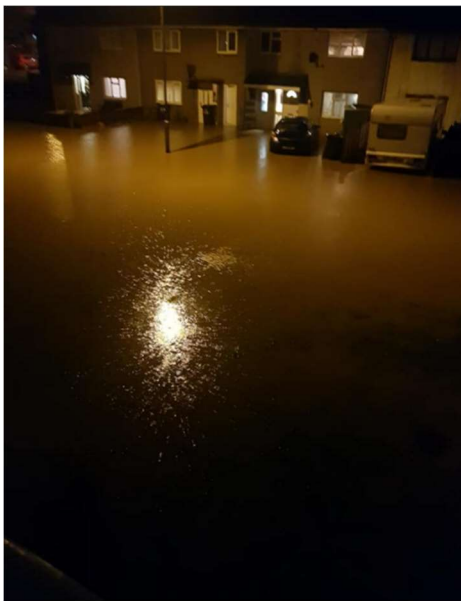
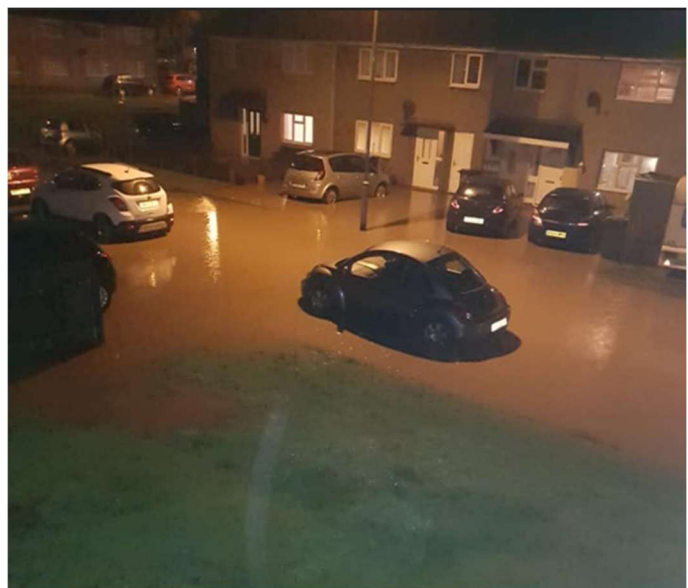
Accounts from residents describe how surface water was observed flowing from nearby fields to the rear of the properties along Mead Crescent, before entering homes from both the front and rear of the properties. Several residents described how furniture was damaged and carpets and flooring ruined throughout the downstairs of their properties. In addition, flooding was also experienced to gardens, driveways and the highway. Figure 11 below presents two photographs taken by residents on the evening of the flood event and shows flood water up to the front doors of properties and along the highway of Mead Crescent.

**Figure 11:** Photographs taken along Mead Crescent on the evening of 16th February 2020 (Images provided by the Housing Association).

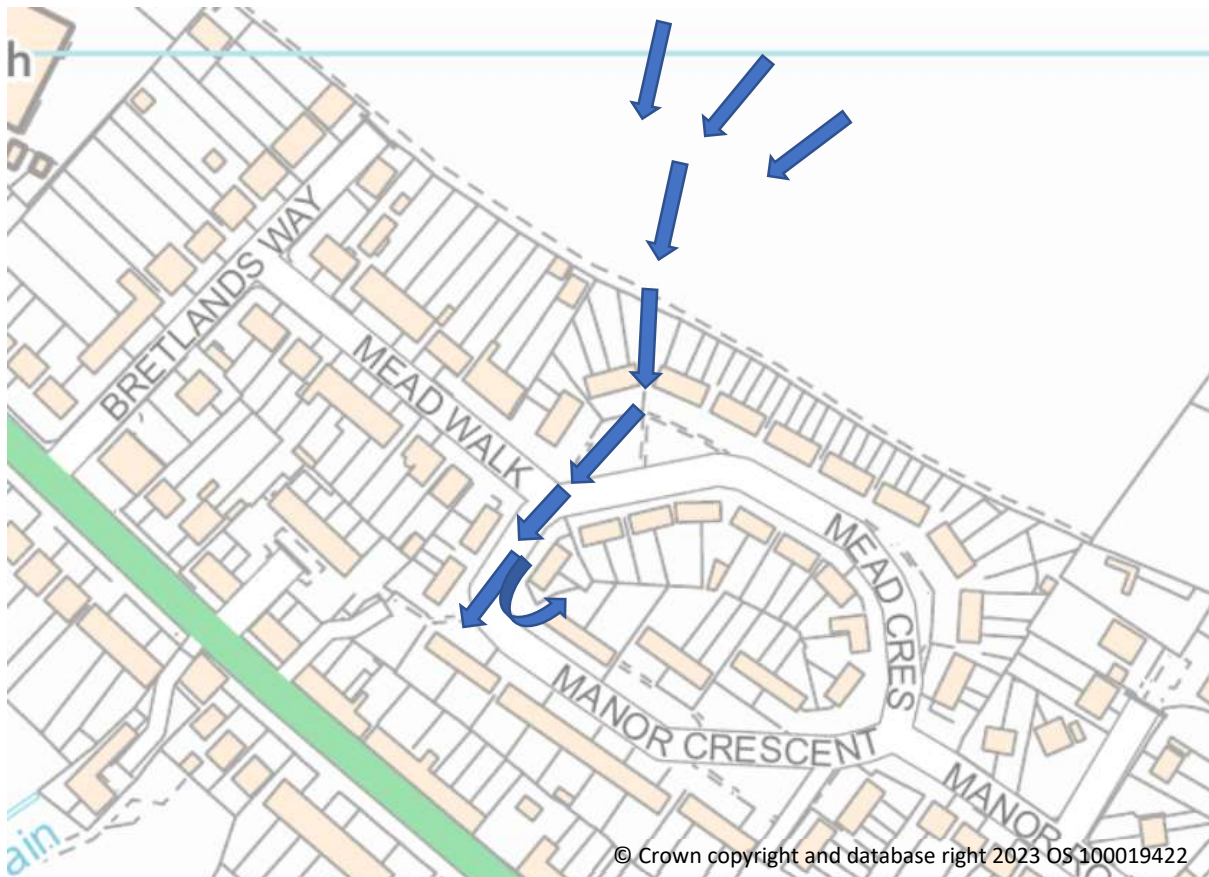
**Figure 13:** Blue arrows demonstrate the flow routes observed during the February 2020 event

Analysis of the rainfall data from the event has indicated that Storm Dennis was a medium intensity storm, with prolonged periods of heavy rainfall. The Housing Association representative described how water flowed from the field to the rear of Mead Crescent and filled the drainage ditch which became overwhelmed and part of the bund between the ditch and houses was washed away by the flood water. The flood water then followed the prevailing topography, between a gap in the properties along Mead Crescent and down towards Manor Crescent (Figure 13), resulting in internal flooding to several properties along Mead Crescent and Manor Crescent.

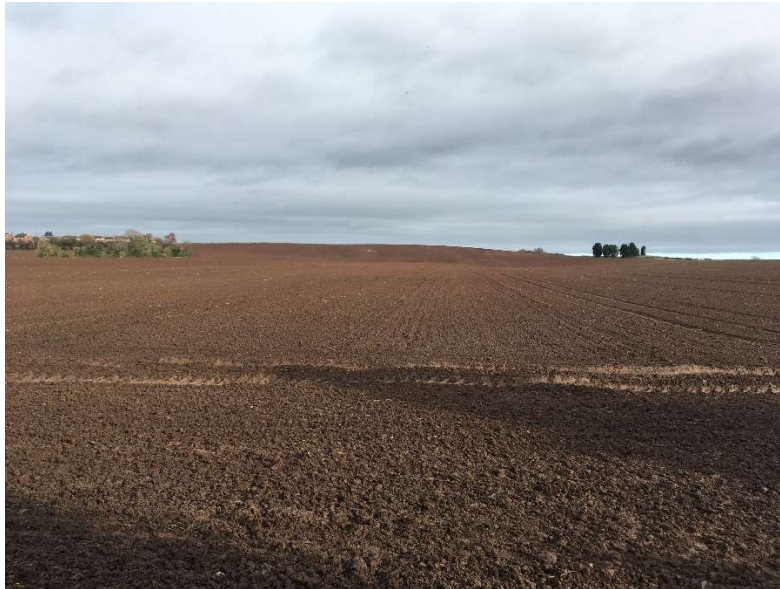
contributed to an increase in surface water flowing overland towards the ditch. Site observations following the event have shown the field to be well compacted (Figure 14) and it was reported that the field had been ploughed in a north to south direction, possibly creating drainage channels towards the ditch.

**Figure 14:** Looking in a northerly direction across the field from Culvert A  
(Photograph taken in November 2020)

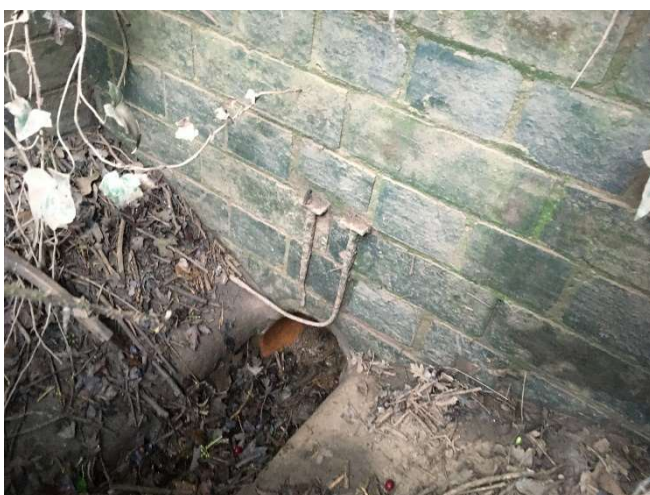
Site observation of culvert A indicates that the outlet pipe from the field comprises a 150mm diameter pipe (Figure 15) with trash screen (bar spacing approximately 90mm) situated above the inlet structure (Figure 17). Anecdotal evidence from the event has indicated that the pipe had

**Figure 15:** Culvert A outlet pipe from field following removal of blockage observed on site (photograph taken in November 2020)

insufficient capacity to convey the volume of flood water from the ditch into the downstream surface water sewer, becoming overwhelmed and quickly reaching its capacity.

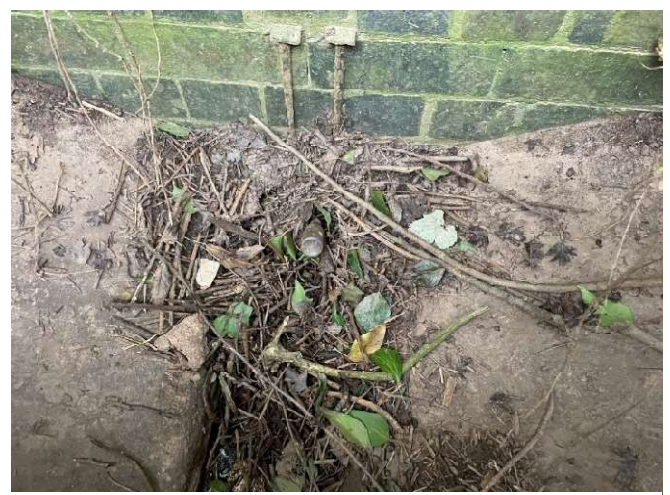
**Figure 16:** Culvert A outlet pipe from field with blockage to pipe as observed on site in March 2022

Whilst no reports of blockage to the culvert of inlet screen have been received as part of this investigation, during the site visit the trash screen at the culvert inlet appeared to be damaged and the outlet pipe was completely blocked with debris (Figure 15 and Figure 16).

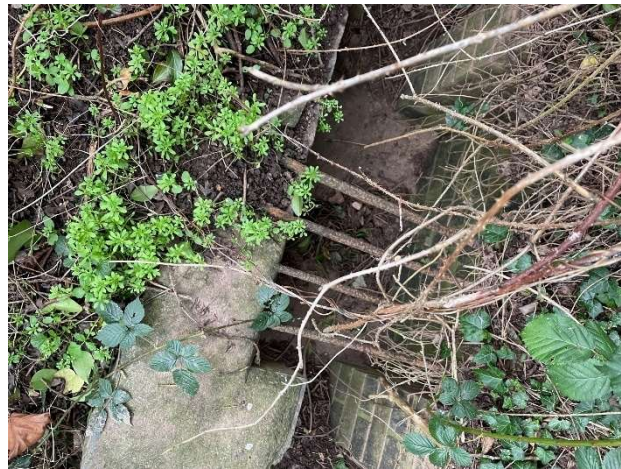
**Figure 17:** Trash screen situated above culvert outlet pipe A

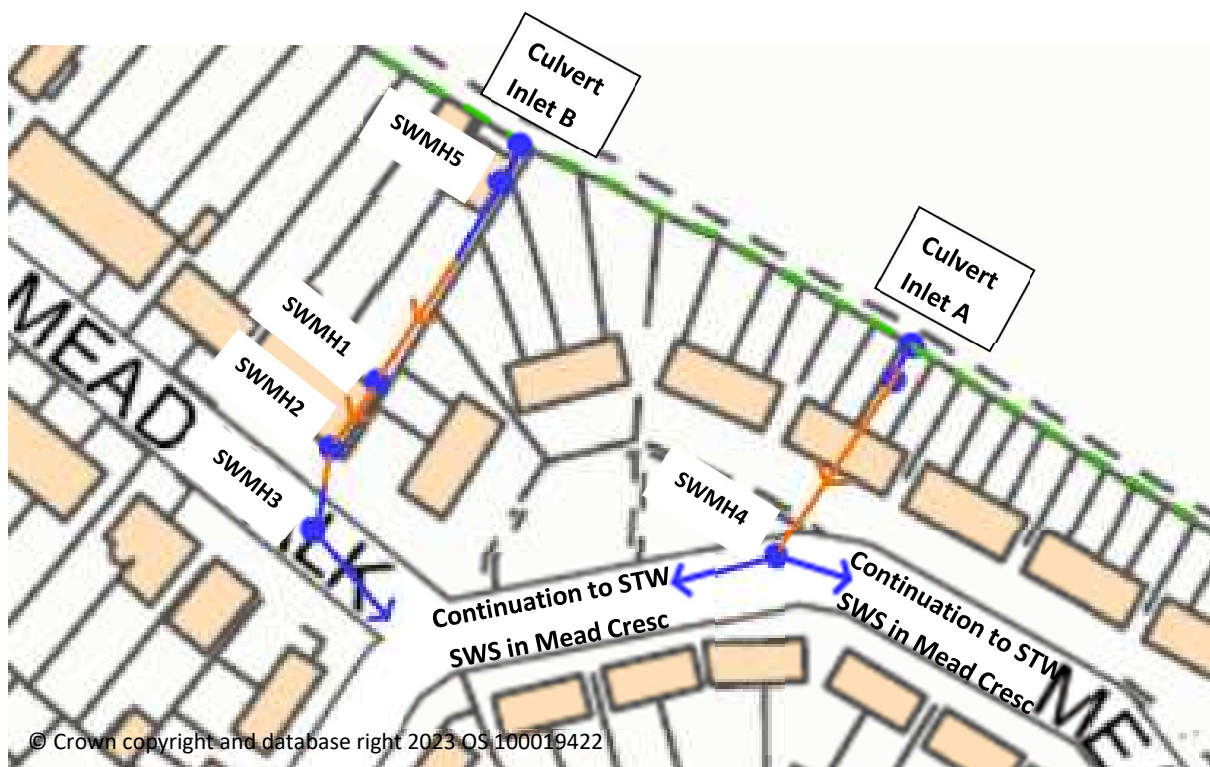
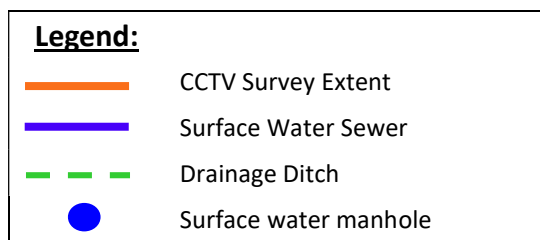
**Figure 18:** Approximate location of CCTV survey undertaken on 13<sup>th</sup> April 2022 showing extent of CCTV survey sections (orange line) and location of identified surface water sewer (SWS) manholes and continuation to Severn Trent Water (STW) Surface Water Sewers (SWS).

Section 1 surveyed in a northerly direction upstream from SWMH1 towards Culvert Inlet Pipe B. This showed the 300mm diameter vitrified clay pipe with no major defects. Several incoming pipes were identified along the route which are likely to be surface water connections from adjacent properties. At 22m, there was a build-up within the pipe and the camera was unable to progress. This is likely to be a build-up of sediment from the agricultural land to the north. The build-up did not present an obstruction to the water flow which was observed to continue to flow through downstream sections of the pipe.

CCTV survey of the surface water sewer connecting to culvert inlet Pipe A was also undertaken. A length of approximately 30m was surveyed from SWMH4 in a northerly direction towards the field ditch. Several incoming connections were identified during the survey. Whilst no major defects were observed, the surveyed was abandoned at approximately 26m. As with Pipe B, this is likely to be a build-up of sediment from the field.

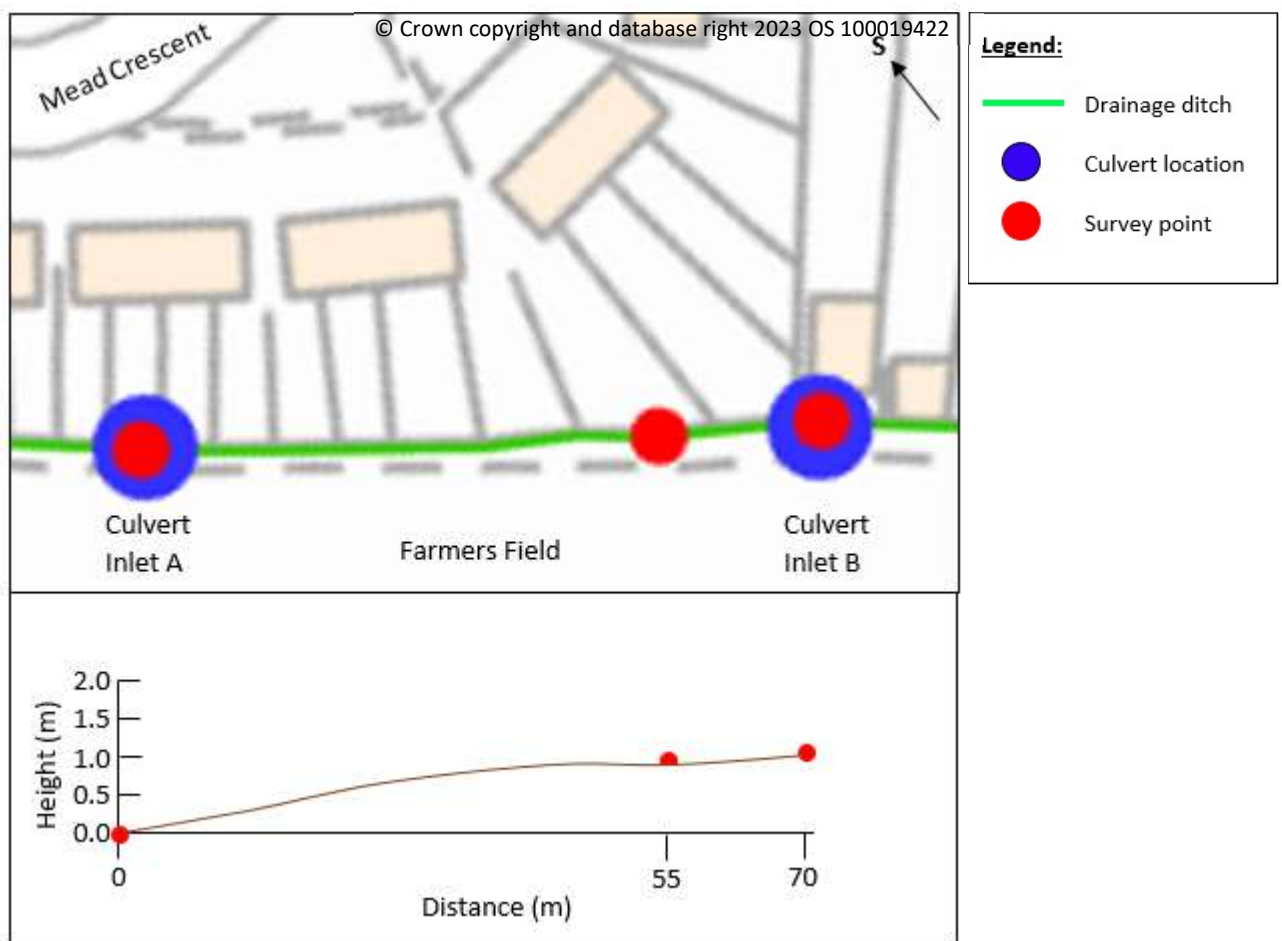
**Figure 19:** Sketch demonstrating locations of surveyed ditch bed levels and increase in ditch bed invert level between Pipe A and B.

The surveyed levels indicated that the invert level of Pipe B was approximately 1.0m higher than the invert level of Pipe A (Figure 19). Observations showed a rise in the ditch bed level between the two pipe inverts. Review of OS contour data for the field and site observations indicate that the

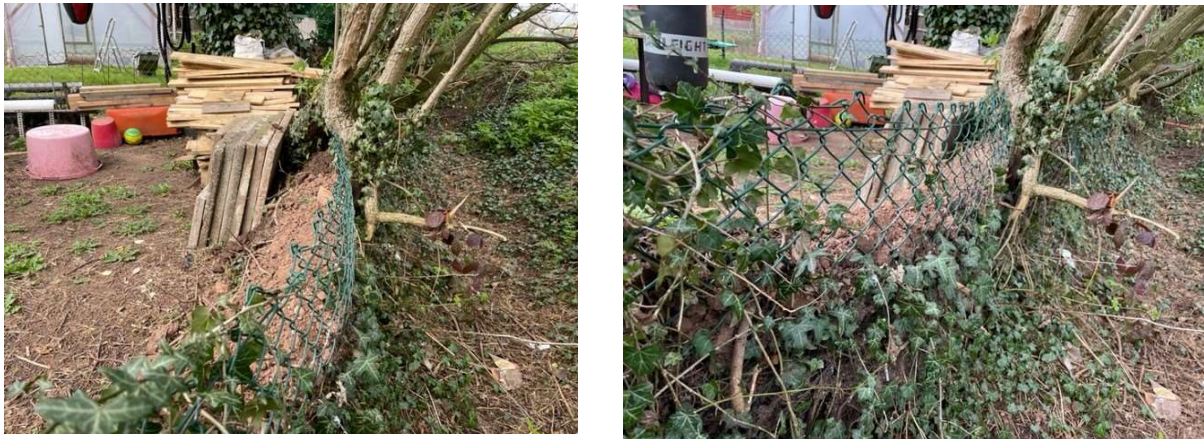
The photographs in Figure 20 below the southern side of the drainage ditch where it backs onto the Mead Crescent properties. An informal soil bund has been built up along the wire mesh fence forming the boundary between the ditch and gardens. The height of the bund varied along the length of the ditch. Initial surveyed levels show the bund to be approximately 0.6m above the top level of the drainage ditch at a point 55m along the ditch between Pipe A and Pipe B. Whilst this will have provided some protection from the flood water, it is likely that the volume of water will have quickly infiltrated into the soil, breaking it up and washing parts of it away during the event. Any subsequent flood water will have then flowed into the gardens and followed the prevailing topography towards Mead Crescent and Manor Crescent.

**Figure 20:** Photographs demonstrating the informal bund between drainage ditch and gardens of properties along Mead Crescent
