# 2020 Flood Events:

# Flood and Water Management Act

# Section 19 - Investigation

# The District of South Staffordshire

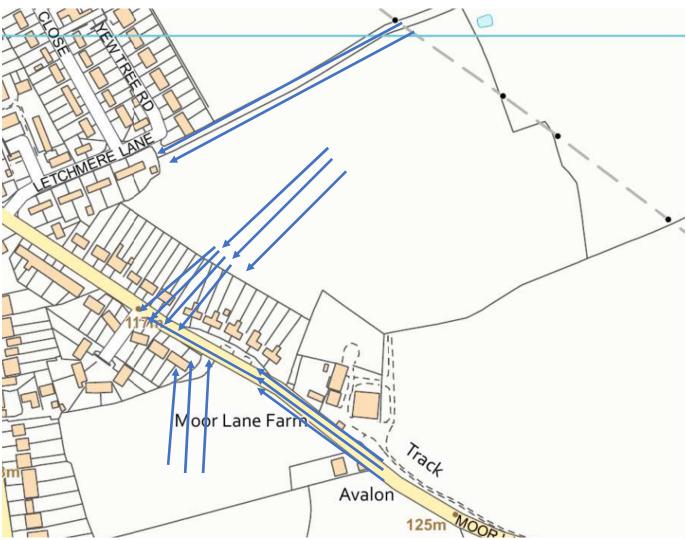
Figure 4: Flow Directions (blue arrows).

surrounding roads, driveways and gardens, both on Moor Lane and the Elms Paddock. It was reported that the flooding came from the agricultural land to the north of Moor Lane, as well as surface water runoff down Moor Lane itself and the field to the south of Moor Lane. Drainage along the north-western boundary of New Peace field (the extension of Letchmere Lane) reportedly conveyed flows south westwards also. Drainage infrastructure on Moor Lane reportedly was overwhelmed. Water flowing from the fields to the North of Moor Lane also reached properties in the opposite side of the road, via gardens and also the highway.

Recommended Actions	Identified Party / RMA
More evidence to be sought regarding flooding to properties for which we do not have data.	SCC (LLFA and Councillor)
Highway Gullies to be put on regular maintenance rota.	Highways (SCC)
Highway drainage system to be surveyed and cleared.	LLFA (SSC) /Highways (SCC)
Engagement with surrounding landowners to discuss options for mitigation.	LLFA (SCC) / Landowners
Follow up eligibility for grant funding for relevant properties.	SSDC / LLFA (SCC)

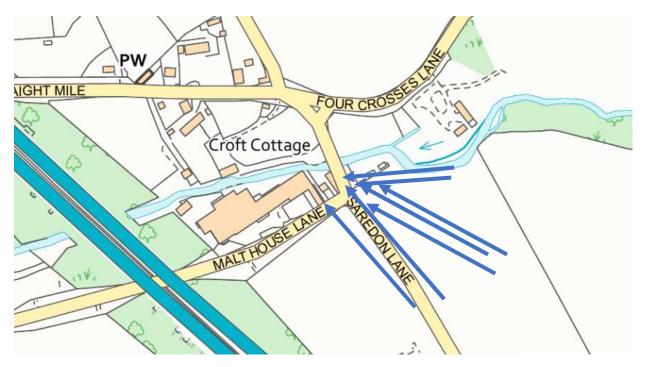
Figure 5- Surface water flow routes (blue arrows)

It is reported that water flows down Saredon Lane, bypassing drainage, through an access gate and into rear gardens of the properties. Four Crosses Lane is also said to flood in three places, not allowing vehicles to pass. The highway floods extensively in this location with water being unable to return to the Saredon Brook.

Recommended Actions	Identified Party / RMA
Affected properties to be offered individual property level flood resilience	SCC (LLFA)
Staffordshire County Council Highways to ensure gullies are maintained and kept clear. Important to ensure existing gully infrastructure is regularly maintained. To consider installing additional gullies in highway.	Highways (SCC)
Environment Agency to be informed to ensure Saredon Brook is maintained appropriately.	SCC (LLFA) / EA
To engage with local landowners to ensure surface water is allowed to flow freely on its natural course.	SCC (LLFA) / Landowner

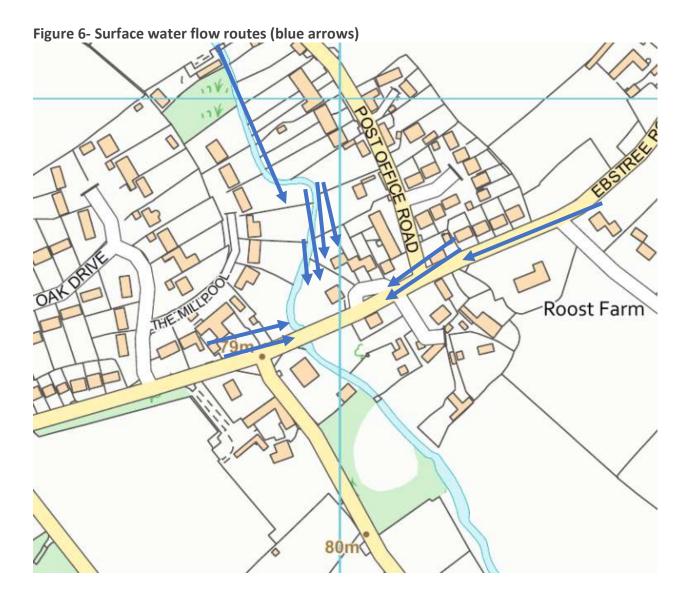
The source of the flooding in this location primarily originated from the Smestow Brook (Main River), which overtopped its banks and inundated surrounding land and property. Surface Water also flowed down Ebstree Road, bypassing drainage infrastructure- therefore exacerbating the flooding issue.

The flooding in this location has been determined to be from Main River (fluvial), Surface Water Runoff, as well as runoff from the highway. Therefore, a multi-agency approach is required in this location. Staffordshire County Council Highways has been contacted to ensure that the gully infrastructure is free and functioning correctly. The Environment Agency will be contacted to recommend that the location assessed appropriately.

Recommended Actions	Identified Party / RMA
LLFA (SCC) to contact and liaise with EA to understand catchment dynamics	SCC (LLFA) / EA
and possible mitigation.	
SCC (Highways) to ensure gully drainage infrastructure is maintained and	SCC (Highways)
functioning correctly.	
SCC to work with residents and local elected members to ensure disseminate	SCC (LLFA)
information.

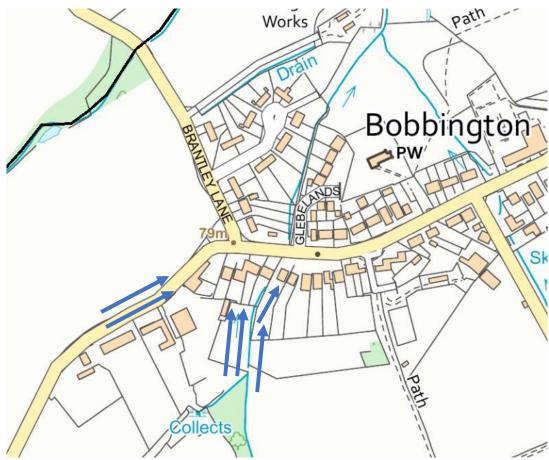
Figure 7- Surface water flow routes- (blue arrows)

Surface water was reported to have flowed down Six Ashes road after sustained heavy rainfall. The drainage infrastructure in the vicinity has been identified as being unable to cope with the volume of water in this event. A small watercourse to the rear of the properties on Six Ashes Road, was identified as breaching its banks. A blocked culvert inlet has been noted as a potential factor here.

It is recommended that the identified obstruction is to be removed or modified in a way to maximise potential channel and culvert capacity. It is also suggested that a new, fit for purpose, upgraded debris screen is to be installed, to minimise the chance of debris causing future blockages.

Recommended Actions	Identified Party / RMA
Private landowner to remove obstruction from over watercourse	Landowner
Review of potential Trash Screen for Culvert	Landowner / Possible FDGIA
Possible installation of Natural Flood Management measures further upstream in the catchment	Landowner / FDGIA

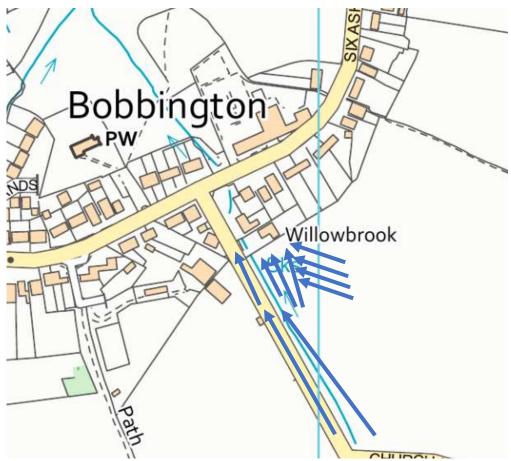
Figure 8- Surface water flow routes- (blue arrows)

The property was flooded following extreme rainfall from Storm Dennis- an exceedance event. Surface water flowed down Church Lane, along with runoff from the surrounding fields. A brook next to the property became full and overtopped its banks.

Flood Risk Officers have visited the location. Several residents have been consulted. It has been identified that Storm Dennis was an extreme exceedance event resulting in abnormally high surface water flows and runoff volumes. Water has been reported as running off neighbouring fields, onto Church Lane itself. A historic road culvert and other drainage infrastructure has been noted as being at least partially blocked. The downstream drainage system has also been identified as having potential blockages and capacity issues.

Recommended Actions	Identified Party / RMA
SCC LLFA to identify potential resilience interventions including ditch and	SCC LLFA
culvert clearing as well as Natural Flood Risk Management	
SCC LLFA to liaise with neighbouring landowners to explore land use change	SCC (LLFA) / Landowners
options.

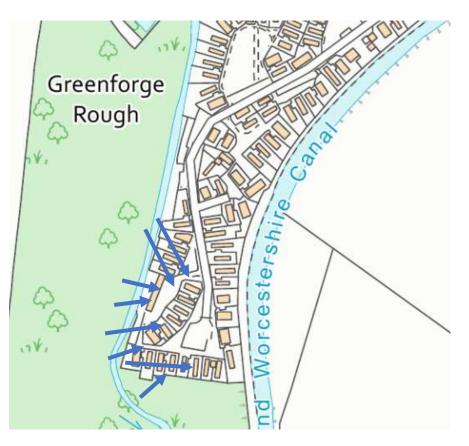
Figure 9- Surface water flow routes- (blue arrows)

On 16<sup>th</sup> February 2020 internal property flooding at Hinksford Caravan Park was reported to a depth of around a metre.

The location has been visited. Numerous residents have been consulted. Questionnaires have been handed out to residents and information regarding the flooding during Storm Dennis is being gathered. Following investigation and talking with residents, the reported cause of the flooding was an obstructed bridge downstream on the Smestow Brook.

It is recommended that as the primary cause of flooding in this location is the Smestow Brook, which is Main River, the Environment Agency are consulted and possible resilience measures downstream on the brook, at the bridge adjacent to the Navigation Inn are considered. Blockages at this bridge have been repeatedly reported as a major aggravating flood risk factor.

Recommended Actions	Identified Party / RMA
NFM, channel / floodplain improvements downstream	EA
Flood warning system to be considered for the park.	EA/LLFA/SSDC
