Flooding in Slindon, Staffordshire

January 2024

Investigation under Section 19
of the Flood and Water Management Act 2010

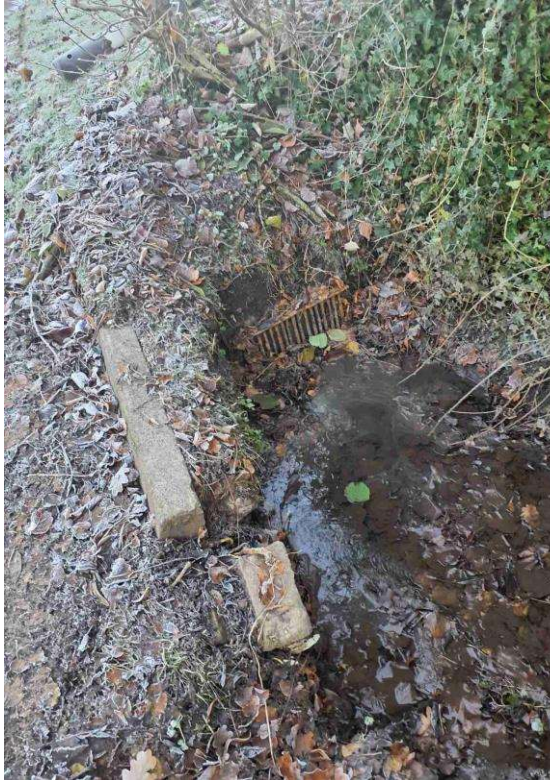
Figure 11: Trash screen on inlet to Aspley Lane pipe

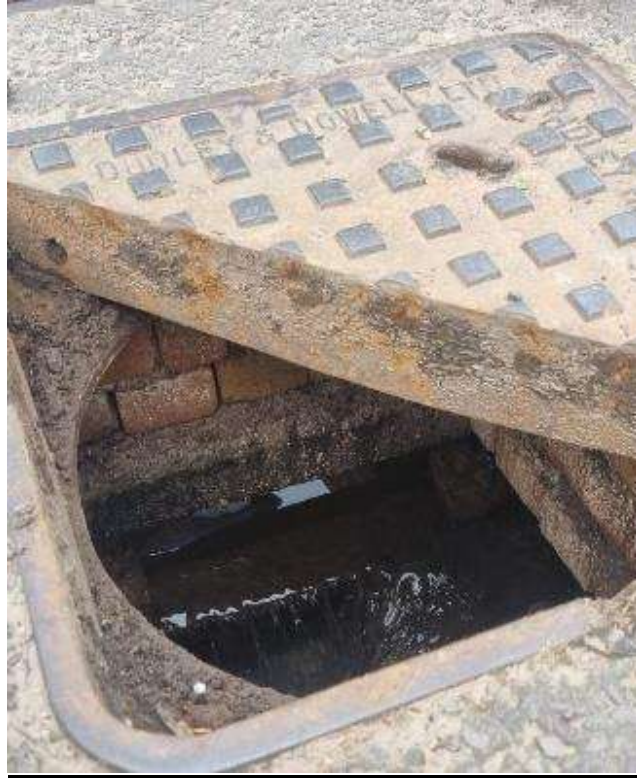
Figure 12: Weir in manhole at top of Villa Farm Lane

At the junction of the A519 and Villa Farm Lane, the Aspley Lane pipe passes through a manhole chamber with a weir (Figure 12). Under high flow conditions, once the capacity of the pipe from Aspley Lane has been exceeded, water will flow over the weir and enter the highway drainage network (Figure 10, yellow drainage route) which conveys surface water flows from the A519.

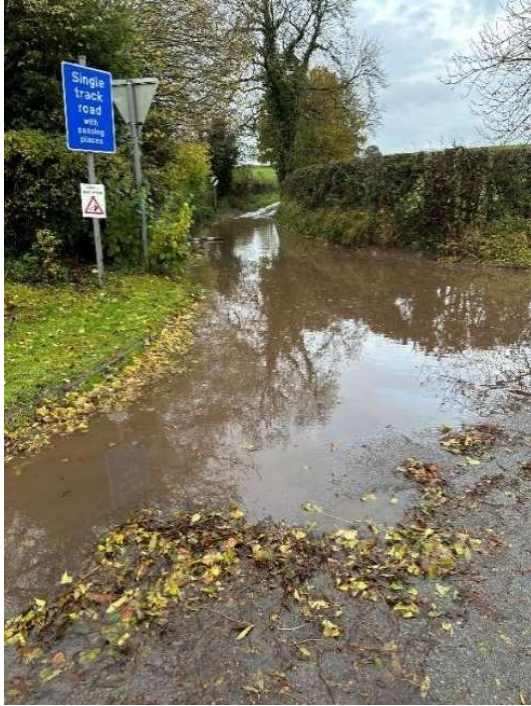
Floodwater initially began to accumulate in the highway at the junction of Aspley Lane and the A519 (Figure 23). Residents reported that the trash screen at the Aspley Lane pipe inlet was blocked with debris and silt washed from the upstream catchment (Figure 24). Topographical data shows that there is very little gradient in the ordinary watercourse and as a consequence, silt has been deposited over time which has significantly reduced the capacity of the channel to convey surface water flows from the village to Meece Brook. This resulted in the ditch quickly reaching capacity and spilling onto the highway. As the volume of water increased, this led to the lane becoming impassable and SCC Highways attended site to close the road.

Figure 23: Surface water accumulating at the junction of Aspley Lane and the A519 (Photo provided by resident)

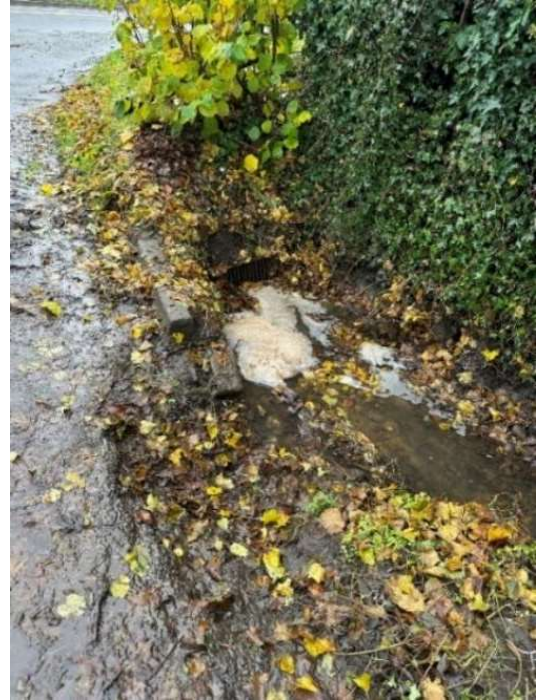
Figure 24: Blocked trash screen at Aspley Lane pipe inlet (Photo provided by resident)

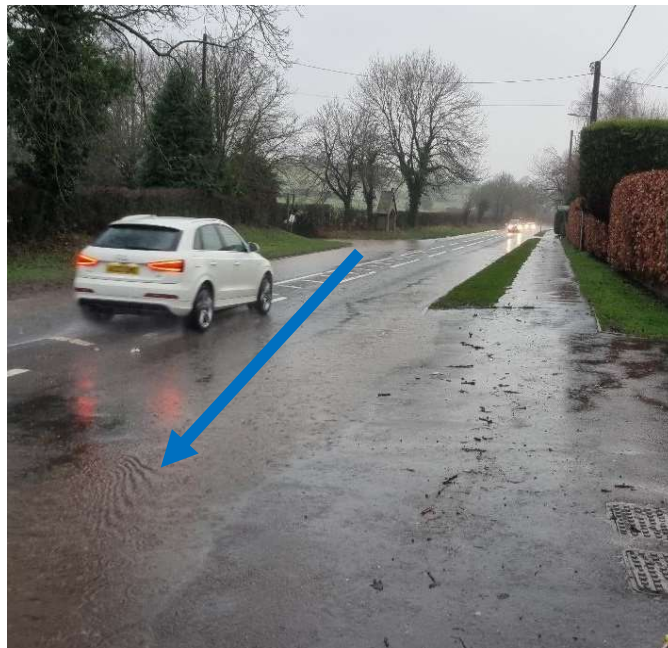
Surface water then began to quickly accumulate on both sides of the A519, and as the volume of water increased, the local highway drainage network became overwhelmed, with water following the prevailing topography, flowing in a southerly direction along the A519 (Figure 25).

Figure 25: Surface water beginning to accumulate at junction of Aspley Lane and A519 and starting to flow in a southerly direction (blue arrow) down the A519 (Photo looking in a northerly direction) (Photo provided by resident)

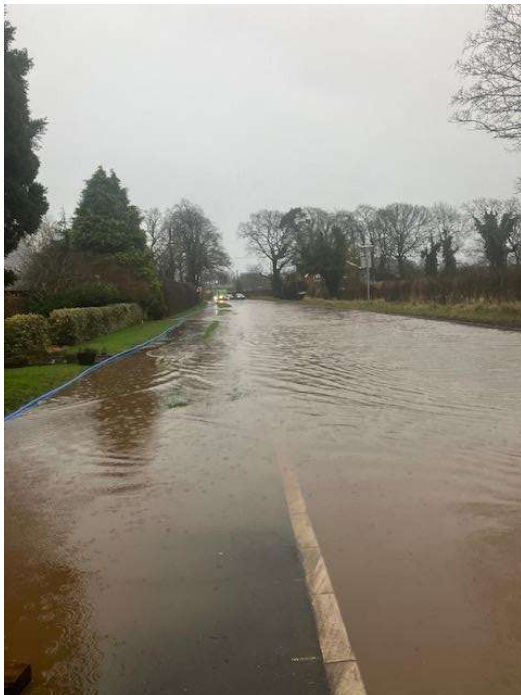
Surface water flows then continued to flow down the A519, impacting properties on the eastern side of the highway at around 14:30-15:00 (Location 4, Figure 22 and Figure 26). Residents reported that the highway drainage network became overwhelmed, with water observed to be bubbling out of the drain adjacent to the old telephone box. Surface water then flowed from the highway towards properties which are situated at a lower level than the highway. The flooding was exacerbated by bow waves from passing cars pushing water towards properties. Two properties reporting internal flooding to depths of between 4 and 5 inches, in addition to significant flooding to gardens and outbuildings.

Figure 26: Surface water along the A519, looking in a southerly direction (Photo provided by resident)

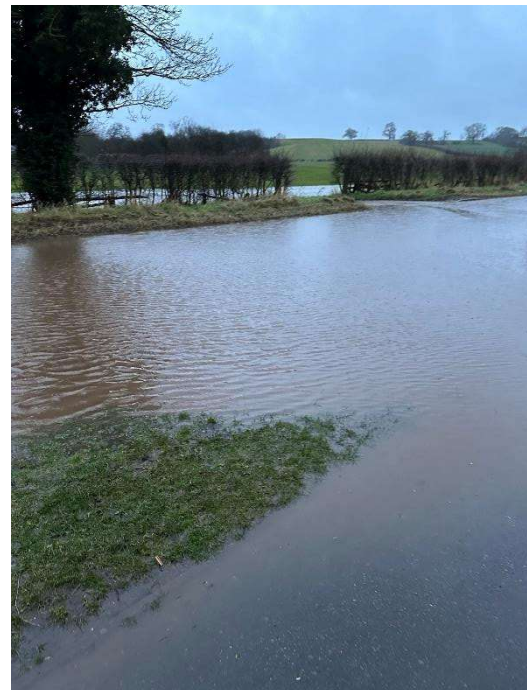
Figure 27: Surface water flowing onto western side of A519 and into adjacent field (Photo provided by resident)

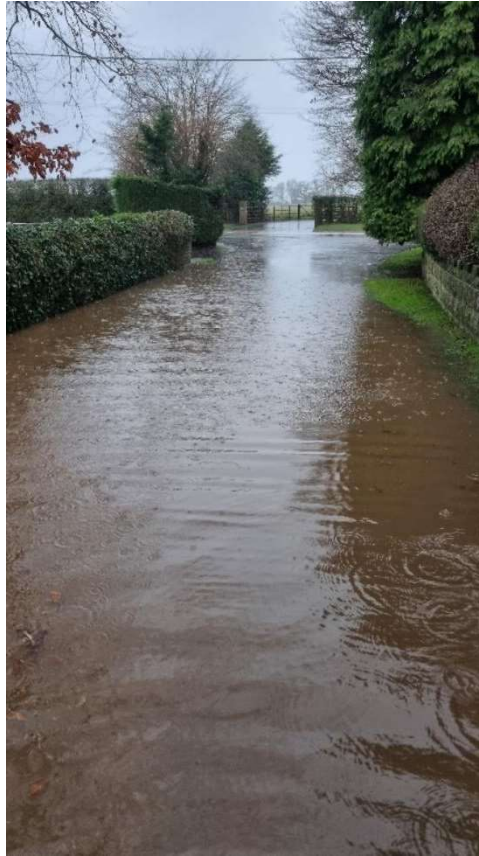
At the northern extent of the village, flooding was also experienced along Villa Farm Lane (Location 6, Figure 22). Residents described how water emerged rapidly from a manhole cover situated along the private lane. Since the lane is below the main A519 road surface level, water accumulated along the lane (Figure 28). As the volume of water on the A519 increased, this also flowed onto the lane, resulting in floodwater reaching depths of approximately 30cm. Whilst no internal flooding to property was reported, access to property was significantly restricted, with some residents also reporting issues with septic tanks and private drainage.

Figure 28: Flooding along Villa Farm Lane (Photo provided by resident)

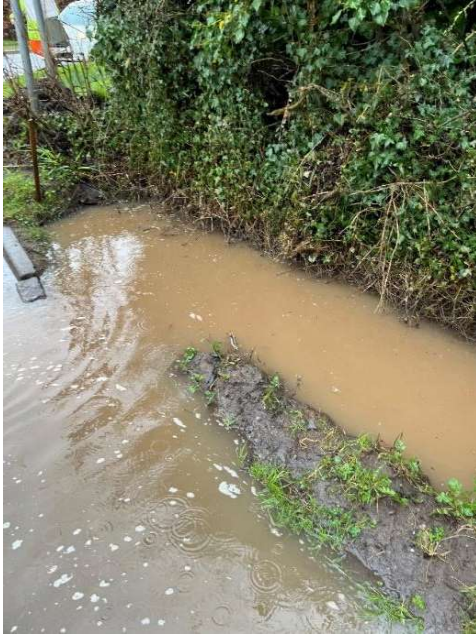
Site inspection found the roadside ditch at Aspley Lane was at capacity, and water was spilling from the ditch on to the highway (Figure 29). Surface water runoff was also observed flowing from adjacent fields onto the highway along Aspley Lane and into the ditch (Figure 30). Whilst the inlet pipe at the downstream end of the ditch was submerged, it was evident that some water was still flowing through the pipe following clearance of debris by SCC Highways. On site it was noted that at around 13:00 the rainfall had eased and water within the ditch at Aspley Lane had started to clear.

Figure 29: Ditch and pipe inlet at junction of Aspley Lane and A519, observed on 22nd February 2024.

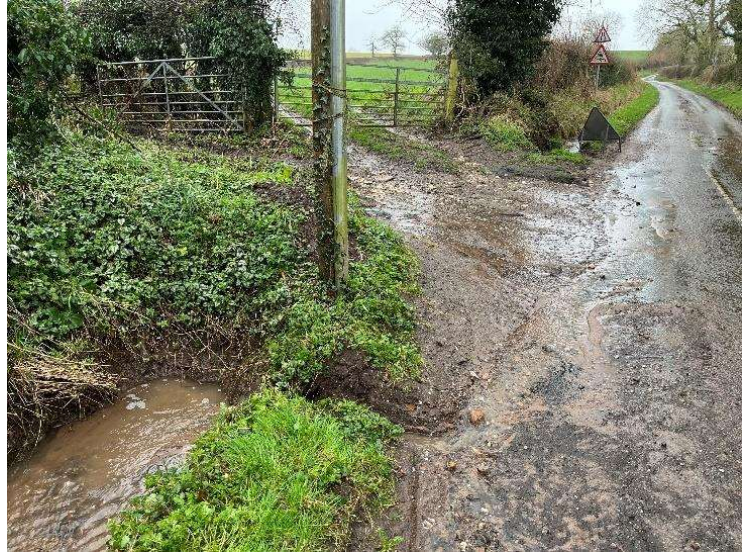
Figure 30: Surface water runoff from fields adjacent to Aspley Lane, observed on 22nd February 2024

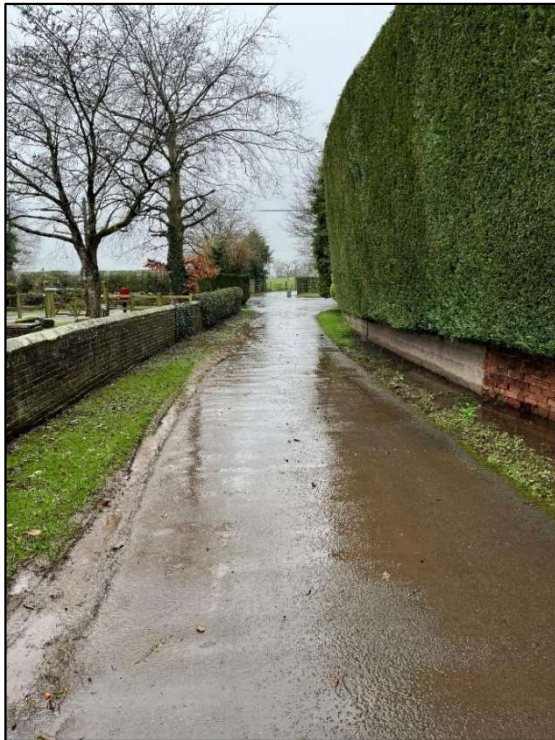
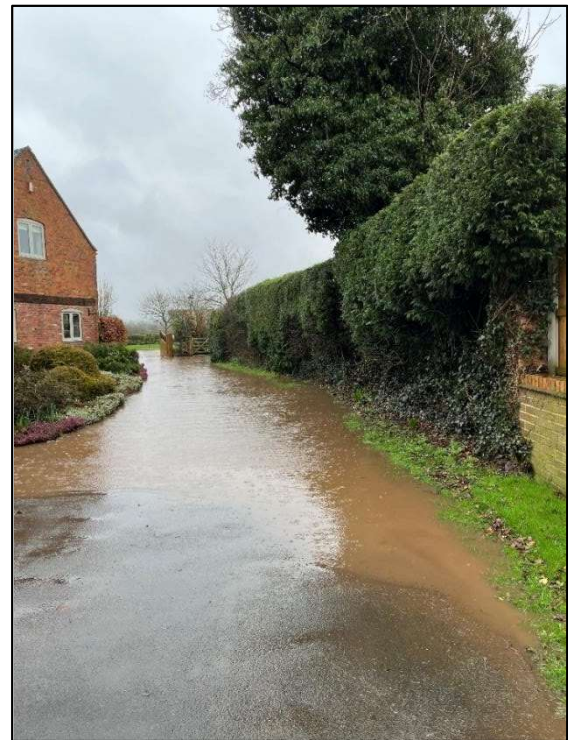
Flooding was also observed along Villa Farm Lane (Figure 31). Discussion with residents on site confirmed that water initially spilled from the manhole at the entrance to the drive before accumulating along the private road, restricting access to property along the road. No internal flooding to property was reported along Villa Farm Lane on this occasion.

Figure 31: Photographs of floodwater along Villa Farm Lane as observed on 22nd February 2024

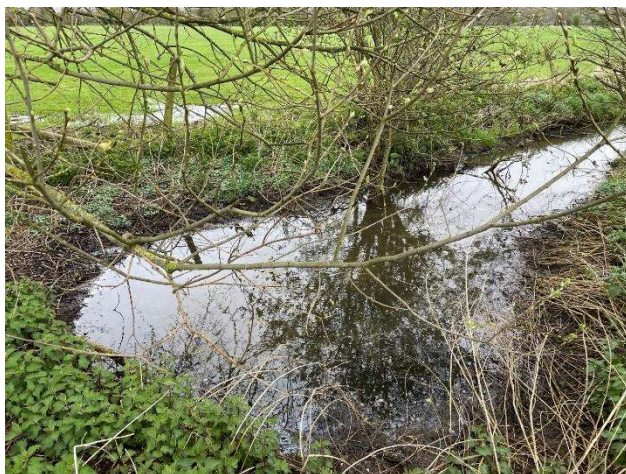
A walkover of the riparian owned ditch from Aspley Lane was undertaken from the point at which the pipe enters the open channel to the point at which it enters the Millmeece Drain South. The channel was found to be heavily silted with significant vegetation growth in several places. The outlet pipe from the Aspley Lane was found to be submerged, and the water level in the channel was almost at bank full in several places (Figure 32 and Figure 33).

Figure 32: Discharge point of Aspley Lane pipe into open ditch to east of Slindon (Photograph taken 10th April 2024)

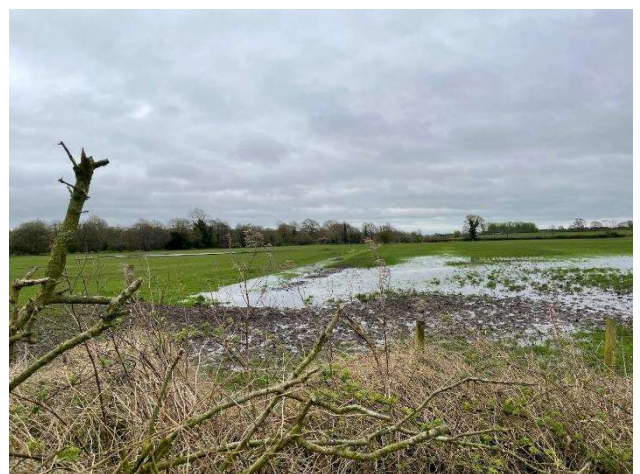
Figure 33: Open watercourse leading to Millmeece Drain South (Photograph taken 10th April 2024)

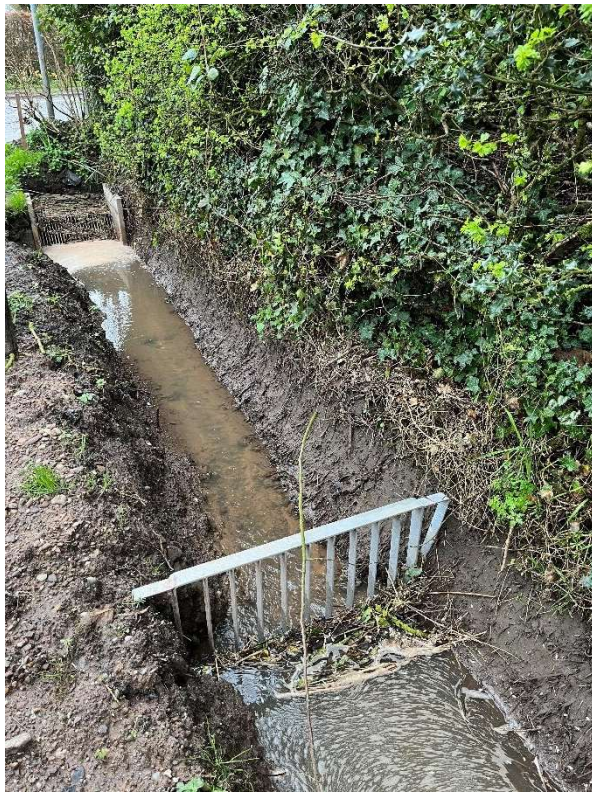
Site observations have shown that both trash screens have been working effectively in preventing debris washing from the upstream catchment and entering or blocking the pipe inlet. However, residents have reported that during heavy rainfall events, the roadside ditch continues to reach capacity quickly with downstream flow restricted. This is likely due to the condition of the downstream channel and potential build-up of silt within the pipe as observed during site inspections.

Figure 34: Two-stage trash screen installed along roadside ditch pipe inlet at Aspley Lane/A519 in February 2024

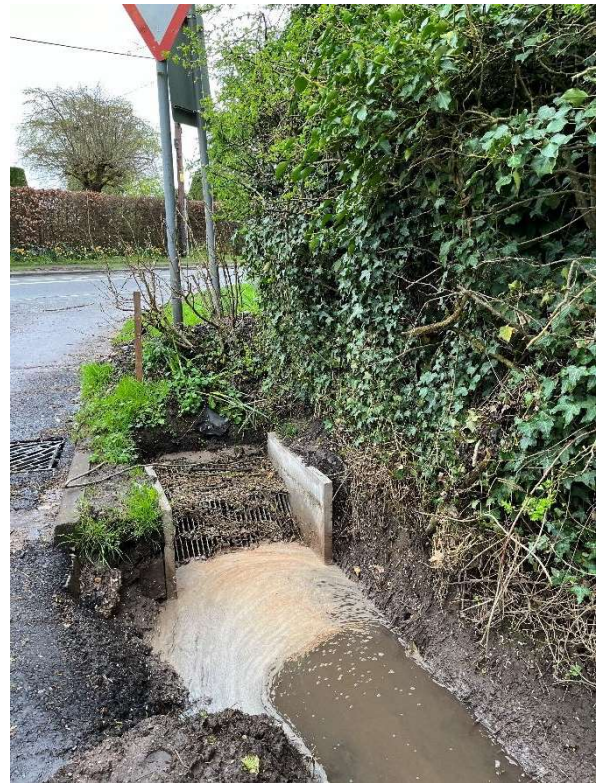
Figure 35: Aspley Lane inlet pipe and new trash screen following heavy rainfall February 2024.

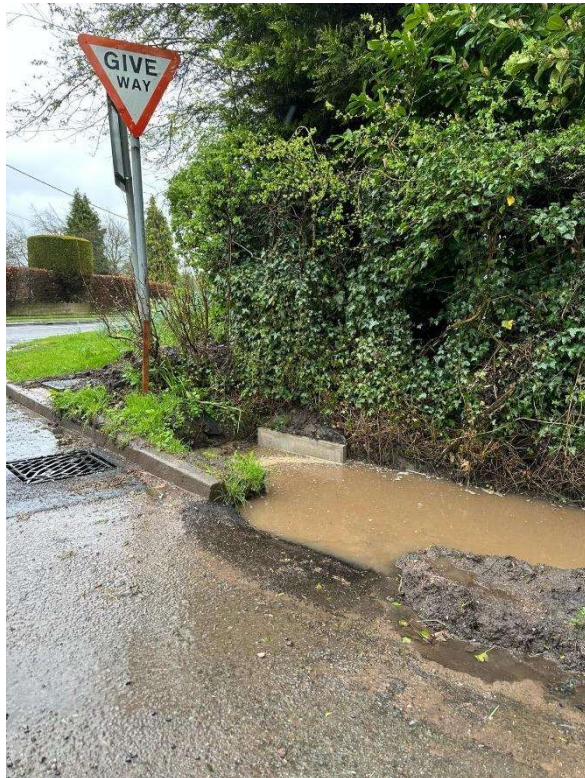
Figure 36: Roadside ditch at capacity following rainfall experienced April 2024

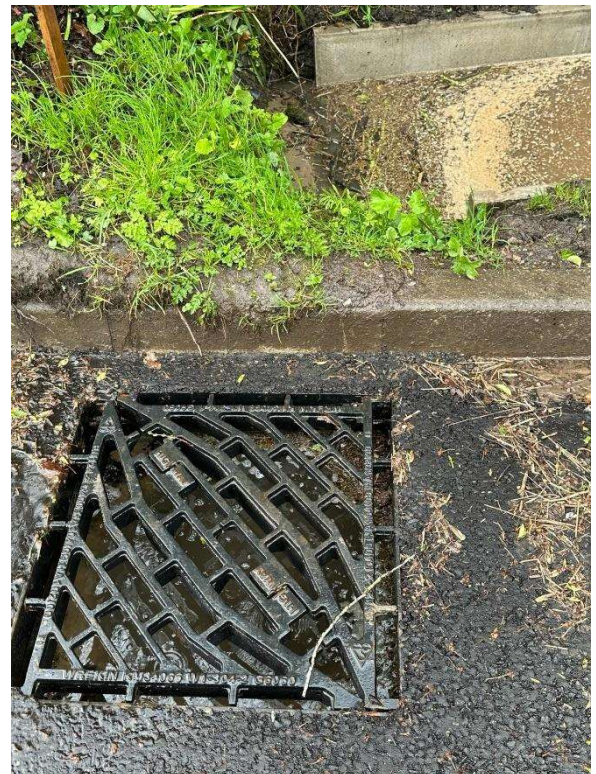
Figure 37: Gully adjacent to Aspley Lane ditch almost at capacity following rainfall April 2024
