# Staffordshire Water Meadows

## An Archaeological Survey and Assessment

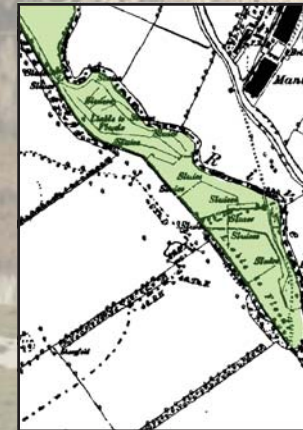
a) 1st Edition Ordnance Survey Map of water meadow near Weston-Upon-Trent (Copyright and database right Crown Copyright and Landmark Information Group Ltd (All rights reserved 2008)).

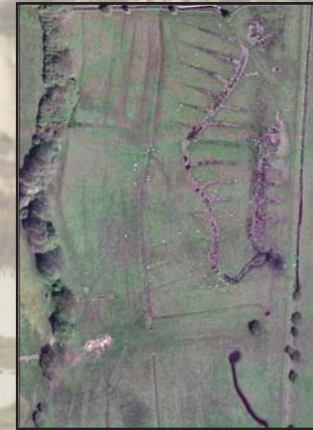
b) Aerial photograph of water meadow near Trentham (Copyright UKPerspectives.com, Licence Number UKP/048/SCC).

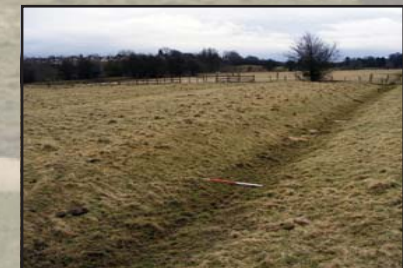
c) Ground photograph of Trentham water meadow taken during fieldwork.

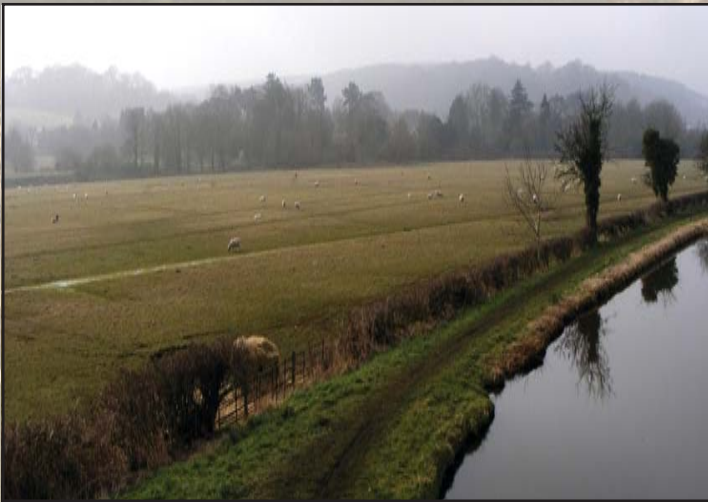
The survey analysed historic mapping for over 1543km of rivers and streams within the county, along with approximately 1200 aerial photographs, and identified over 180 possible water meadows. Individual sites ranged in size from a single hectare to over 450 hectares in size. 76 of these possible meadows appeared to be well-preserved in the year 2000, the rest were in varying poorer states of preservation, with at least 15 having been completely destroyed since the 19<sup>th</sup> century. The largest numbers of meadows were found to lie on the Trent, Sow, and Blithe rivers although further targets were identified on almost every major river in the county.

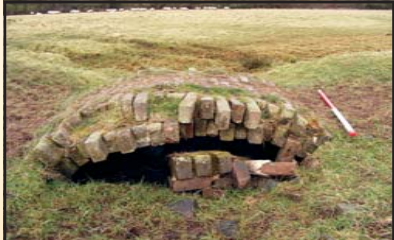
**1: Trentham**  
This meadow was one of the most complete systems found by the survey, with preserved earthworks and structures typical of water meadows. Historical records show that farmers around Trentham were enthusiastic about water meadows in the early 19<sup>th</sup> century, and were encouraged to build them by the Marquess of Stafford, who had an example made at Trentham - possibly the meadow revealed during this survey.

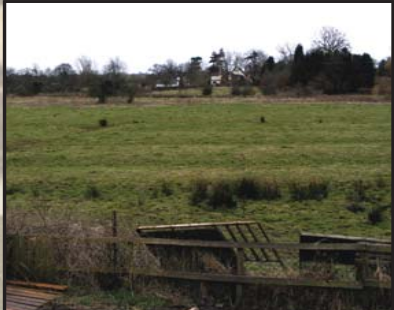
**2: Stone**  
A wealth of water meadow remains was found in this area, with a clearly defined complex of carriers and drains. These remains appeared to reflect a mainly intact system of earthworks, apart from within the north-eastern area of the system, which has been transformed into wetland environment for conservation and fishing.

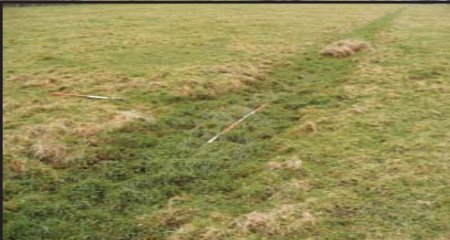
**6: Willows Farm, Uttoxeter**  
This is one of the biggest meadows in the county (226 hectares). Carriers and minor drains were found, still retaining their original grid pattern. In addition, sandstone sluice hatch settings and a well-preserved buried sandstone bridge were also found. These suggest this is an early water meadow, possibly pre-eighteenth century in date.

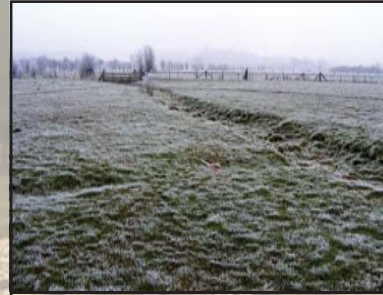
**5: Orgreave/Yoxall Meadows**  
Two distinct water meadow systems were identified, with the survival of earthworks representative of main drains, and of minor drains and carriers across the area. A single area contained very well-preserved remains of both major and minor features, and is potentially a fully-preserved portion of water meadow.

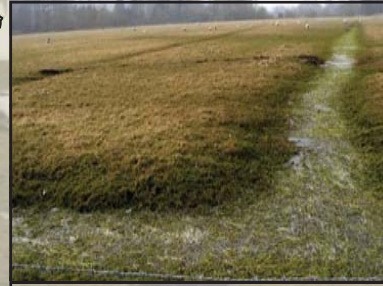
**4: Rugeley**  
This water meadow is an island between the two bodies of water of the Trent and Mersey canal and the River Trent. Historic mapping had shown a series of channels crossing the area, and aerial photography indicated the presence of earthworks. Field survey revealed striking remains of both main and minor drains and of carriers, many of which were still directing water.
