Staffordshire Water Meadows Survey

March 2008

By Paul Breeze, Keith Challis and Mark Kincey
HP VISTA Centre
K.Challis@bham.ac.uk

Staffordshire County Council

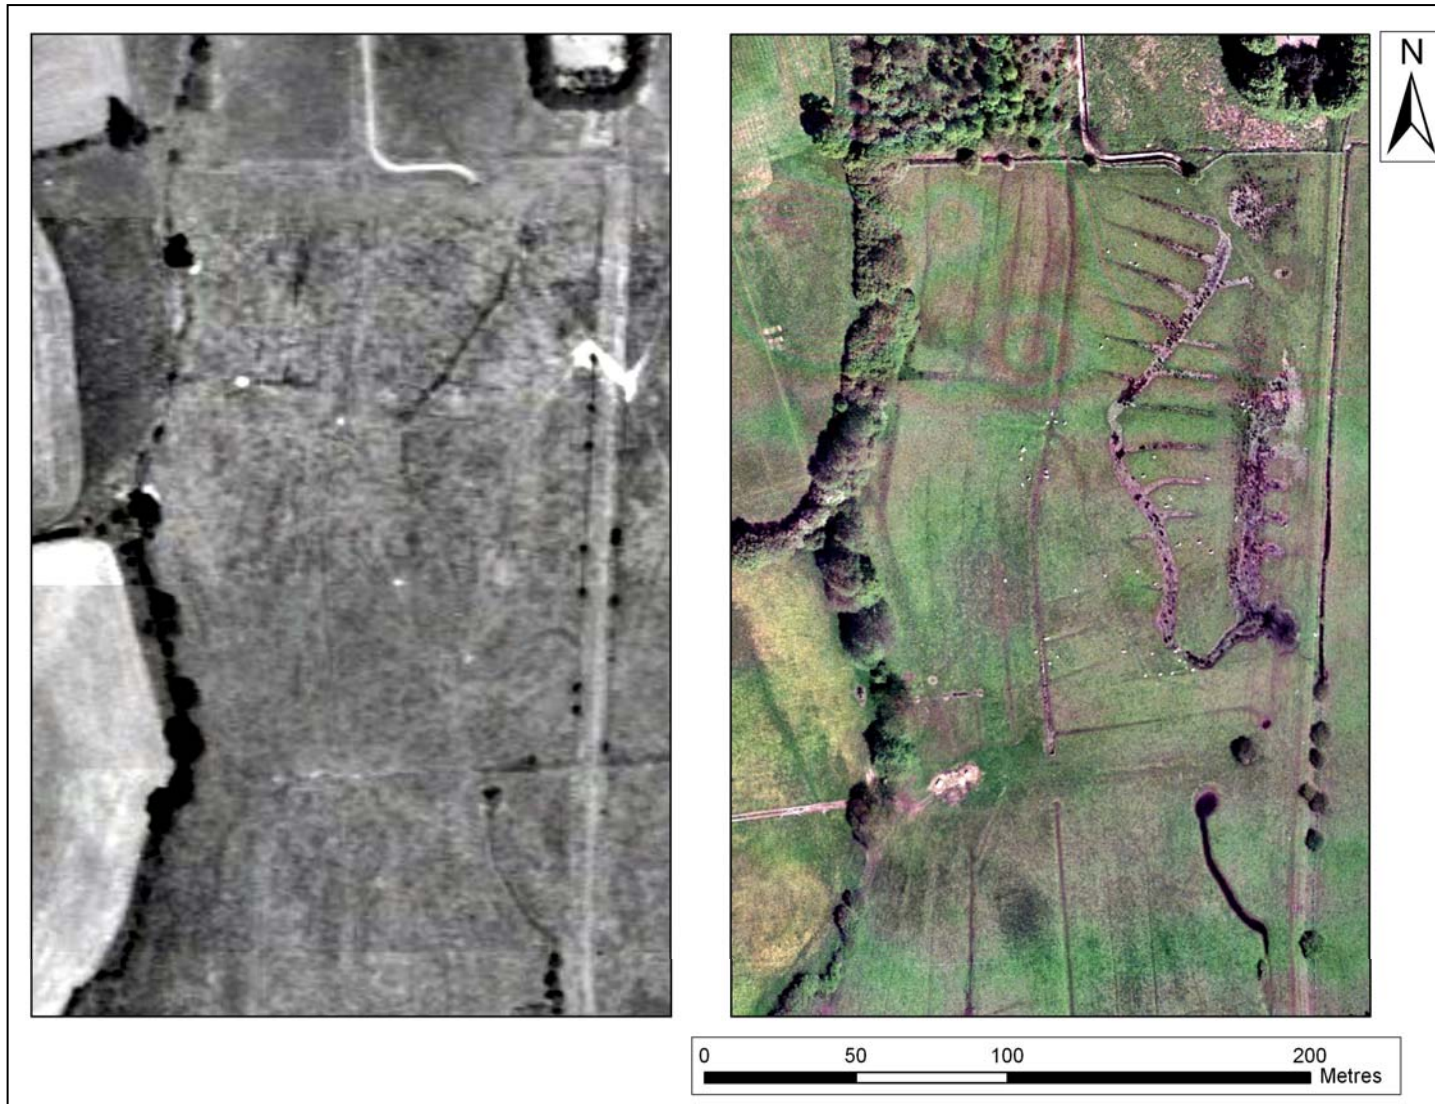
Figure 4- 1963 and 2000 Aerial photographic imagery (Trentham Water Meadow).

A further purpose of the analysis of imagery from different periods and flights was to obtain a preliminary measure of the likely state of preservation of former water meadow systems within the study area. In order to quantify this information, numerical values, representative of target condition in 1963 and in 2000, were assigned to the defined polygons as attribute data. It should be noted of course, that whilst the 2000 flight represented the most recently available data, this imagery was already outdated by more than 7 years at the time of this assessment, consequently the values of condition provided by the desk-based components of this project can merely be considered to reflect *recent* condition, rather than current condition at the time of completion.

However, whilst results proved encouraging, this methodology was subject to several limitations, which should be noted. Much of the available imagery was of a scale and resolution which prohibited the visibility of finer meadow features such as carriers and minor drains, and consequently, target identification and definition erred on the side of caution. In addition, this inhibited conclusive assessment of target condition, and required the addition of a value representative of uncertainty to the condition attributes.

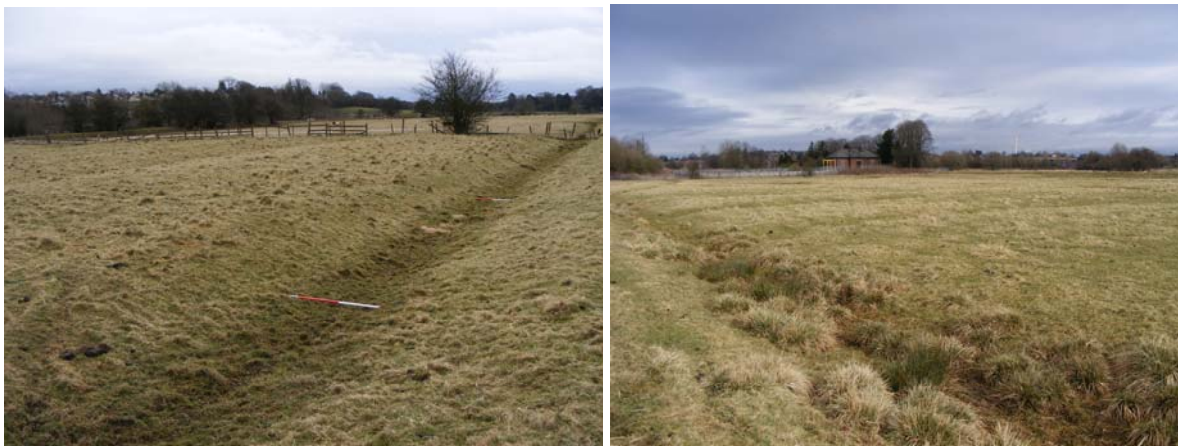
Figure 10- Carriers and drains visible within surveyed land at Trentham

Fieldwork showed the system to be well preserved along its central core, with substantial preservation of large numbers of earthwork panes within the area of survey, and of the drains flanking these features which empty into the main drains (Figure 10).

These well preserved earthworks appeared only to be present in the western extent of the target meadow, with the eastern portion of the target (east of the sewage pipes) appearing to have been largely landscaped, destroying any remains in this area. It should be noted that the high level of the ground relative to its former level (as indicated by the structures to be discussed below) is likely due to alluviation from the frequent flooding of the area. Consequently, the emphasised nature of the extant banks and ditches may in fact represent recent re-cutting of the drains and emplacement of material upon the panes in order to further prevent flooding, in effect a partial recent maintenance of the former system. The antiquity of the major extant channel courses can however be confirmed by their concurrence with the historical mapping data, and by the presence of structures typical of water meadows within these channels.

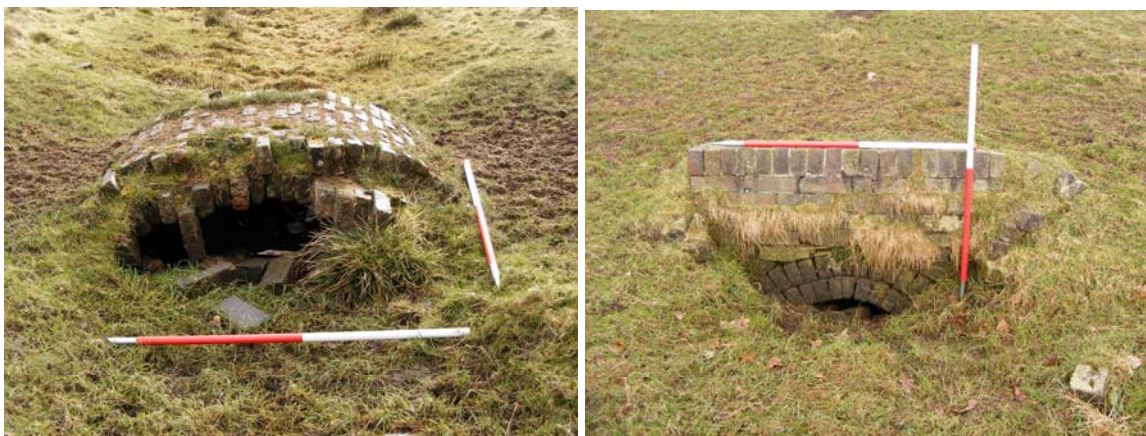
Figure 13- Water meadow structures visible at Trentham

The combination of well-preserved earthwork and structural remains within the surveyed area confirmed the efficacy of the survey within this area, with the prediction of the overall system as having a likely preservation level of 2, and the central portion of the system as having a likely preservation of 1 confirmed during the fieldwork (with the exception of the eastern portion of the meadow which appears to have been subject to extensive re-working).

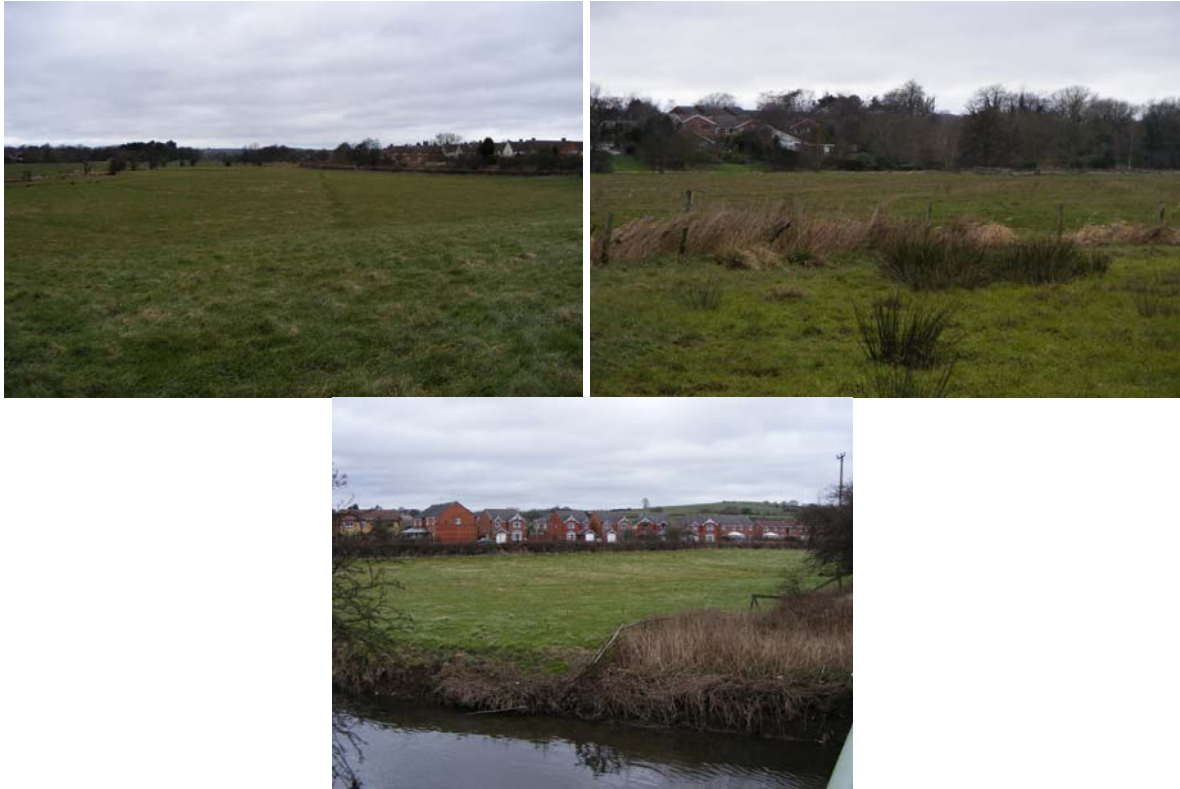
Figure 16- Extant earthworks of water meadow carriers and drains at Stone

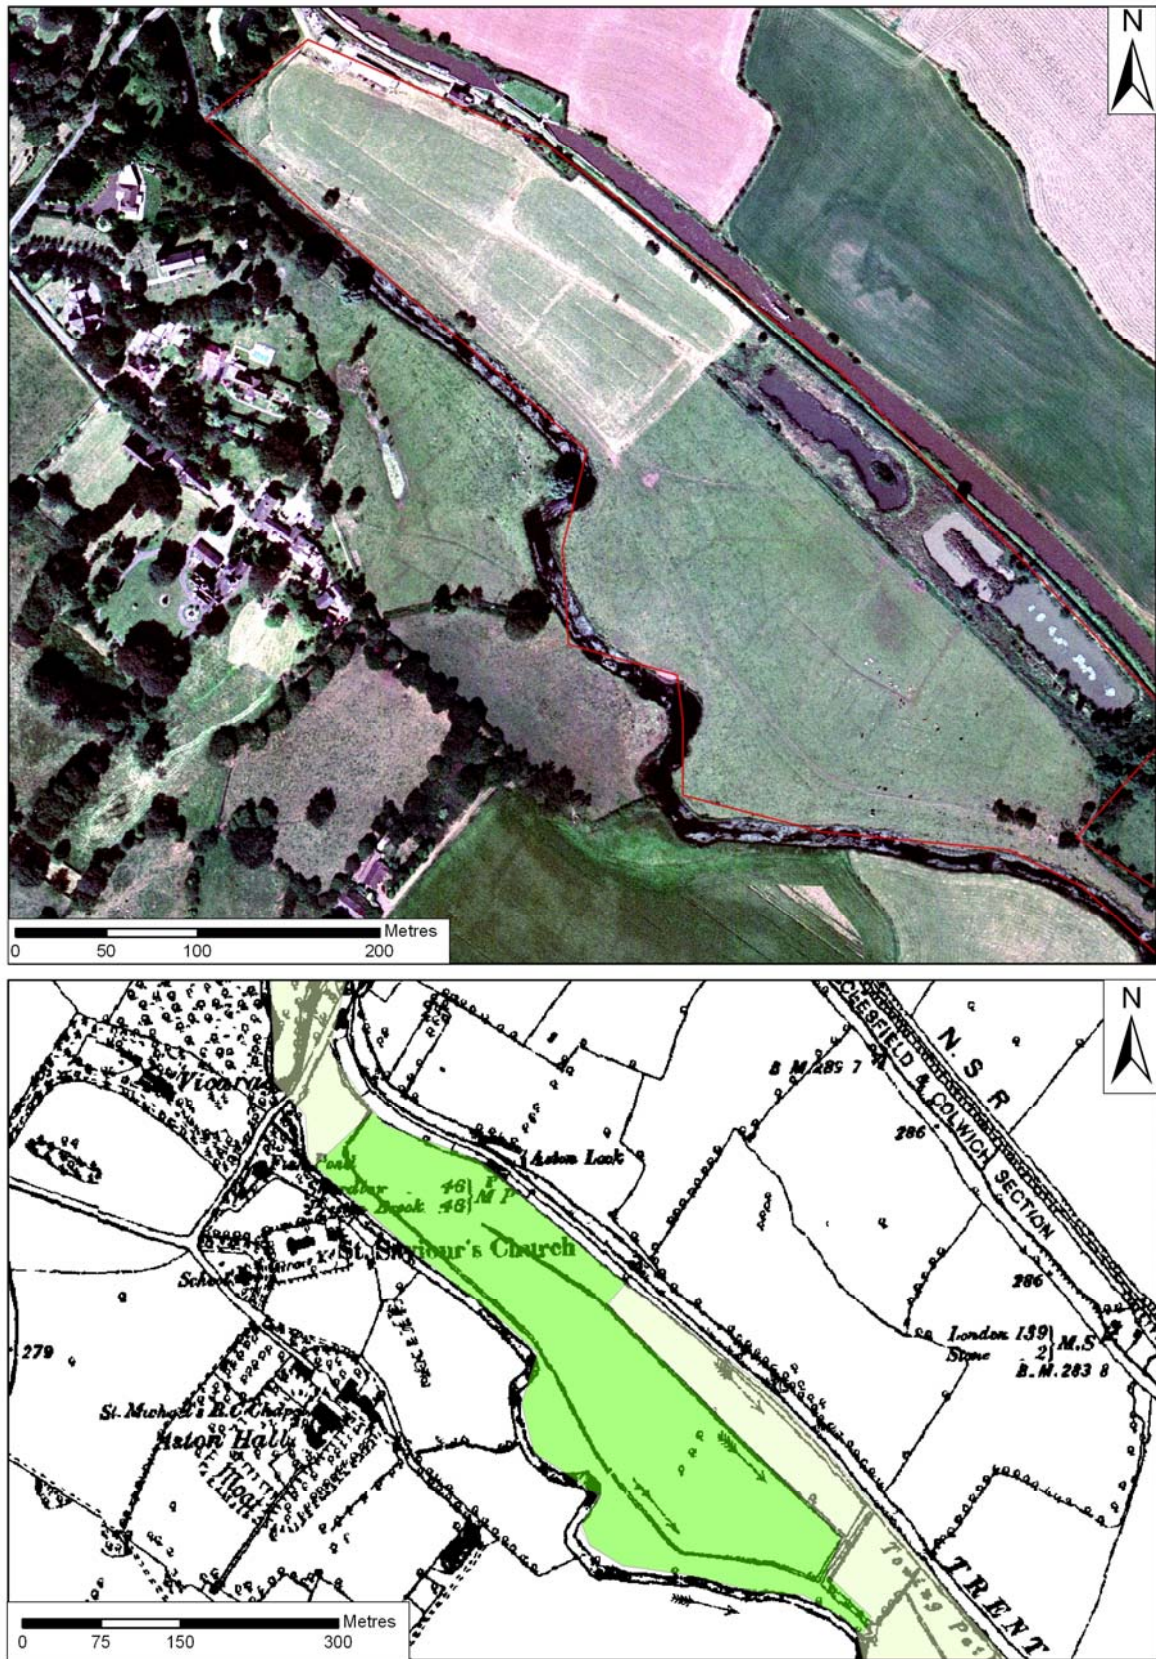
Figure 17- Ashton-by-Stone 2000 aerial imagery and 1st edition mapping.

Whilst access was limited to the northern central area of the system, field assessment revealed a wealth of water meadow remains within the area, visible from this vantage point. The majority of the defined area (7.3 hectares in size) was found to contain a clearly defined complex of earthwork features, ranging from main carriers and main drains to the more subtle individual carriers and flanking drains.

Consequently, this system, the most intact (in terms of earthworks) seen within the study, was judged to have a current condition of 1 based upon the field assessment, confirming the results of the desk-based assessment in regards to this target.

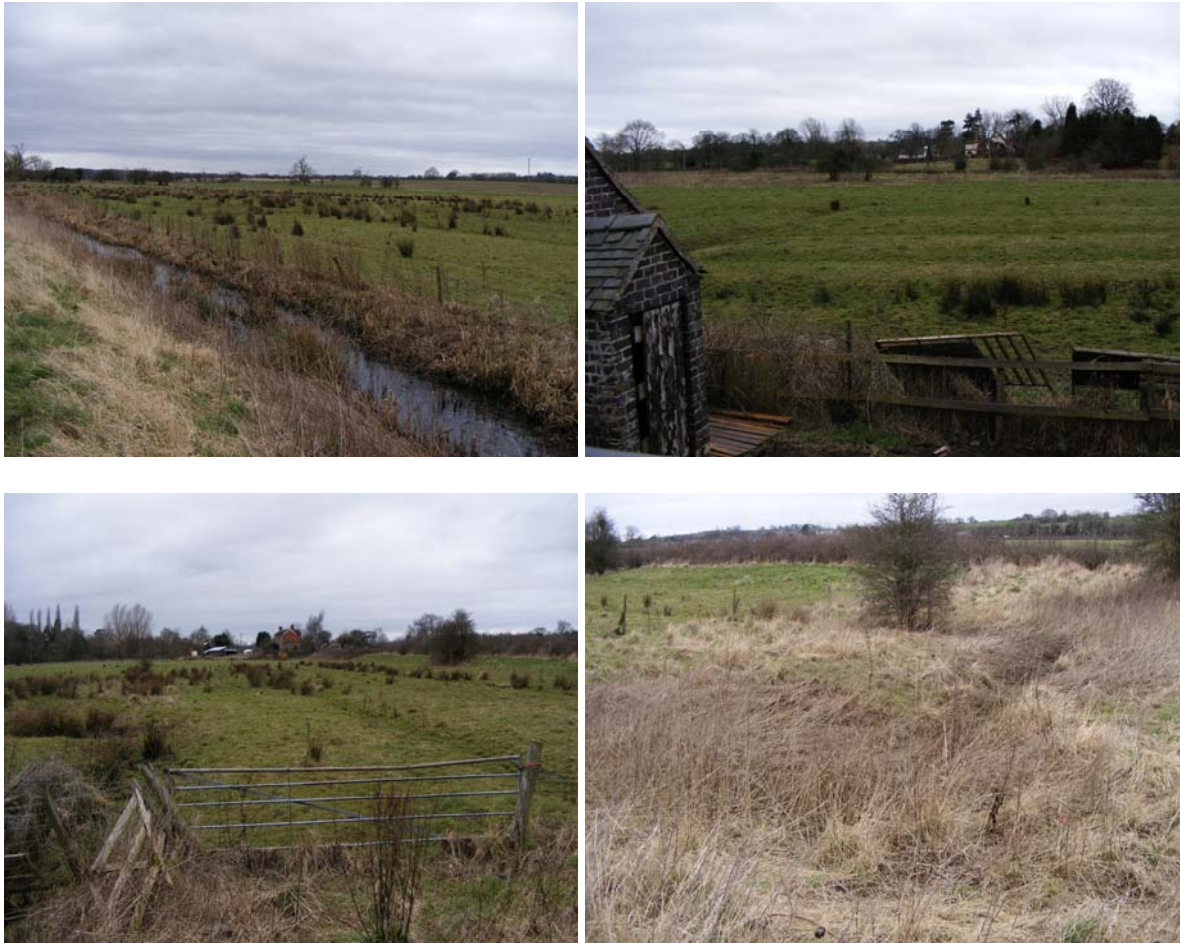
Figure 18- Extant earthworks at Ashton-By-Stone.

(Some survival even within emplaced wetland area- bottom right image)

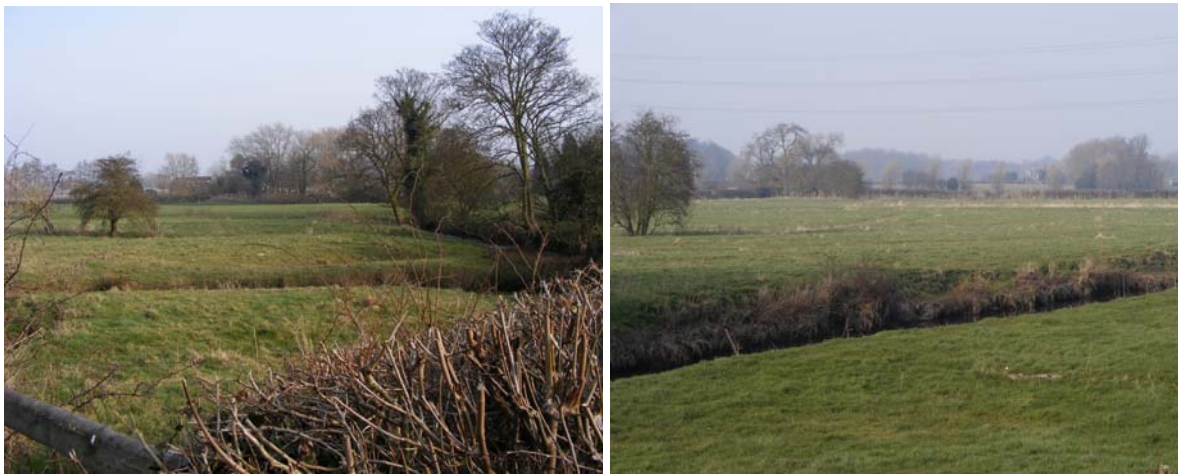
Figure 19- Drain features at Great Haywood

Field survey results for the area proved limited. The lines of drainage features which appeared to represent water meadow drains appeared clearly visible within the southern area of survey, previously allocated a recent condition of 1 in the desk-based assessment (light green polygon (Figure 20)). However, a provisional condition of 2 has been assigned to this area on the basis of field survey having demonstrated the presence of some features and of aerial imagery inferring substantial meadow preservation, however, actual on-site assessment at a future date is strongly recommended.

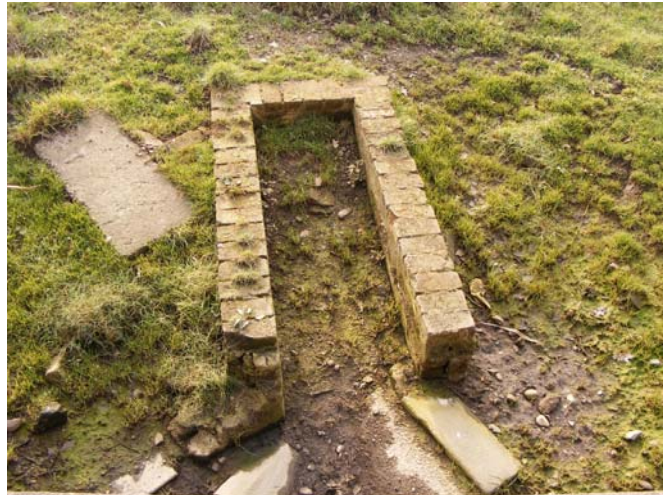
Figure 21-Unknown brick structure in proximity to historic sluice location-Great Haywood

Field survey to the immediate northeast of this area, investigating the sluice systems marked on the 1st edition mapping on the opposite side of the road revealed little trace of these remains. Despite the apparent visibility of channel lines within aerial photography no trace of these features could be seen on the ground, with the field in question extremely flat in nature. It would appear, therefore, that these features are either too subtle to be seen from this perspective, or that they have been destroyed by ploughing subsequent to the date of the aerial images. A single brick-built structure (Figure 21) was visible from the vantage point of a road bridge above it, and correlates with the apparent position of a sluice marked on the 1st edition mapping, however further investigation with access to the feature would be required before it can be confirmed whether this may represent the remains of a sluice system.

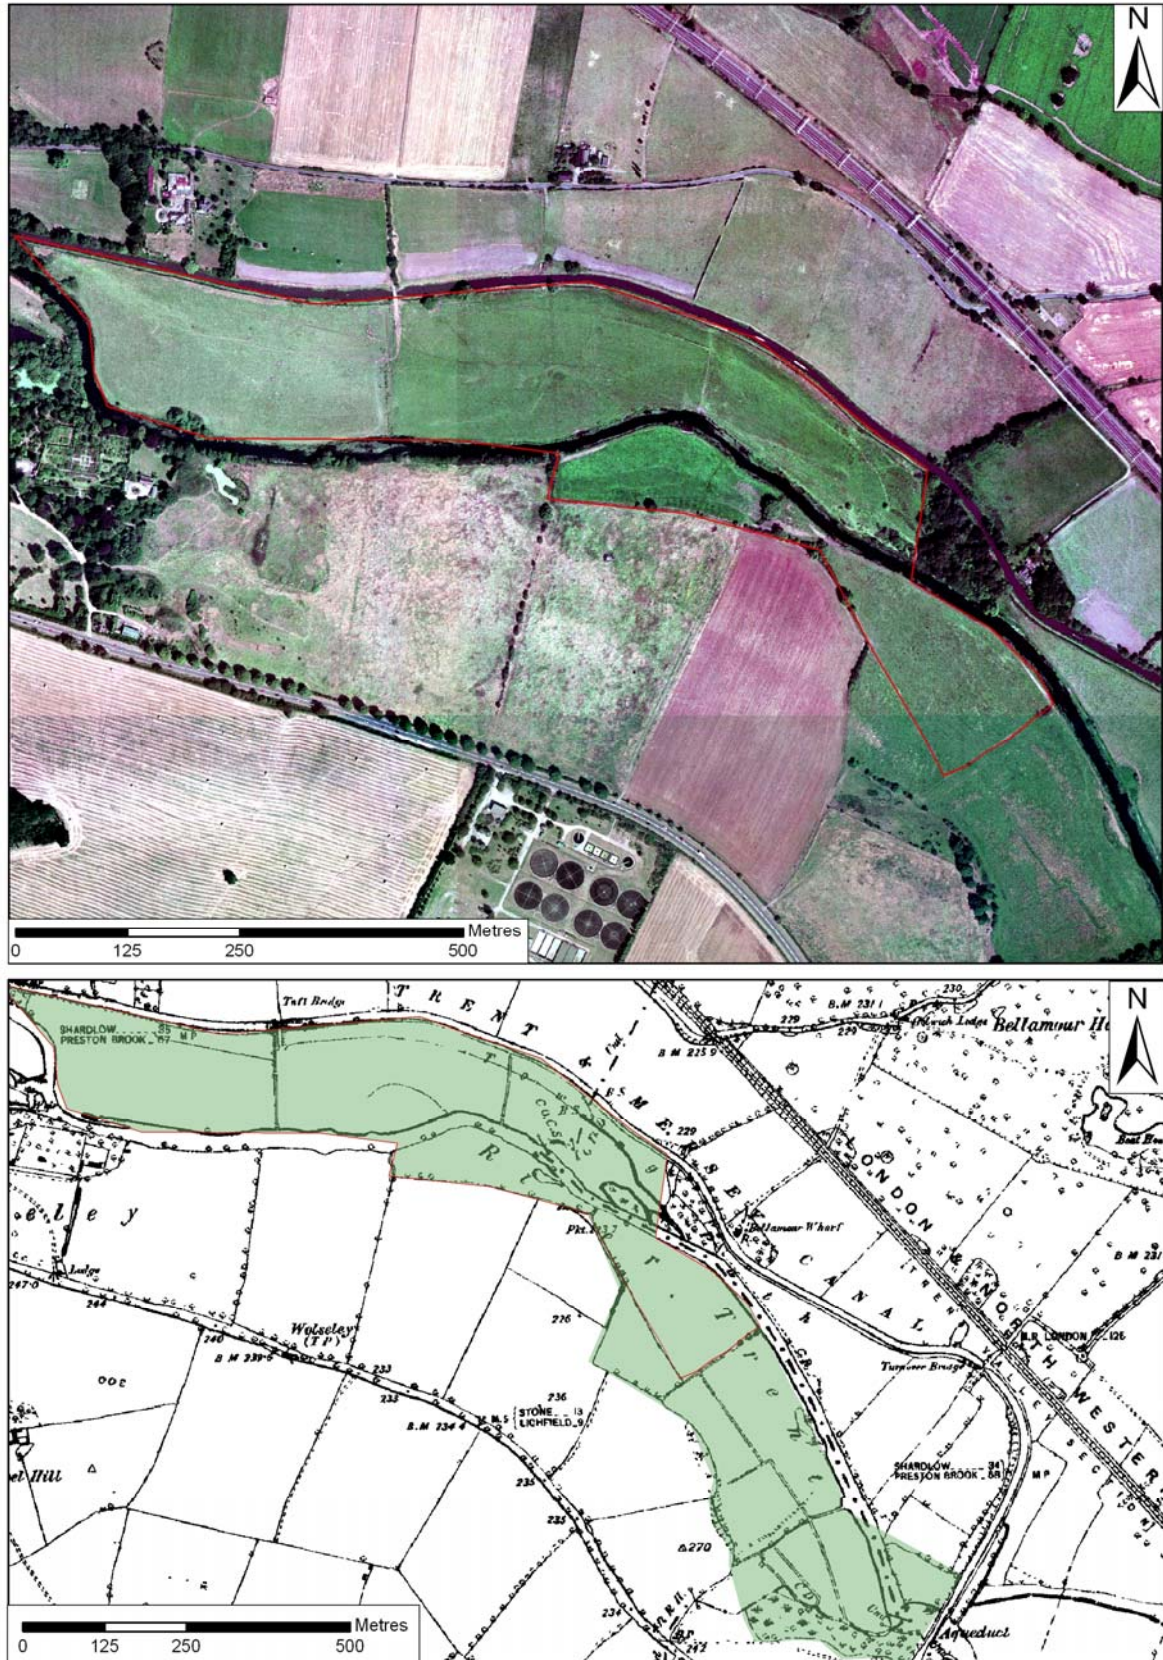
Figure 22- Rugeley target, 2000 aerial imagery and historic mapping

Field access was made available for the fields to the east of the Toft Bridge, which allowed the detailed assessment of the central 'island' and limited assessment of land opposite this on the other side of the Trent River. The southernmost extent of the target system, on the south side of the River was inaccessible, but was visually assessed from an elevated road bridge which overlooks the site.

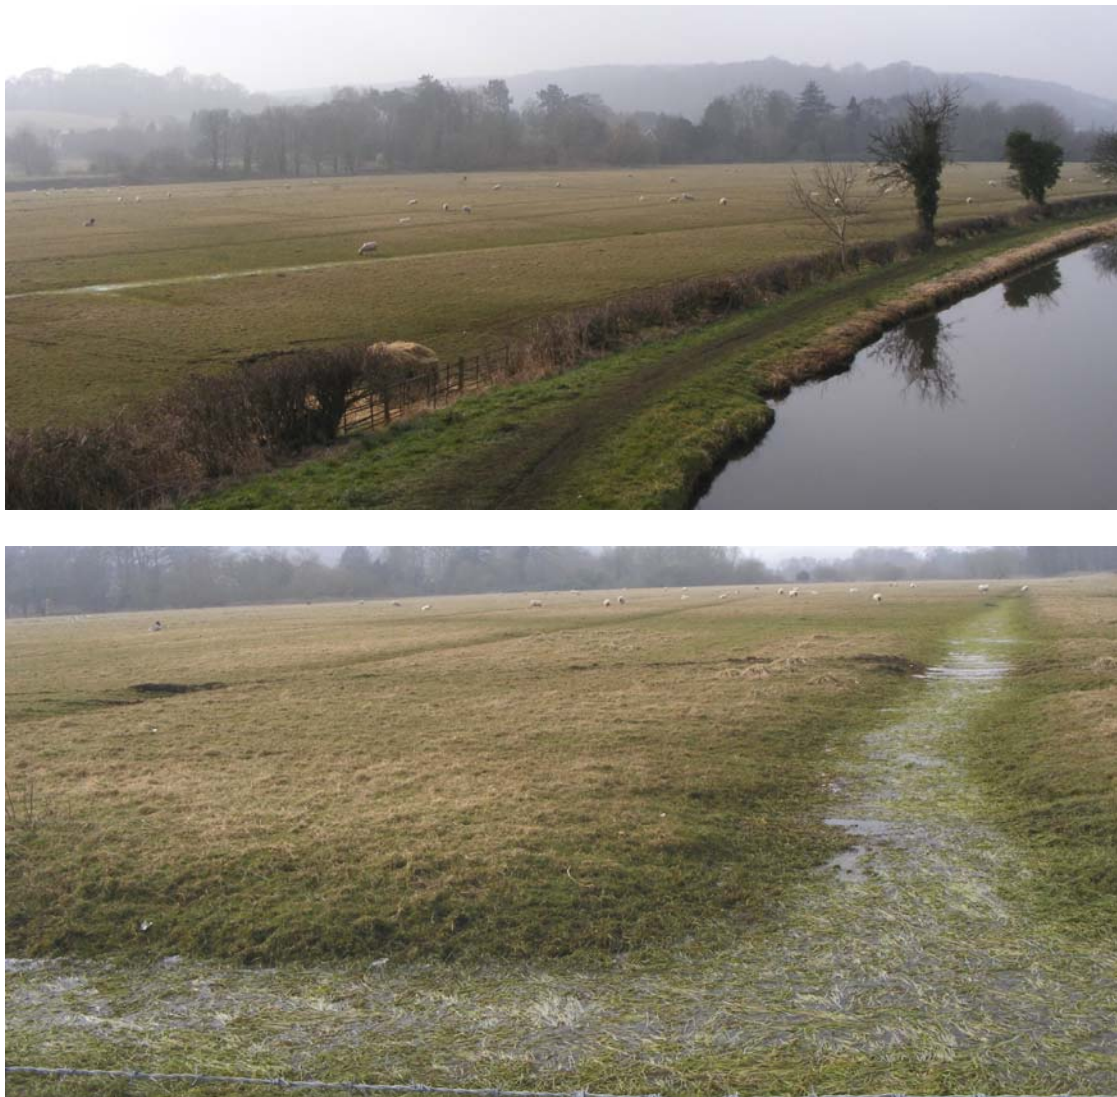
Figure 23- Well-preserved water meadow drains- Rugeley

Field survey revealed a distinct difference in conditions within adjacent land parcels within the target area. The field to the west of the Toft Bridge was seen to contain striking remains of both main and minor drains, many of which were still directing water at the time of survey (Figure 23). Carrier remains between these features appeared relatively shallow, although it was unclear whether this was reflective of the true height of the carriers, or merely an impression created by the drains being in flood to some depth. A small collapse of large apparently faced sandstone blocks was also visible in this area, reminiscent of sluice remains seen at Willows Farm, Uttoxeter (section 3.3.1), however as direct access was not possible it was unclear whether these remains may represent part of a former meadow structure. This area was inaccessible to walkover survey, preventing detailed assessment of any structural remains which may be present in association with the extant channels, and would benefit from further survey, should the opportunity arise.

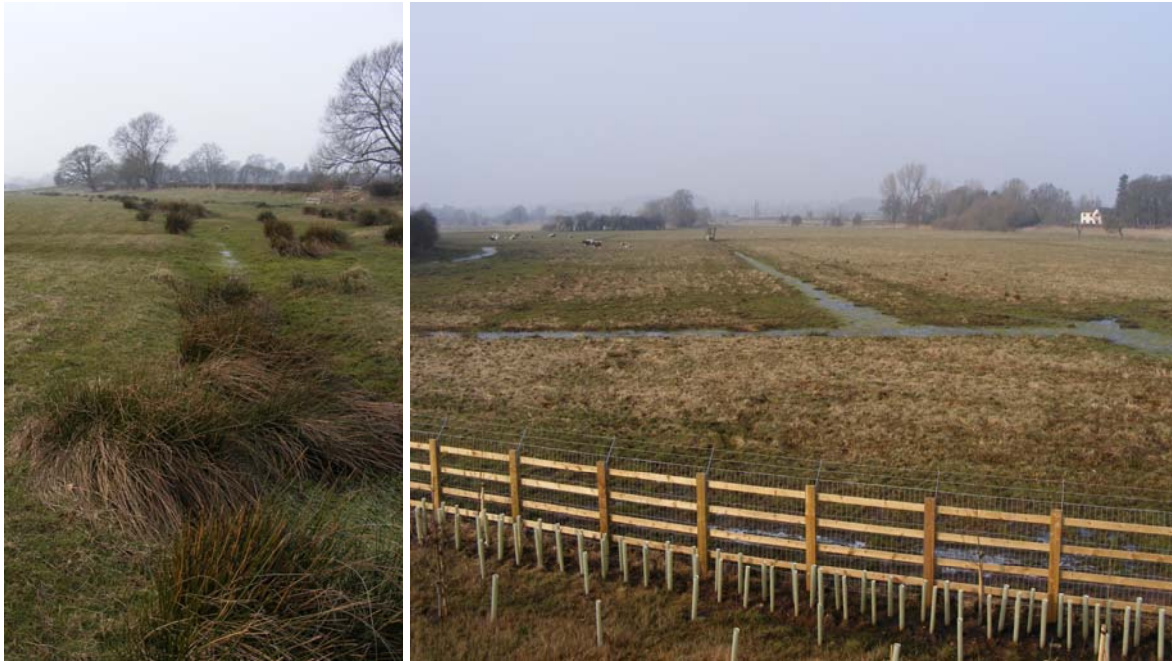
Figure 24- Main drains defined by water- Rugeley

To the east of the Toft Bridge, a further series of preserved drains was also visible, but upon a much reduced scale, with only main drains surviving. A palaeochannel was also visible within this area, corresponding with the position of an arched line visible upon the 1st edition historic mapping, previously thought to represent a possible meadow channel during the desk-based assessment. The southernmost area of the target (visible above right) revealed yet another series of channels, which were again well-defined due to the presence of water within the system at the time of survey.

Following field assessment, the system was judged to have an overall current condition of 2, in comparison with a prior predicted condition of 1. This remains a conservative estimate as a consequence of the lack of direct access to the western portion of the target area. Meadow remains within this area appear to be very highly preserved, and should direct access be available and future survey undertaken to confirm the extent of these remains, it may be that this condition value would need revising to a level of 1.

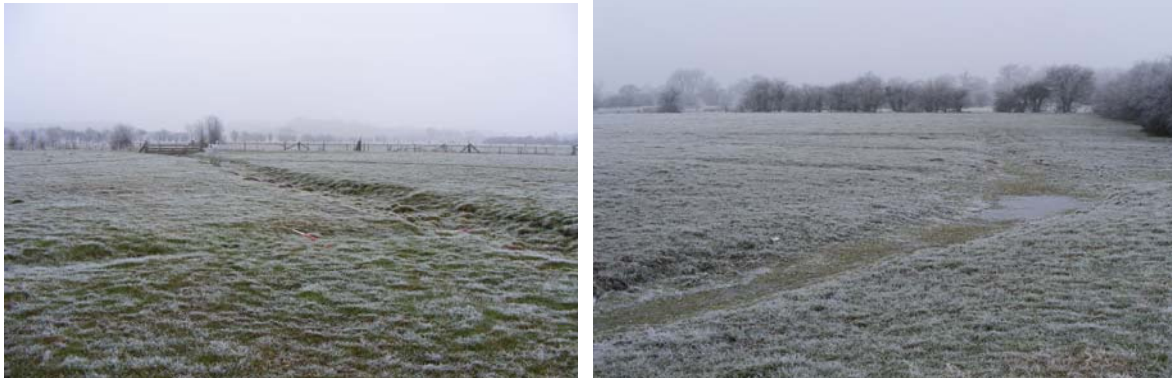
Figure 26- Earthwork remains of Main and minor drains, northern area- Orgreave

Survey to the north of the Trent demonstrated the survival of earthworks representative of main drains, and select minor drains and carriers across the area. No structural remains were visible during the field survey, and earthwork remains were significant and demonstrative of the presence of former water meadow, however these remains were somewhat scattered, suggesting partial survival of former meadow within this area. Relatively little evidence was seen of carrier banks, and the majority of drainage features visible were shallow, potentially suggesting that across much of the surveyed area only the deepest original features have survived, perhaps due to plough damage.

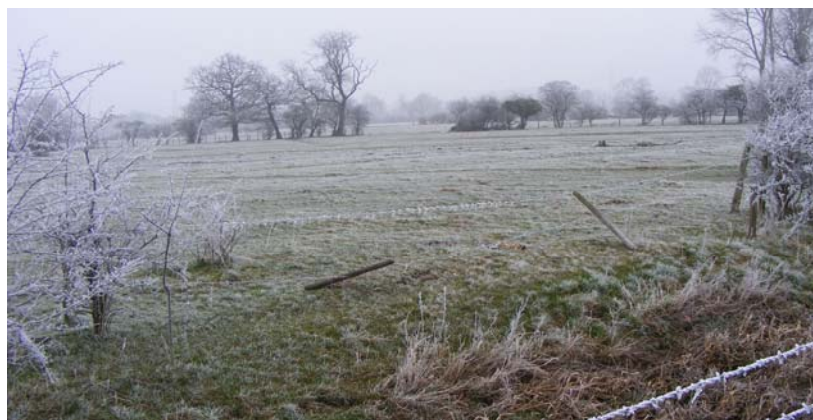
Figure 27- Well preserved subtle earthwork features- northern area, Orgreave

The north-western portion of the survey area had previously been designated as having a likely condition of 1 during the desk-based analysis. This appeared to be confirmed during field survey, with the apparent well-preserved remains of both major and minor water meadow earthworks within this area (Figure 27), potentially representing a fully-preserved portion of meadow. However, due to lack of access permissions, this area could only be assessed from a distance, and would benefit from survey should further opportunity arise.

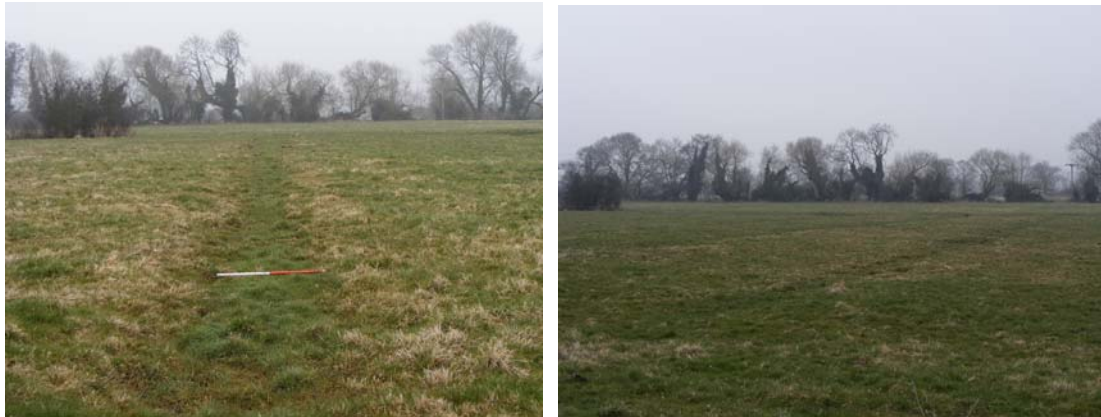
Figure 28- Probable water meadow earthworks- southern area, Orgreave Meadows

Survey to the south of the Trent, within land to the north of Lupin farm, also demonstrated the presence of subtle apparent water meadow earthworks, along with a few major drains still holding water. These features were consistently present across the majority of the surveyed area, and appeared within a grid pattern. It should be noted that this form of pattern is equally plausible for either water meadow or extensive field drainage, and consequently field assessment within this area should be considered provisional until further research can be undertaken to confirm or deny these remains as former water meadow. A single structure, in the form of a concrete bridge, was recorded in the area; however, as this feature is merely access related and recent in date, this provides little support in the interpretation of this area.

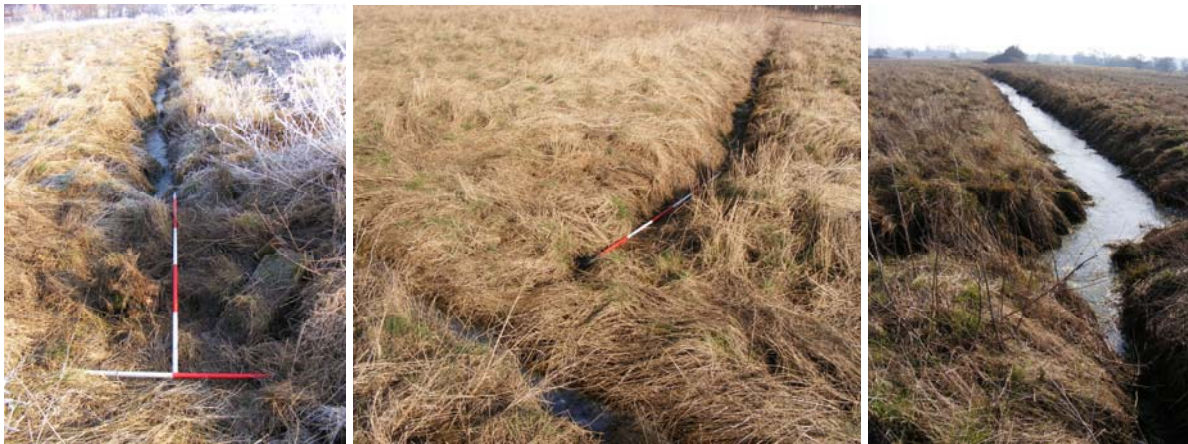
Field assessment of the island area supported the possibility that this target may represent a former water meadow system, with the identification of a series of channels, and collapsed brick features, potentially representative of sluice systems. However, whilst the channel features appeared to share many of the features of water meadow drains, certain aspects of the morphology of these features raised questions. Channel features to the northwestern end of the island, whilst appearing similar to many of those seen elsewhere, possessed flanking bank features (Figure 34), a characteristic which annuls their usefulness as meadow channels and apparently suggesting these features may represent drainage. However, due to the known extensive remodelling of the island, it remains a possibility that this area represents former water meadow which has been truncated to provide material for the creation of the further island extent to the east, with remaining channels reinforced for drainage purposes. The major channels visible on the historic mapping, within the southern area of the island, have certainly been recently modified in order to provide drainage into the flood relief channel, with the addition of concrete drainage features. Detailed topographic survey (LIDAR or Differential GPS) would be required in order to resolve the origin of the land patterns visible, through helping to identify any subtle earthwork traces invisible within the on-site undergrowth.

Figure 34- Channel features at Broad Meadow Island

Note banks visible in central picture, and width of channel above right

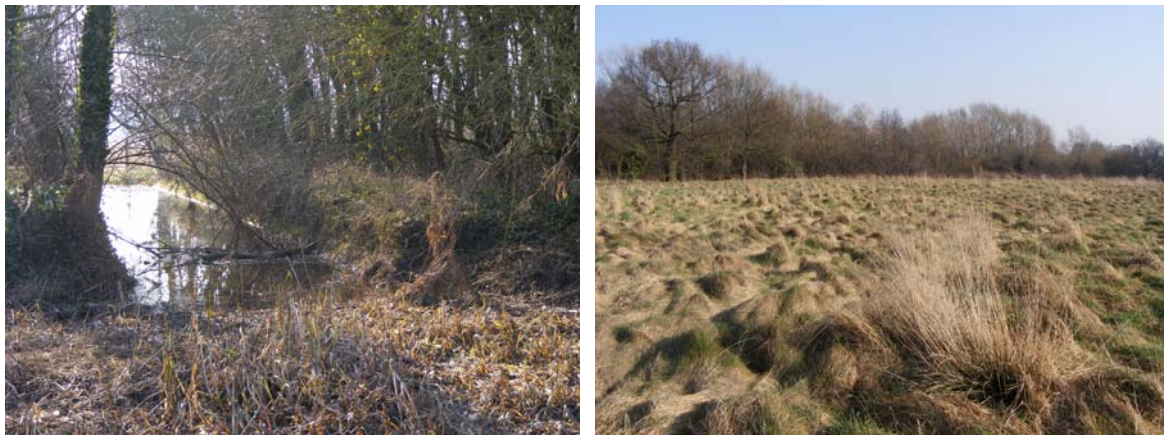
Field survey demonstrated the lack of any earthworks or structures typical to water meadow sites, and confirmed the large channel to be a substantial drainage feature associated with the dismantled railway running northwest to southeast across the site.

Figure 35- Disused Railway drainage feature and uncultivated land- Warwickshire Moor

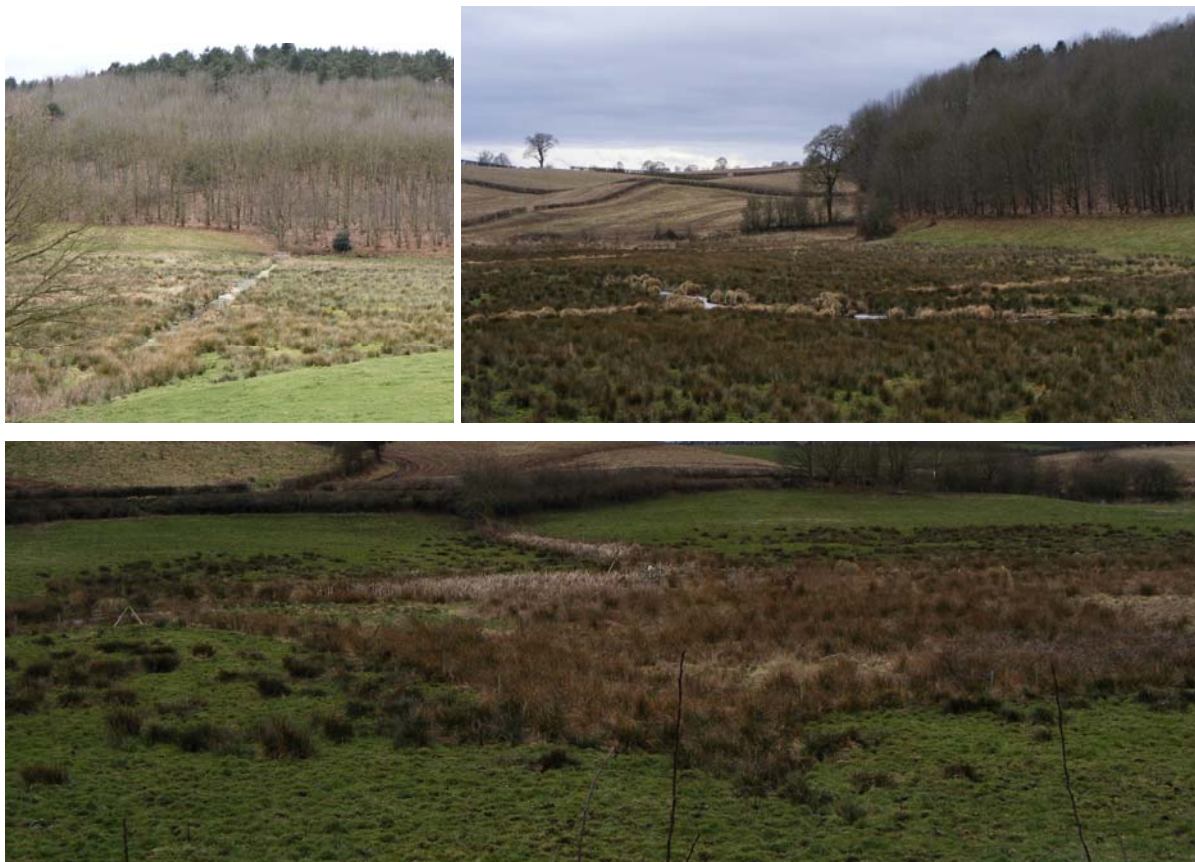
Figure 43- channel features at Bishops Wood, defined by rushes

Prior to field analysis, the target was seen to have a condition value of 3 within both available series of historic mapping.

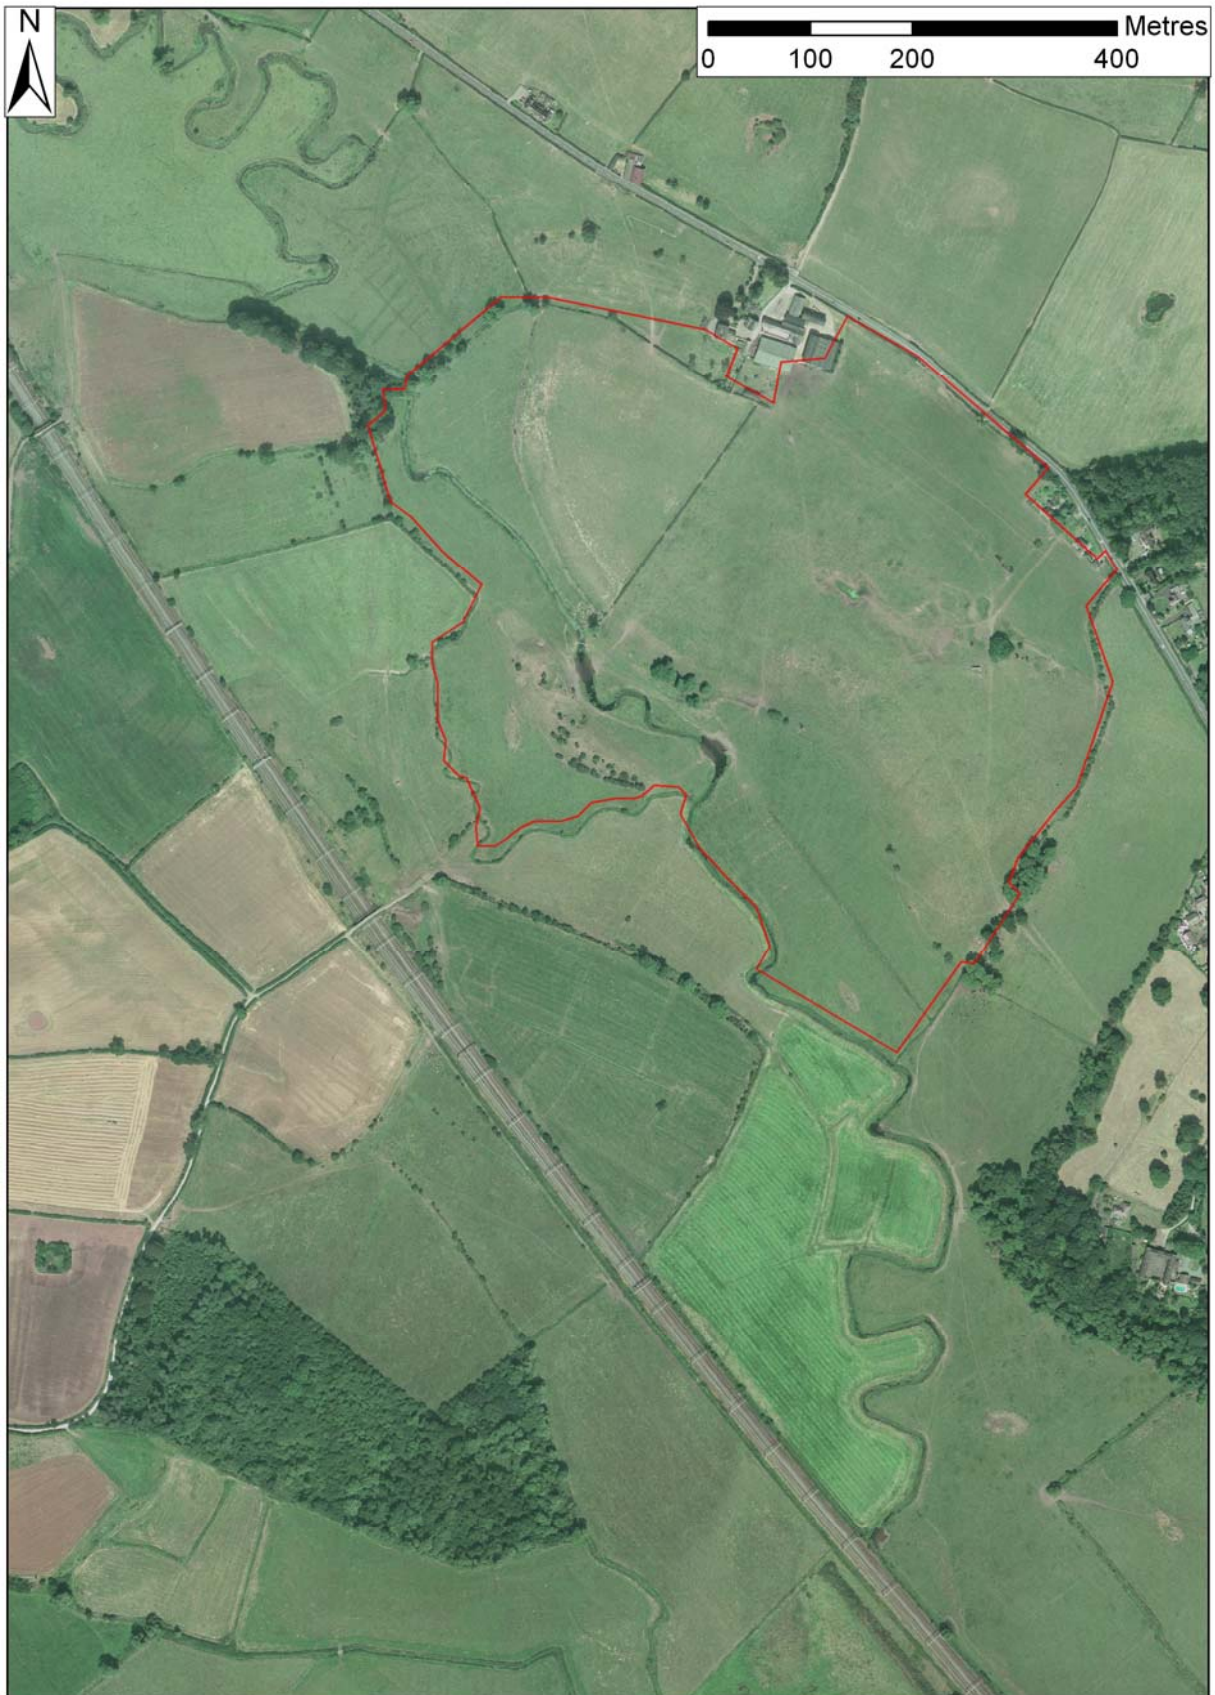
Figure 47- Cresswell farm, Seighford meadows, 2000 aerial imagery. Red marks area of field survey.

Cresswell farm lies to the northwest of Cresswell village, at the northern end of the defined target area. Desk-based survey suggested the presence of well-defined water meadow features within the area, with main drains and their associated carriers clearly visible in both aerial photographic series, forming one of the most well-defined areas visible within desk-based survey. Figures 47 and 48 show a comparison of the aerial photographic imagery for the area, with a prediction of a field condition of 2 for this target area.

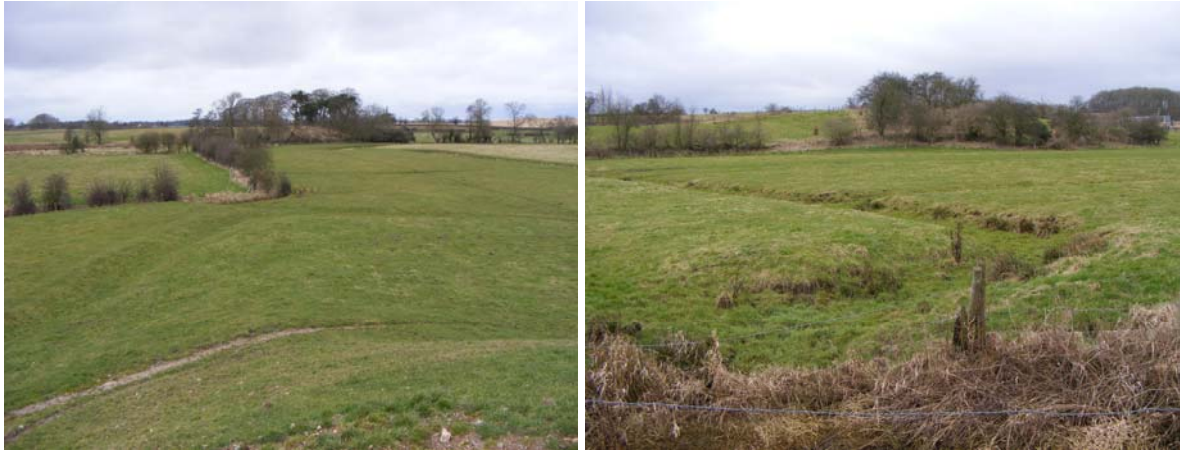
Less complete systems of former channels were visible across the southern portion of the surveyed area, with many modern field boundaries apparently defined by former main drains which were still holding water.

Figure 49- Preserved main drains and carriers- Cresswell Farm, Seighford Meadows

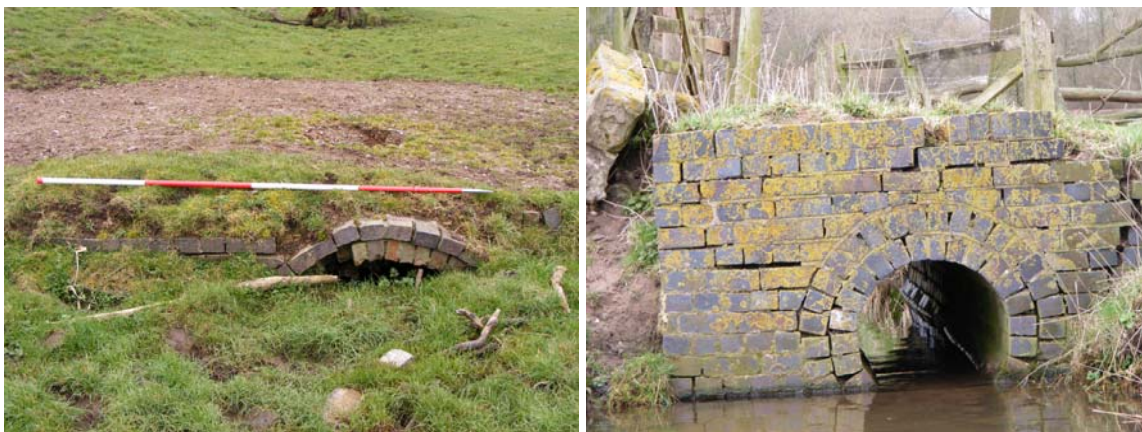
In addition, several water meadow structures were visible within the area, primarily in the form of culverts or bridges. These appeared mainly to be composed of blue industrial brick, (most likely Staffordshire Blue Brick) and appear to suggest mid to late 19th century maintenance of access and drainage. Some large sandstone blocks were visible being used as support for the banks of some channels; however these features were in proximity to modern drainage, and may merely represent recent maintenance.

Figure 50- 19th century culvert and bridge features, Cresswell Farm

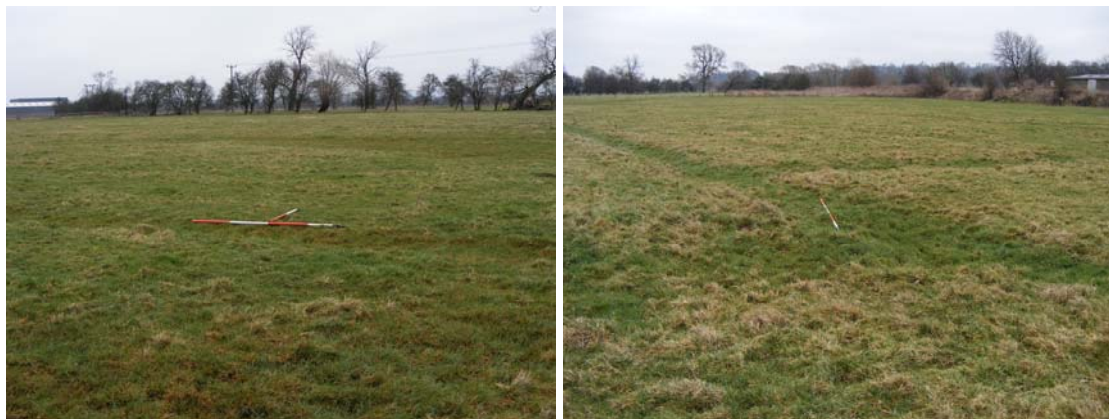
Field survey identified a series of channels crossing some portions of the southern surveyed area, apparently representative of carriers and minor drains, and still retaining the grid pattern of the original meadow plan. Across most of this area the main drain features were clearly visible, although in many places these appeared to utilise and follow the course of natural streams with little alteration of these.

Figure 58- Drain features visible at Willows Farm

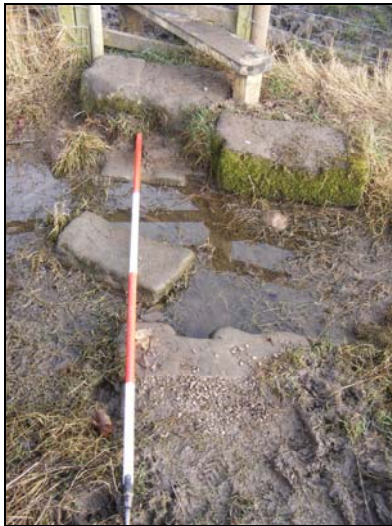
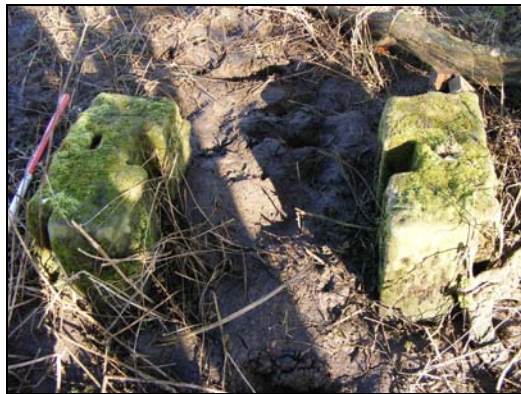
Sluice hatch settings- support or housings for sluice hatches, often with a pair with matching vertical slots where a hatch once was.
