Staffordshire Water Meadows Survey

March 2008

By Paul Breeze, Keith Challis and Mark Kincey
HP VISTA Centre
K.Challis@bham.ac.uk

Staffordshire County Council

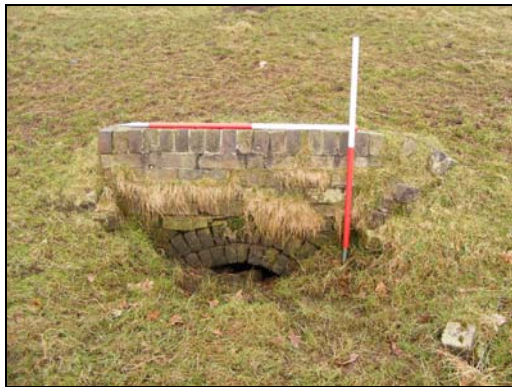
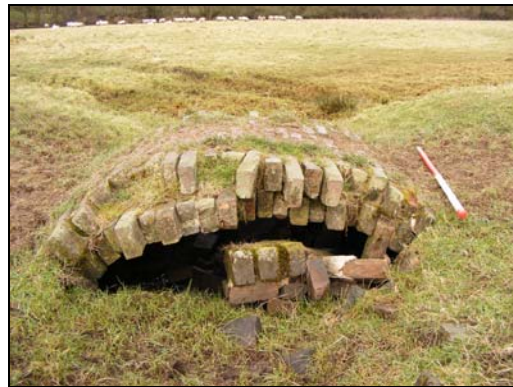
Bridges and culverts- used to provide access across a meadow and for water control

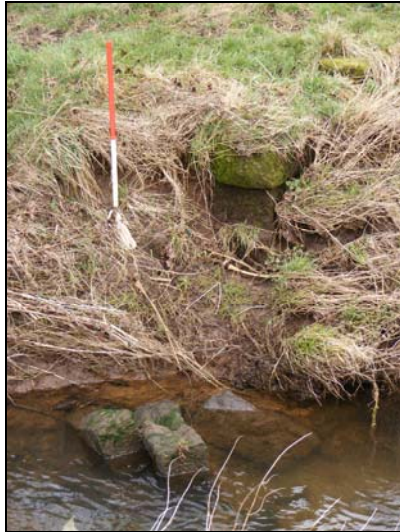
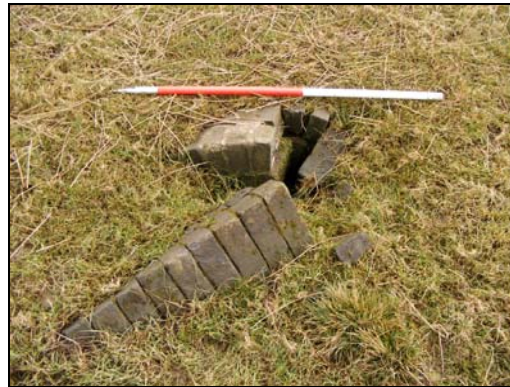
Remains of former lined channels, often seen near to banks of rivers or streams,
