2020 Flood Events:
Flood and Water Management Act
Section 19 - Investigation
Newton Leys, Burton-Upon-Trent

This report focuses on Newton Leys, Burton-Upon-Trent. The investigation undertaken has been summarised, outlining the extent of flooding reported, the most likely cause of the flooding and the actions that have been completed, or are proposed to be completed in the future.

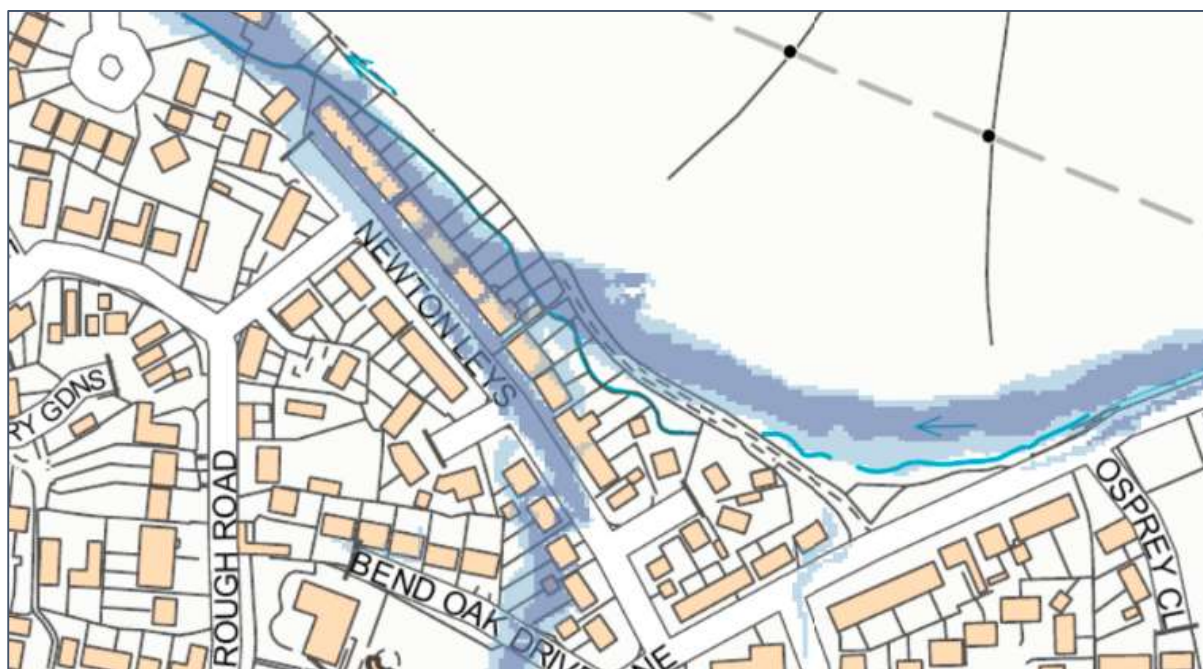
Many properties on Newton Leys lie within the 1 in 30yr RoFSW Zone or the 1 in 100yr RoFSW zone. This means each year, the area has a chance of flooding of greater than 1 in 30 (3.3%), or greater than 1 in 100 (1%). The surface water flooding extents can be seen in Figure 5 below.

Figure 5: Newton Leys Location Plan with Risk of Flooding from Surface Waters Layers. RoFSW 1 in 30 years (Dark Blue), RoFSW 1 in 100 years (Light Blue)

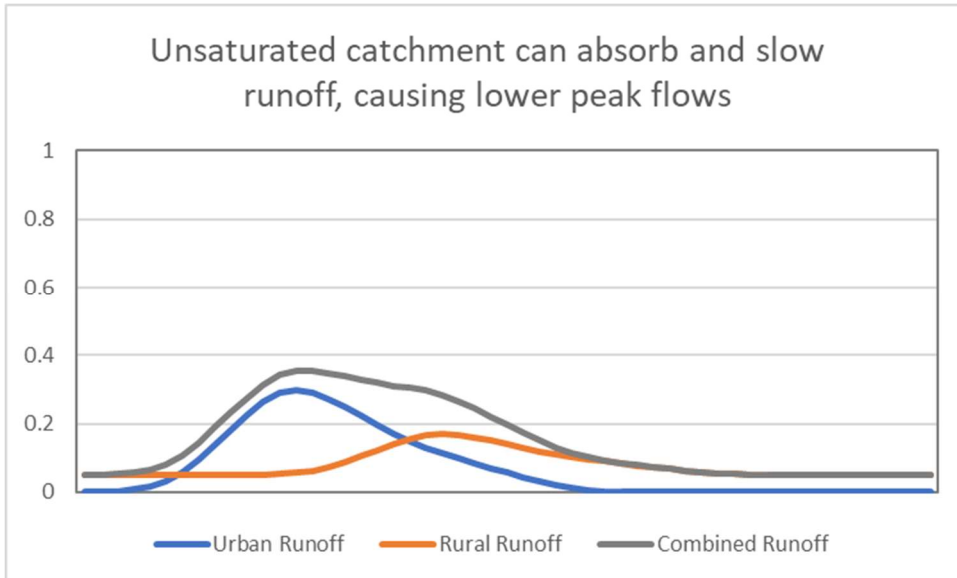
Runoff from both the impermeable urban part of the catchment and the saturated rural area would have been rapid, with both peaking quickly and coinciding. If the ground had been less saturated the peak rural runoff may have been delayed, causing a broader, lower peak in river level.

Figure 11 and Figure 12 illustrate the impact of rapid runoff from saturated ground coinciding with peak runoff from the urban catchment.

Figure 11 - Unsaturated catchment absorbs and slows runoff

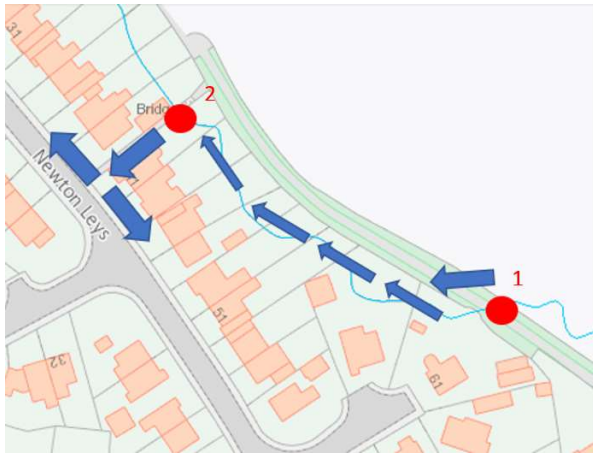
Figure 13 shows the locations of two culverts where footpaths cross Dale Brook. These have the potential to constrict flow in the channel, particularly if blocked by debris.

Figure 13 - Culverts (red circles) where footpaths cross the watercourse

As illustrated in Figure 13, flood water then followed the topography of the road and down towards properties on either side of the footpath.

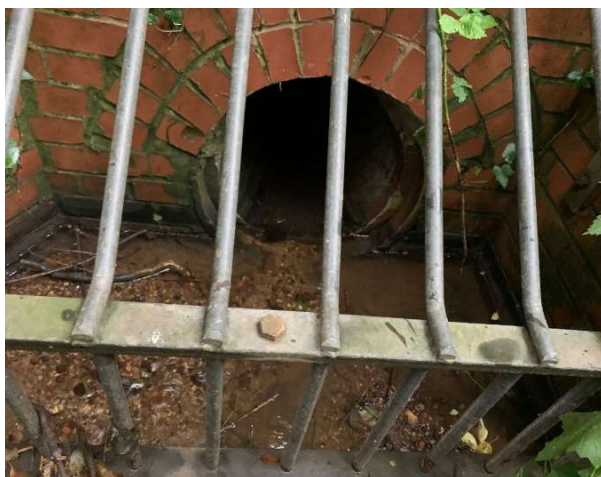
Culvert 1 (Figure 14) is approximately 450mm in diameter, with a trash screen.

Following consultation with residents it is thought that the pipe and screen were installed around 30 years ago. The pipe connects to a culvert which takes the Dale Brook underneath the garden of a property at the end of Newton Leys before becoming an open channel again.

Figure 14 – Culvert 1: 450mm pipe and trash screen at eastern footpath crossing

During the February 2020 event, it is understood that the capacity of this pipe was exceeded by the flows in the watercourse. There is no indication or reports from residents that the trash screen or pipe was blocked at the time of the event. During an initial site visit the screen and pipe appeared to be clear. This therefore suggests the pipe was overwhelmed by sheer volume of water coming off the fields rather than a blockage in the screen or pipe.

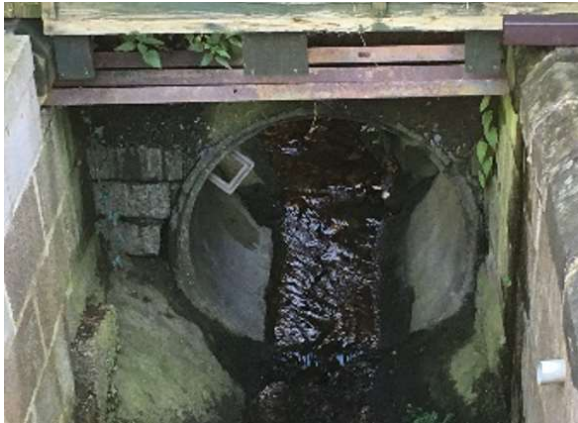
Culvert 2 (Figure 15) is approximately 1m in diameter and provides a crossing place for the footpath.

Figure 15 - Culvert 2: Approximately 1000mm diameter

The footpath is fenced on both sides with solid fencing, so forms a continuous barrier across the floodplain. Any flow exceeding the capacity of the culvert therefore backs up behind the fences and is forced out along the footpath (Figure 16) towards the highway as shown in Figure 13.

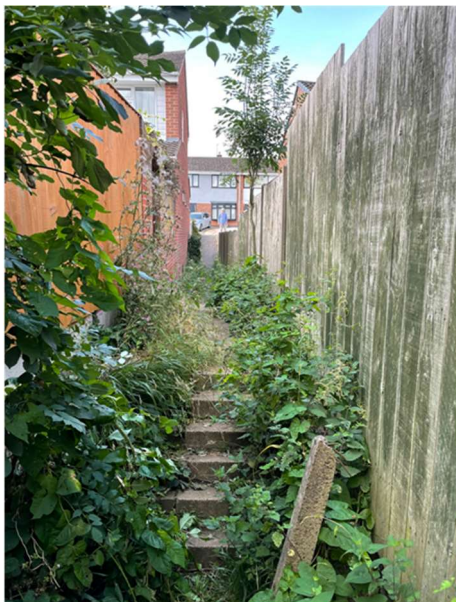
Figure 16: Footpath at Culvert 2
