2020 Flood Events:
Flood and Water Management Act
Section 19 - Investigation
Brookside, Rolleston

Document Ref:			2020 Flooding: Section 19 Flood Investigation for Brookside, Rolleston		
Revision	Date	Description	Originated	Checked	Authorised
0	11/08/2022	Draft for RMAs	Caroline Parkin	-	-
1	31/10/2022	RMA Comments Incorporated	Caroline Parkin	Chris Archer	Jamie Cooper

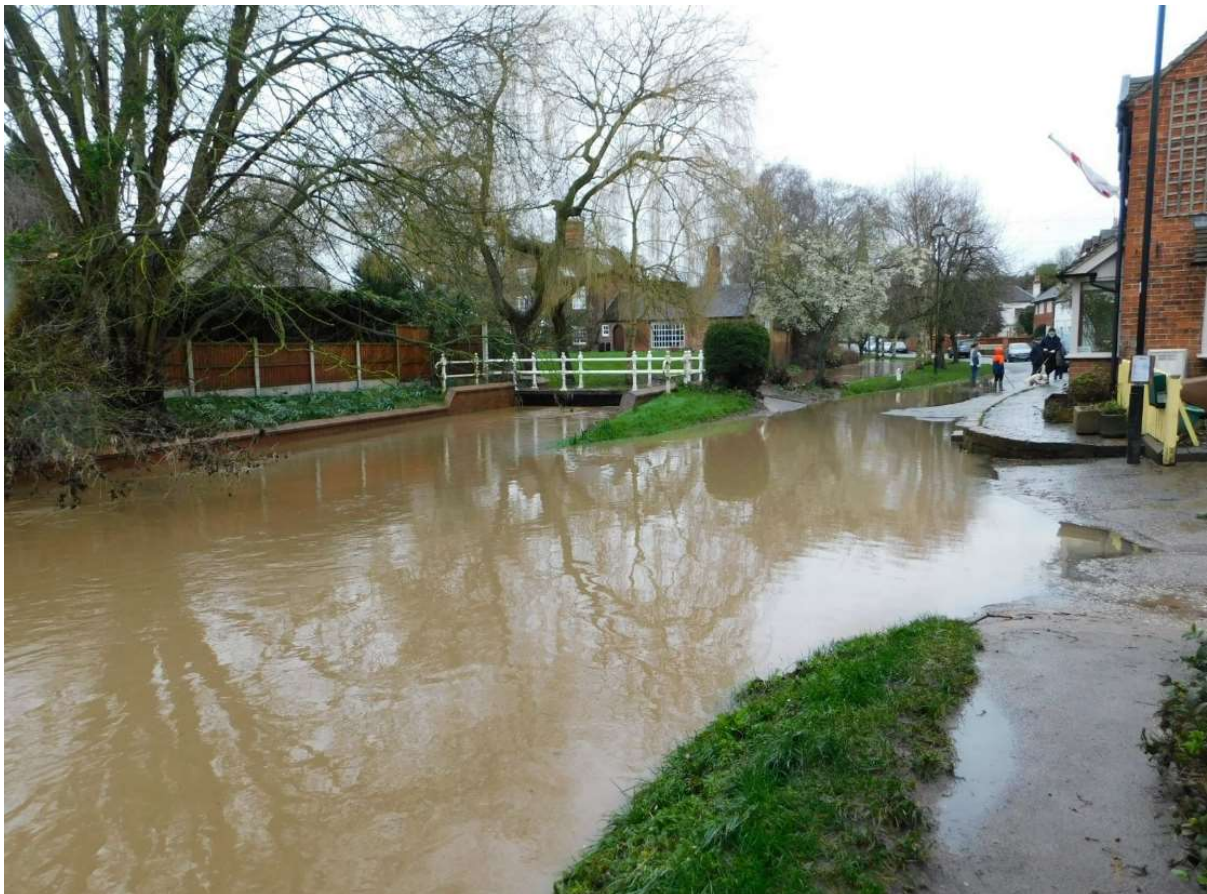
Figure 1: Flooding from the Rolleston Brook at Brookside, Rolleston, February 2020 (Image provided by the Environment Agency)

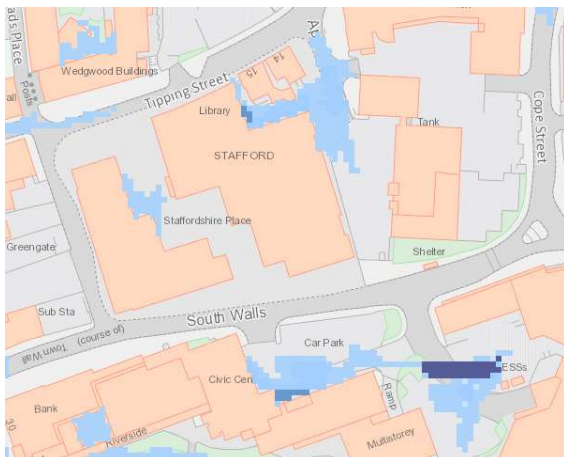
It should be noted that this mapping has been produced at national scale with a number of assumptions and therefore there are some limitations at a local scale and is not appropriate for identifying individual property level flood risk. This mapping is publicly available for use:

Figure 2: Example of Environment Agency updated Flood Map for Surface Water Flooding

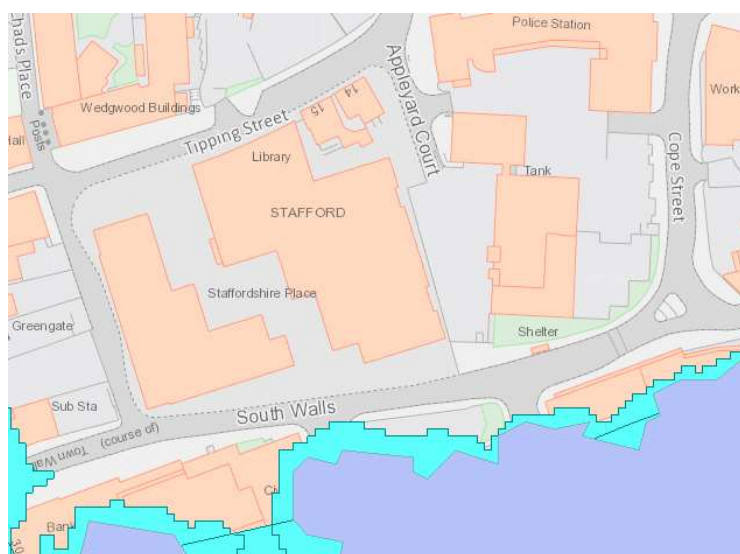
This modelling is publicly available as the Environment Agency's Flood Risk from Rivers or the Sea map and is available online at: <https://flood-warning-information.service.gov.uk/long-term-flood-risk/postcode>

Figure 3: Example of Environment Agency River Flood Zones mapping

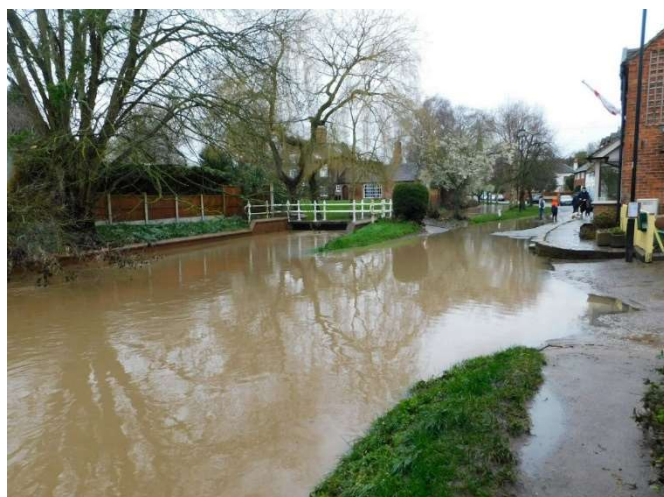
Figures 12 to 14 present photographs of flooding along Brookside in February 2020. Whilst the photographs were taken after the peak of the flood had subsided, they demonstrate the extent of flooding and the significant depth of water that was experienced.

Figure 12: Flooding along Brookside in February 2020 (Looking in a westerly direction) (Photograph provided by the Environment Agency).

Information received suggests that the main source of flooding at Brookside was from Rolleston Brook directly and has therefore been identified as main river flooding. Whilst some of the records received indicate that floodwater may have been contaminated, residents commented that this was a result of agricultural contaminants that entered the water from nearby fields.

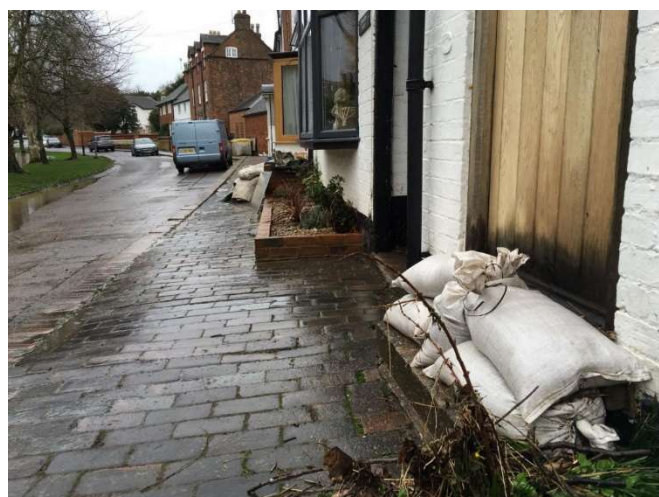
Figure 13: Flooding along Brookside in February 2020 (Looking in a westerly direction) (Photograph provided by the Environment Agency).

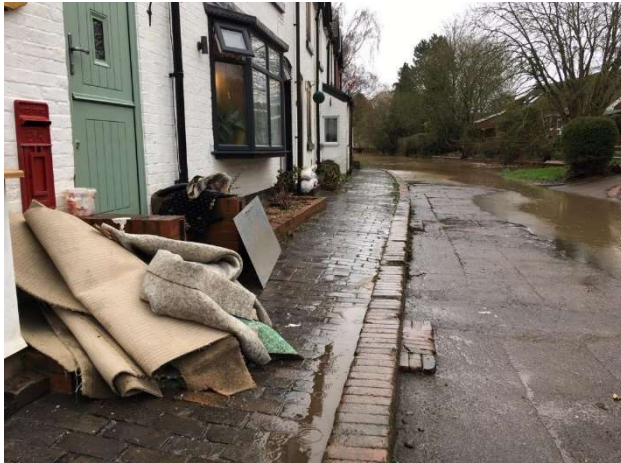
Figure 14: Flooding at Brookside in February 2020 (looking in an easterly direction) (Photograph provided by the Environment Agency).

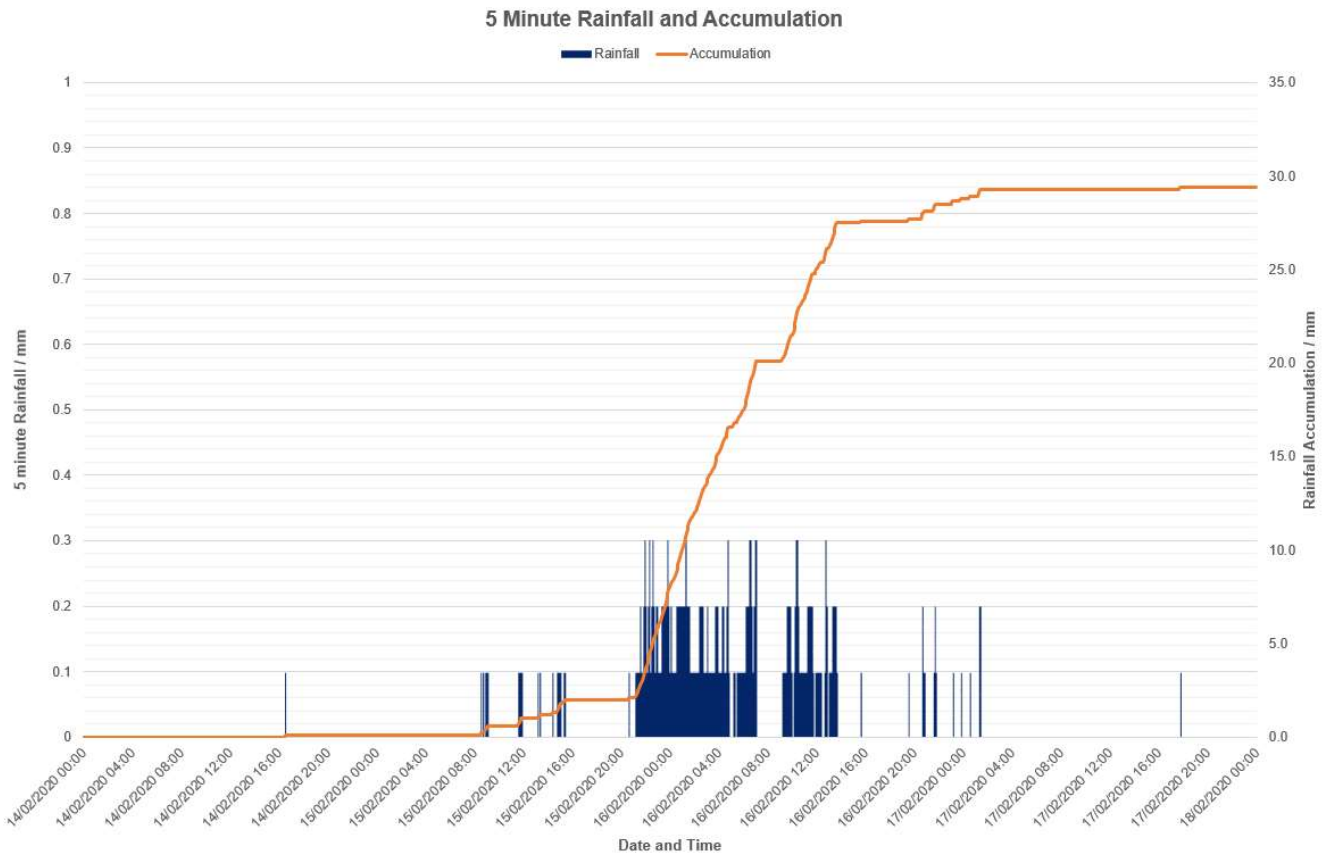
Figure 15 shows the 5-minute HydroMaster rainfall data for Brookside. A total of 28.7mm of rainfall was recorded over the 24-hour time period 15th February 2020 to 16th February 2020. Of this total, 25.4mm was recorded during a 17-hour period between 21:10 on February 15th and 13:40 on 16th February 2020 demonstrating that the storm was relatively intense, with rainfall falling continuously throughout the duration of the storm.

Figure 15: 5-minute Rainfall data for Brookside, Rolleston-on-Dove, from February 14th, 2020, to February 18th, 2020 (Source: Hydromaster)

The rainfall return period of the February 2020 event has been estimated as less than a 1-year event by HydroMaster software (Table 1). Although this presents as relatively insignificant, the average rainfall for February (1981-2010 baseline) for the area, recorded by the closest Staffordshire MET Office climate station in Denstone, is 62.1mm. Therefore, almost 50% of the monthly rainfall fell in the Rolleston-on-Dove area within 24-hours, making it significant to the area.

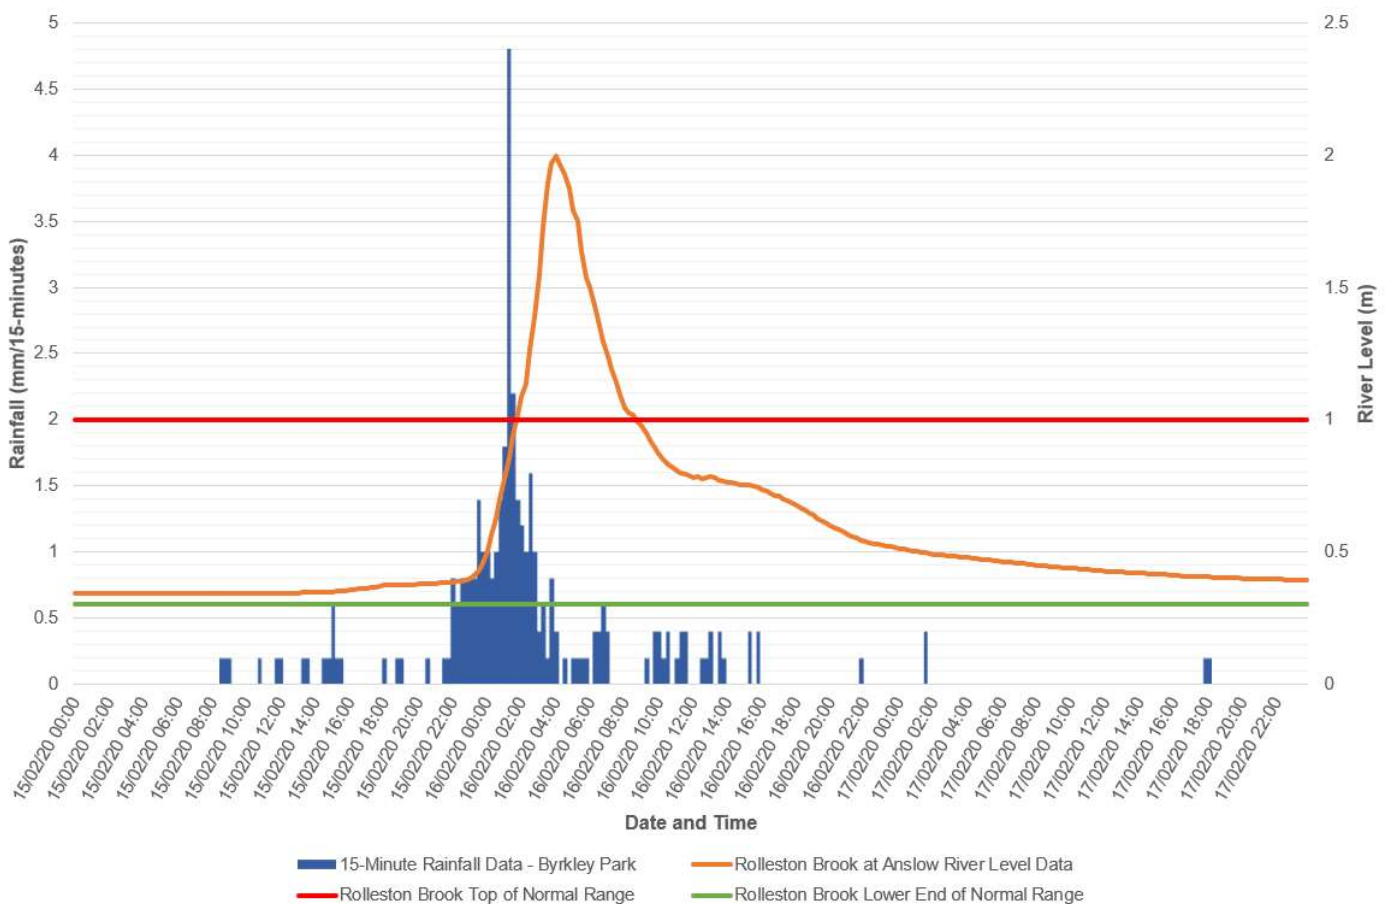
Figure 19 presents 15-minute river level data provided by the Environment Agency for the river level gauge at Anslow for the period 14th to 17th February 2020. This demonstrates that prior to the event, river levels were within the normal expected range for the watercourse (0.3m to 1.0m above datum). Shortly after the rainfall event commenced at around 21:00 on 15th February, water levels within the Rolleston Brook rose quickly, peaking at a level of 1.97m at 04:00 on 16th February 2020. This represents the highest recorded level on Rolleston Brook since records began. Levels then began to fall rapidly, returning to a normal range of around 0.5m by the early hours of 17th February 2020. Reports from residents indicate that properties were inundated for a period of approximately two hours.

Figure 19: River Level data for Rolleston Brook at Anslow between 14th and 17th February 2020 (Source: Environment Agency)

As commented previously, residents reported that their properties were inundated for around a period of 2-hours before the flood water started to recede. The river level data presented in Figure 19 demonstrates that Rolleston Brook responded quickly to the rainfall event experienced. In significant storms, water from the hillside above the village can struggle to flow through the channel, down to the floodplain of the River Dove, eventually spilling out at various points within the village.

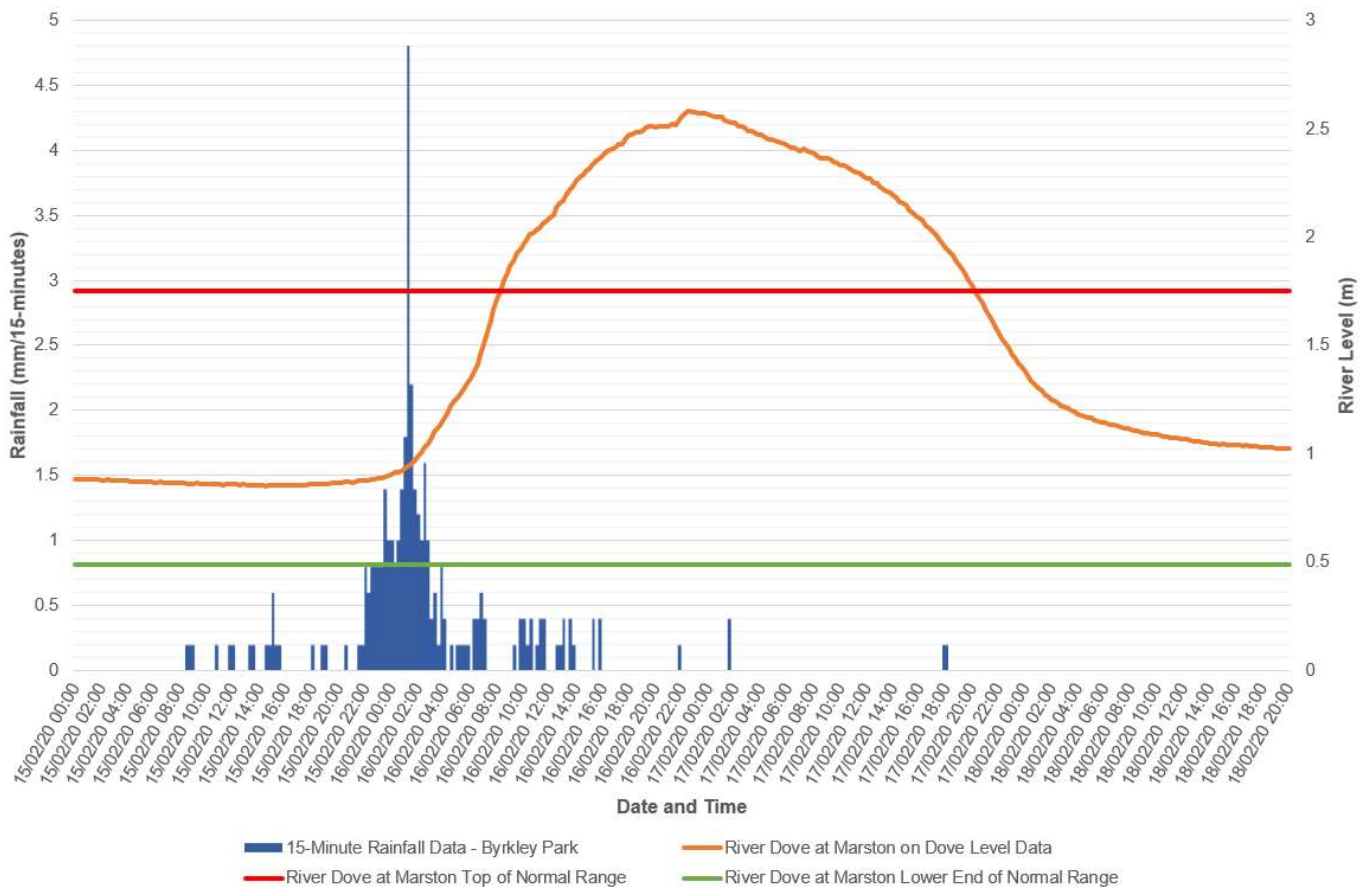
Figure 20 presents recorded river level data for the River Dove at Marston-on-Dove between 14th and 17th February 2020. This shows that in comparison to Rolleston Brook, water levels increased at a much slower rate and remained elevated for a longer duration. Review of the data indicates that a peak level of 2.6m was reached at 22:30 on 16th February 2020. This was almost 20 hours after the Rolleston Brook peaked and occurred at a point when water levels on Rolleston Brook were known to be receding. Descriptions of the event received from local residents indicate that by the time the River Dove reached its peak, flood water was already receding from their properties. This confirms that the flooding experienced at Brookside in February 2020 was solely the result of flooding from

Rolleston Brook, and the River Dove did not have a significant impact on the flooding to property on this occasion.

Figure 20: River Level data for River Dove at Marston between 14th and 17th February 2020 (Source: Environment Agency)
