2020 Flood Events:

Flood and Water Management Act Section 19 - Investigation Price Court, Shobnall

Document Ref:		2020 Flooding: Section 19 Flood Investigation for Price Court, Shobnall			
Revision	Date	Description	Originated	Checked	Authorised
0	04/05/2022	Draft for RMAs	Caroline Parkin	Chris Archer	-
1	24/08/2022	RMA Comments Incorporated	Caroline Parkin	Jamie Cooper	Jamie Cooper

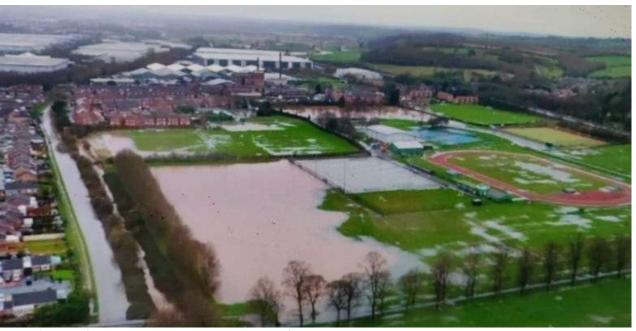
(Photo of Flooding to Shobnall Fields at rear of Price Court - Photograph provided to SSC LLFA by representatives from Shobnall Centre)

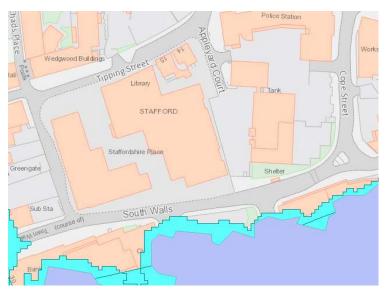
Figure 2: Example of Environment Agency updated Flood Map for Surface Water Flooding

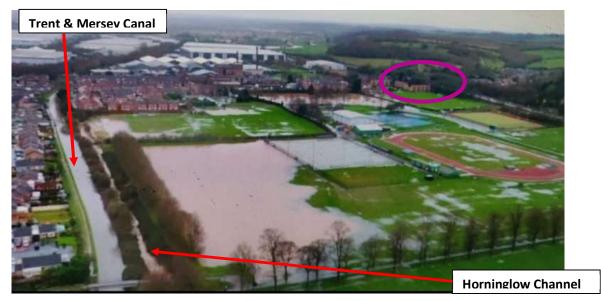
Figure 9: Flooding to the Leisure complex fields to the rear of Price Court (pink circle). Photo is looking in a southerly direction towards Price Court. (Source: Photograph provided to SSC LLFA by representatives from Shobnall Leisure Centre. The exact date and time of the photograph is unknown).

Review of the photograph shows that the flood water on the playing fields is similar in colour to the water in the Horninglow Channel, suggesting that it originated from the open section of the watercourse which flows through the playing field. Comparison of the observed flood extents following the February 2020 event with the Environment Agency's Risk of Flooding from Surface Water map shows the observed flood extent is similar to the 1 in 100 year RoFSW map and exceeded it in several places (Figure 14). It should be noted that the flood event presented is an approximation produced based on the photograph presented in Figure 9 and may not include all areas that were affected by the flooding.

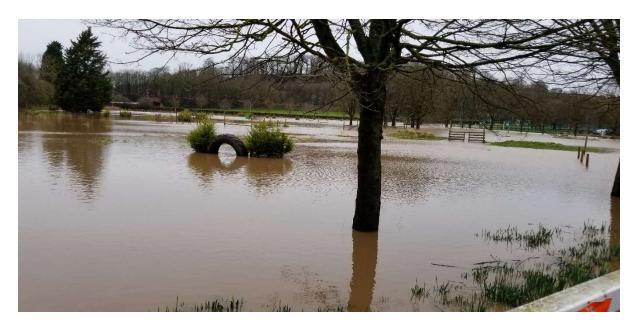
Figure 10: Flooding observed on the footgolf pitch at Shobnall Leisure Centre (Source: Photograph provided to SSC LLFA by representatives from the Leisure Centre. The exact date and time of the photograph is unknown).
