2020 Flood Events:

Section 19 - Investigation

Main Street and Bond End, Yoxall

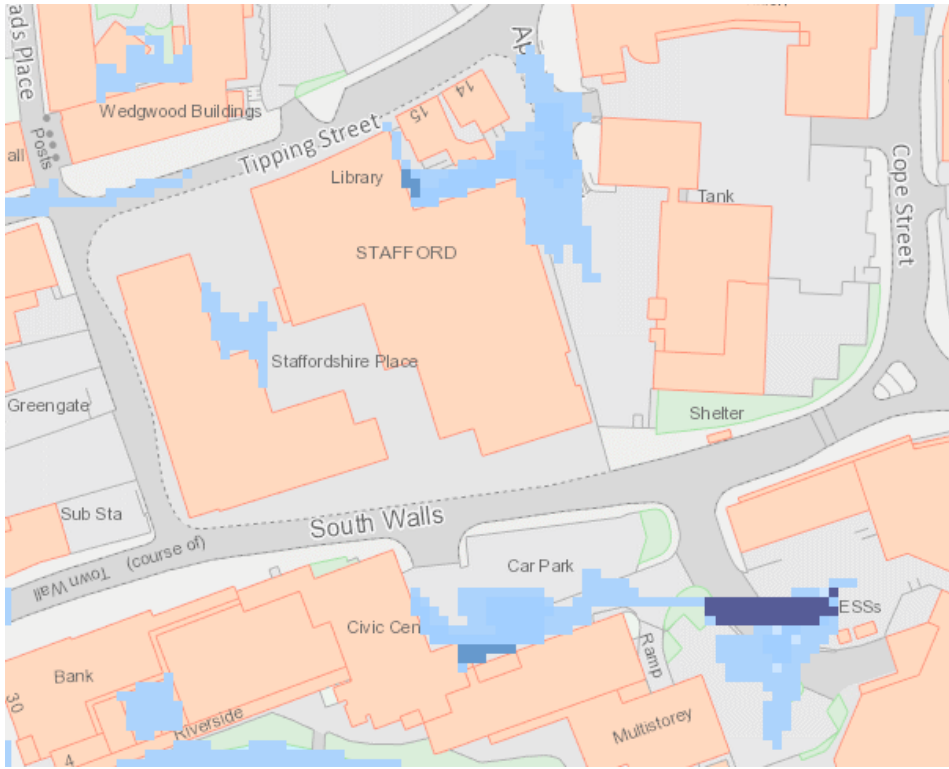
Figure 1: Example of Environment Agency updated Flood Map for Surface Water Flooding

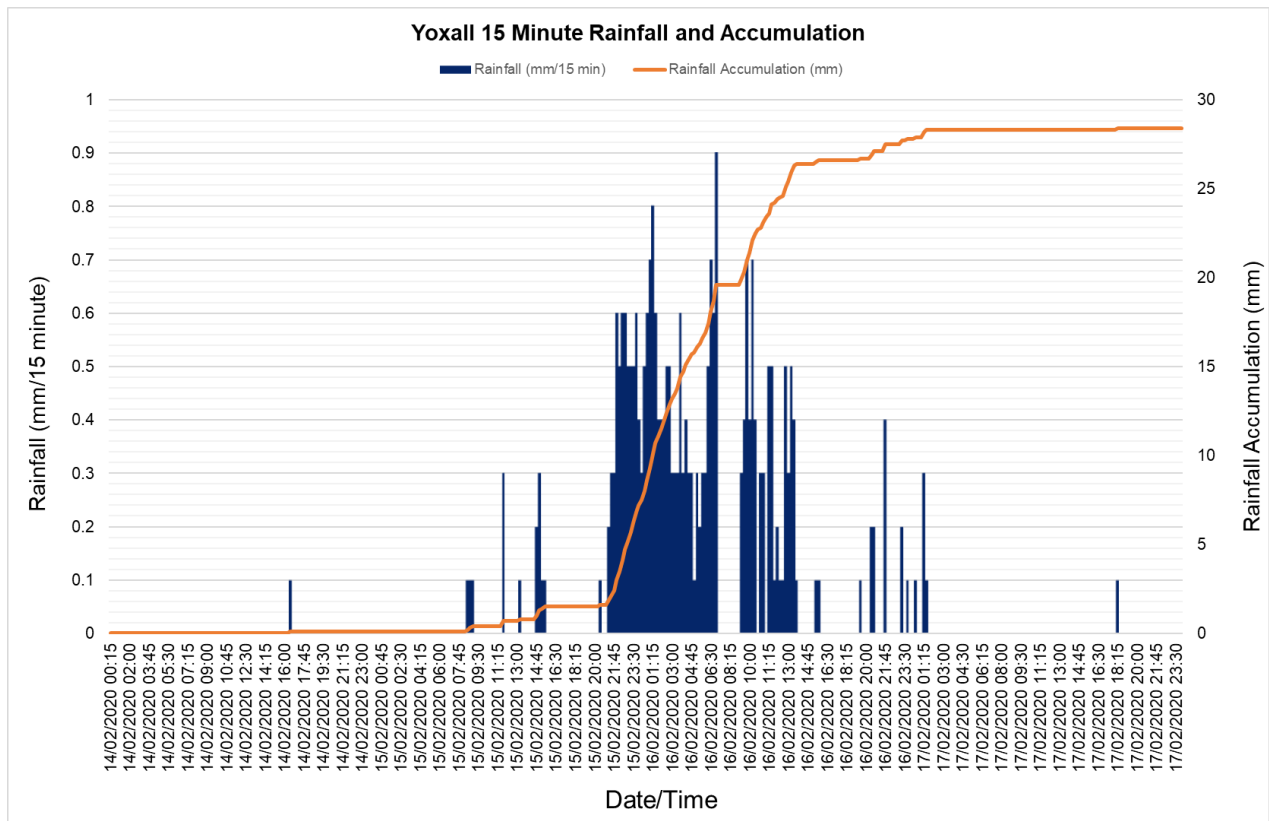
On the 15th and 16th of February, Storm Dennis generated a severe weather warning over much of the Midlands. The Storm Dennis event has been characterised as a long duration, low to moderate intensity rainfall event that spread over a large catchment and is typical with winter rainfall storm events. **Figure 11** below shows the recorded 15-minute rainfall for Yoxall from February 15th to 18th.

Figure 10: Recorded 15-minute rainfall (mm) totals for Yoxall between the 15th and 18th of February 2020. Source: HydroMaster software

A total of 28.3mm was recorded during this period, with 24.8mm recorded during a 17-hour period between 21:15hrs on February 15th and 14:15hrs on February 16th. The 24-hour storm duration return period has been identified as just below a 1-year event by Hydromaster software. Although this presents the event as unexceptional, the average rainfall for February (1981-2010 baseline) for the area, recorded by the closest Staffordshire Met Office climate station in Denstone, is 62.1mm. Therefore, more than 50% of the monthly rainfall fell in the Yoxall area within two days making it significant to the area.

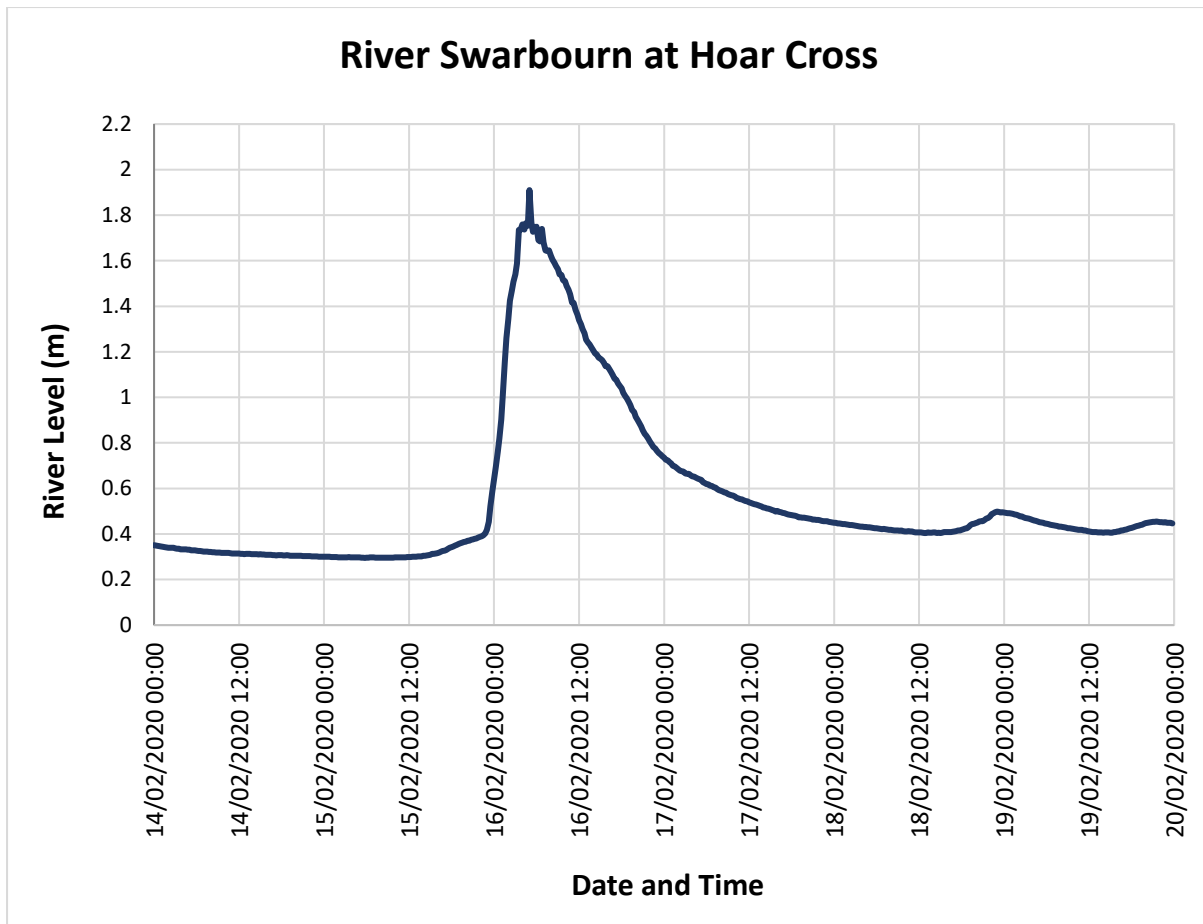
The intense periods of rainfall that occurred across Staffordshire caused many watercourses in East Staffordshire to record their highest levels since records began. This includes the highest level ever recorded for the River Swarbourn at Hoar Cross monitoring station, upstream of Yoxall, of 1.91m on February 16th 2020 at 05:00hrs (**Figure 13**).

From the 2008 River Swarbourn Hydraulic Modelling report, a developed rating curve for the River Swarbourn calculates the flow for 1.91m river level (stage) as approximately between 15 and 16m³/s. Estimated return periods for the rating curve identify a 5% AEP event, or a 20-year return period, as 16.1m³/s This indicates that the event was, if not very close to, a 5% AEP event. The hydraulic modelling data has a short range from 2001 to 2008, when the report was published, that suggests a limited confidence in the rating curve output. However, the modelled results for the 2007 flood incident that estimated the event as between a 20% and 10% AEP reasonably matches the anecdotal evidence from the event in relation to the soffit of the central arch of the Town Hill Bridge.

Figure 12: River Swarbourn levels recorded between February 14th and 20th 2020 at the Hoar Cross monitoring station that identifies the highest recorded level of 1.91m since records began at 05:00hrs on February 16th. Source: Environment Agency WISKI (Raw Water Resources Monitoring Data) service

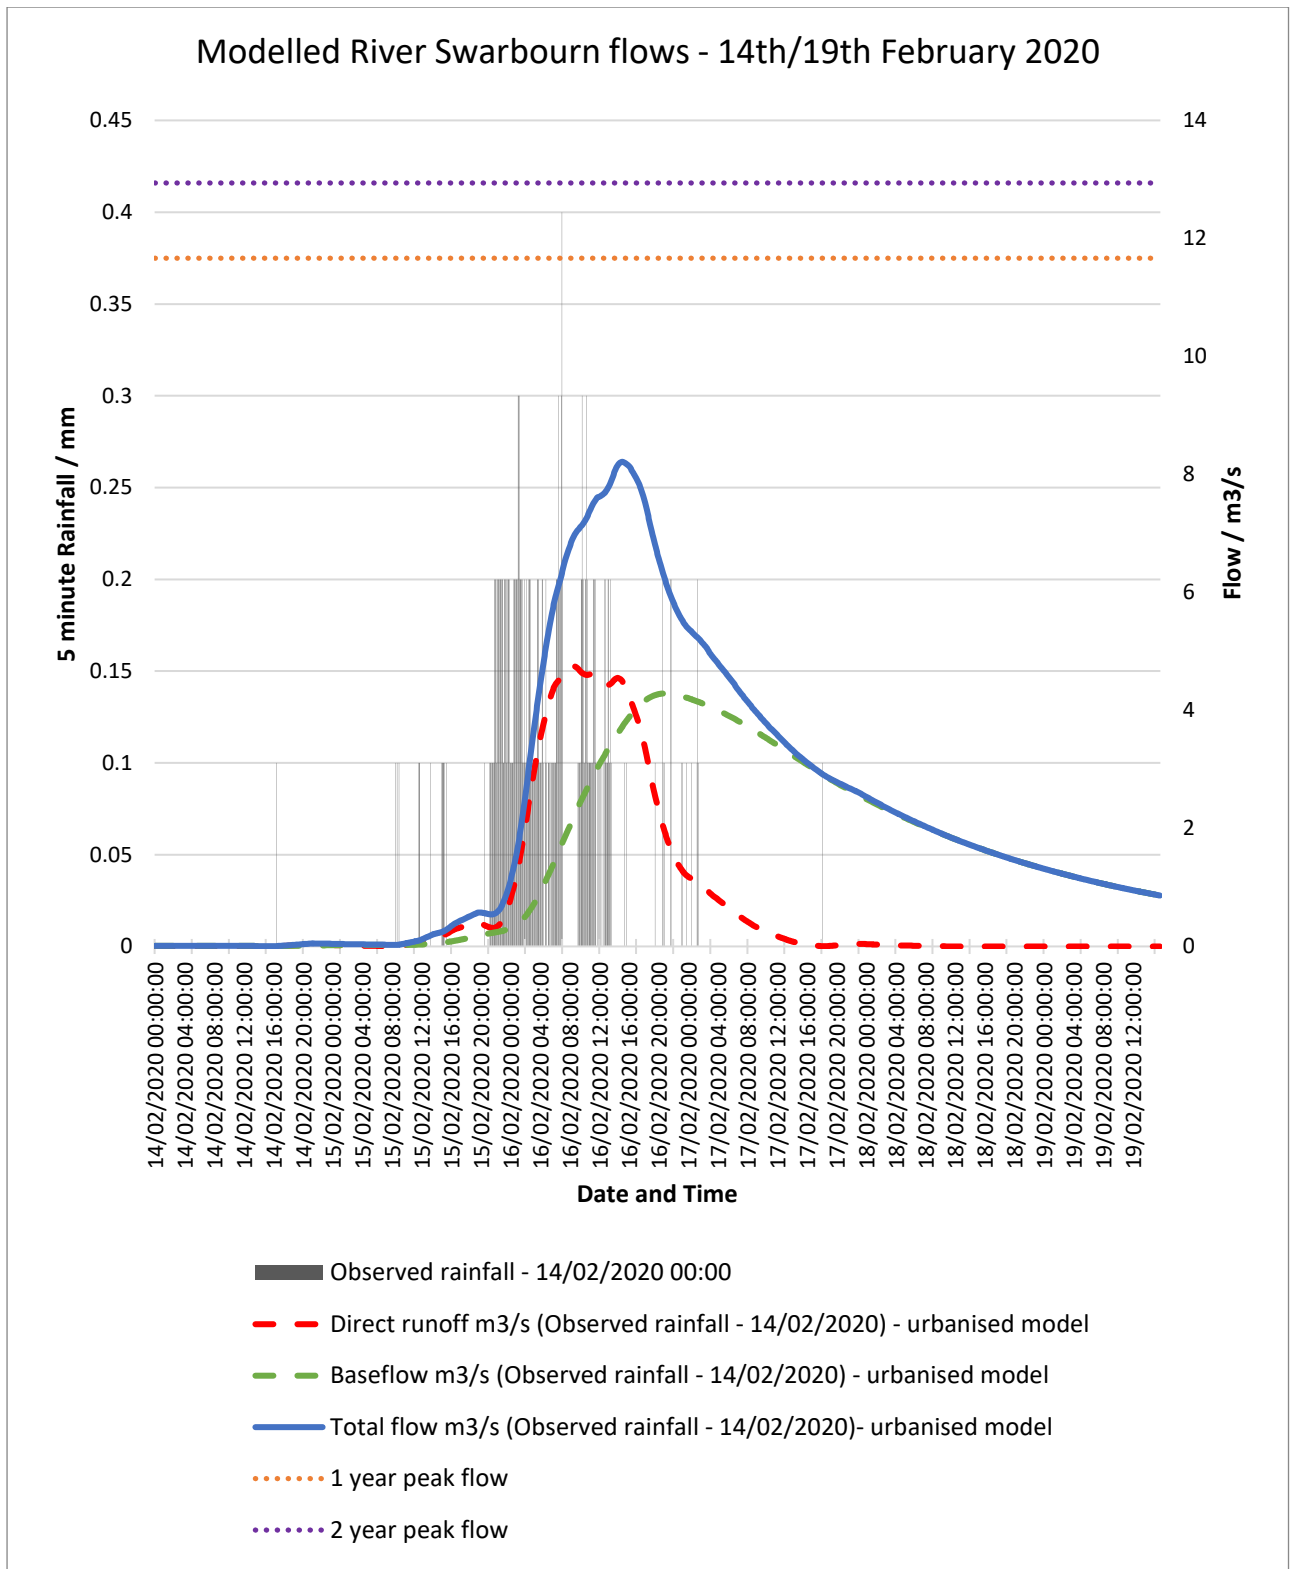
ReFH software has also been used to create a hydrograph from observed rainfall and catchment characteristics, as well as modelled hydrographs for design storms of different return periods. The resulting hydrograph is available in **Figure 14**. This shows rainfall from February 14th to 19th 2020 and identifies peak rainfall at 06:55hrs on February 16th that resulted in responding levels from the River Swarbourn with a peak discharge of 8.1m³/s at 16:15hrs on February 16th. Comparison of modelled peak flows has calculated the return period of this River Swarbourn event as less than a 1-year return period.

Yet, while ReFH modelling has calculated the flow, it may have underestimated the antecedent conditions and the saturation of the catchment that increases run off and overland flow rates of rainfall entering the River Swarbourn. The software may also have underestimated the levels already in the River Swarbourn, leading up to Storm Desmond event. For instance, the 2008 Hydraulic Modelling report identifies that the levels in the River Swarbourn at the Hoar Cross monitoring station remain consistently above 0.2m for the length of the record and was recorded prior to the increase in river levels from February 14th to 16th (**Figure 13**).

Figure 13: Modelled ReFH hydrograph of observed rainfall and modelled response on River Swarbourn levels between February 14th and 19th 2020. The results indicate a return period of less than 1-year peak flow. Source: HydroMaster software

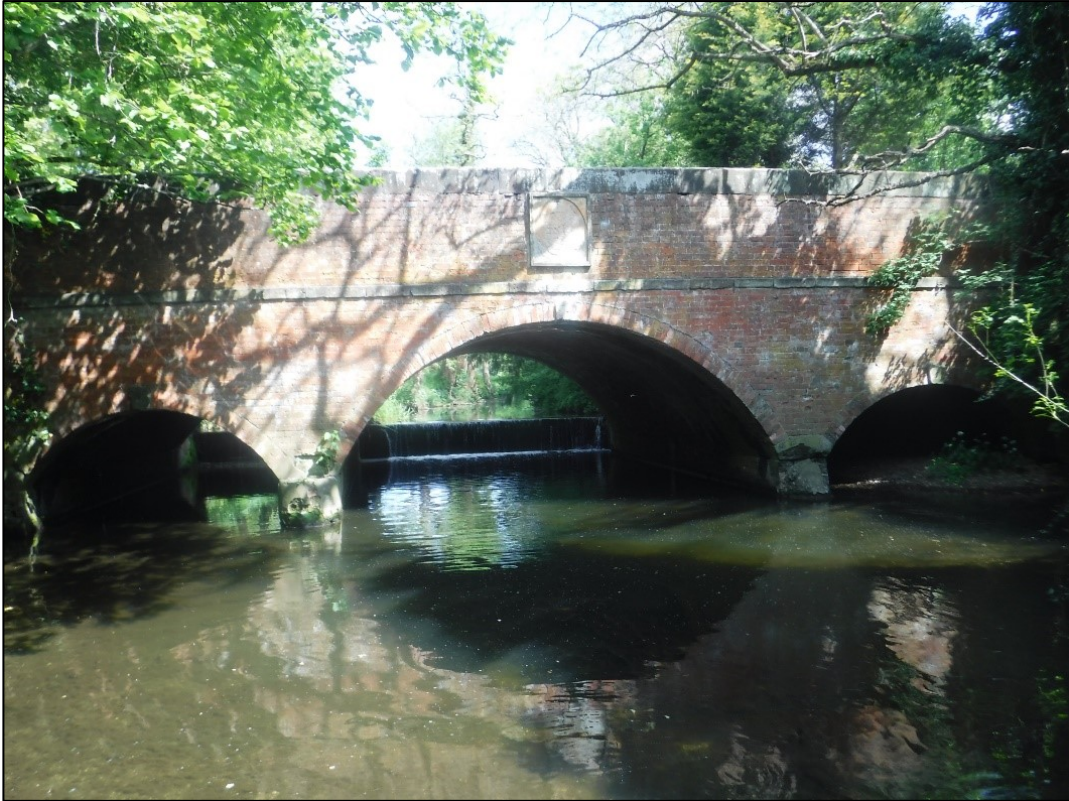
Consultation with the Staffordshire County Council (SCC) Highways team has identified that no blockages or obstructions of the Town Hill Bridge were reported during the February 2020 event, which was a key factor during the serious flood event in November 2000 when a branch was suggested to have blocked one of the arches. The bridge is inspected by the Highways team every two years and there has been no record of any recent blockages, with the Town Hill Bridge documented in May 2019 showing no blockages (**Figure 15**). However, it is noted that by the Highways team that a large tree could easily become grounded and butt up against the bridge, so further inspections of this should continue in the future. High River Swarbourn levels were also experienced at the Town Hill Bridge during Storm Christoph in January 2021 (**Figure 16**). However, the river levels remained below the soffit level of the bridge, and no blockages were reported.

It was also agreed following consultation with the Environment Agency and SCC Highways that the weir upstream at the north elevation can worsen flooding events in Yoxall, previously being noted as a key factor in the November 2000 flood event. Weirs have a significant impact on the flow regime both upstream and downstream and this problem can be heightened during high rainfall events. During high rainfall events weirs can cause increased water levels, depth, and flow width along with reduced flow velocity. This is a known problem at Yoxall and was likely a factor during the February 2020 event.

Figure 14: Town Hill Bridge in May 2019 showing no blockage prior to February 2020 Flood Event

Issue/Risk	Recommendations/Actions	Responsible RMA
The Town Hill Bridge becoming blocked with debris	Current inspection of the bridge is undertaken every two years should continue as normal. SCC Structures Team to explore the possibility of performing a special inspection of the Town Hill Bridge following flood events on the River Swarbourn as large debris can become trapped during a flood event. This would enable a record of blockages at the structure during flood events, with associated actions taken to reduce this if there is a resulting high likelihood.	Staffordshire County Council (SCC) Highways

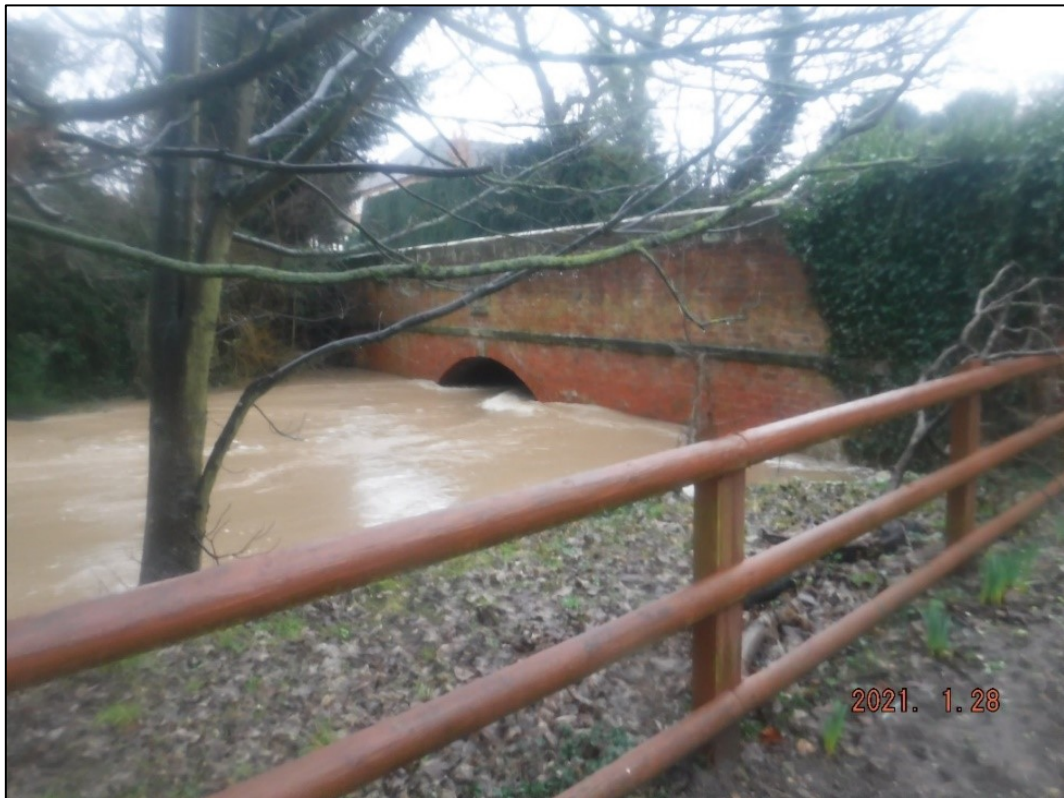
Figure 15: High river levels at Town Hill Bridge during Storm Christoph, January 2021

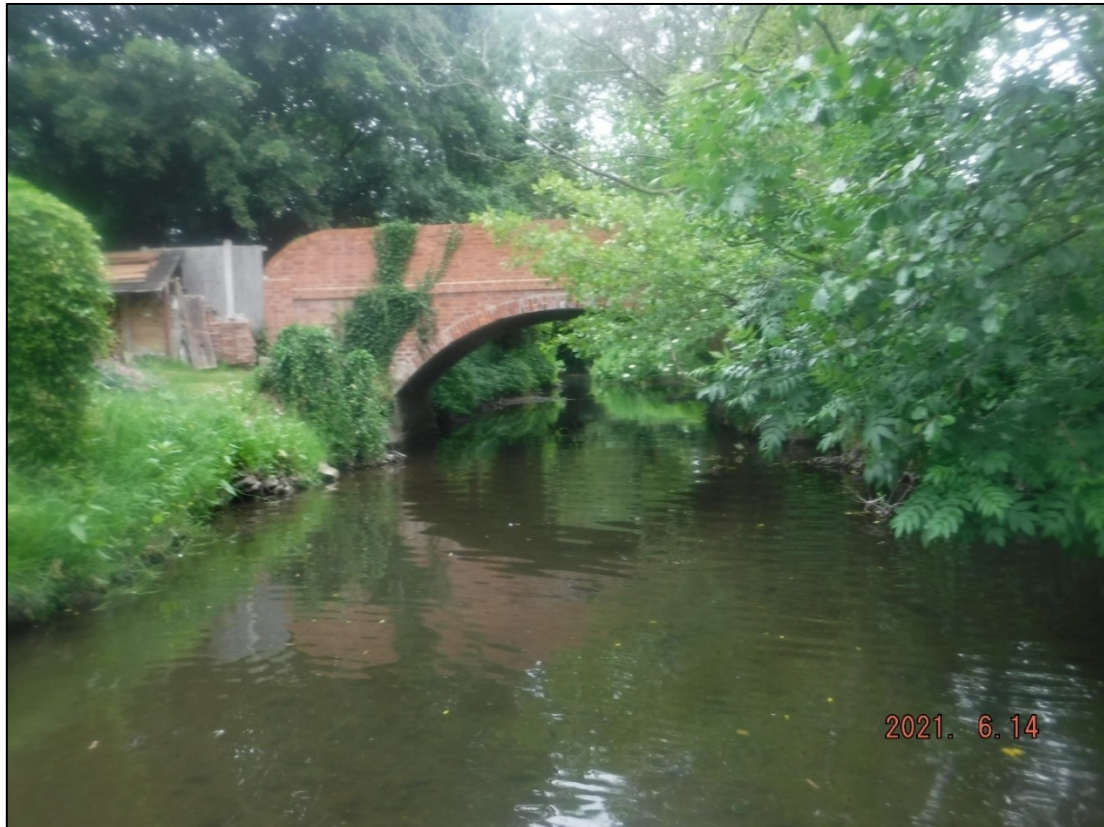
Like the Town Hill Bridge, the Bond End Footbridge (**Figure 17**) acts as another significant constriction in the channel that water can back up against. This was also acknowledged in the 2008 Modelling Report. Additionally, It is noted that this stretch of the River Swarbour also has insufficient capacity to convey flood waters during a 2% AEP event (1 in 50-year return period). This mechanism of flows backing up against the Bond End Footbridge, and record flow levels in the River Swarbour in the February 2020 event, resulted in several properties in Bond End flooding internally during the early hours of February 16th, 2020.

Figure 16: Bond End Footbridge photographed in 2021 during a period of typical flow on the River Swarbour
