Local Cycling and Walking Infrastructure Plans

Walking Route Audit Tool

Local Cycling and Walking Infrastructure Plan: Walking Route Audits - Newcastle Under Lyme
Liverpool Road

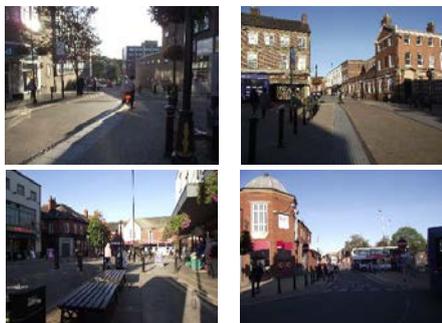
Comments	Improved environment at northern end where there is part time access for taxi and access to bus station.
Actions	Streetscape works to bring northern end of street up to similar standard as the fully pedestrianised areas. Crossing/entry treatment at southern end of Friars st by Lower St.

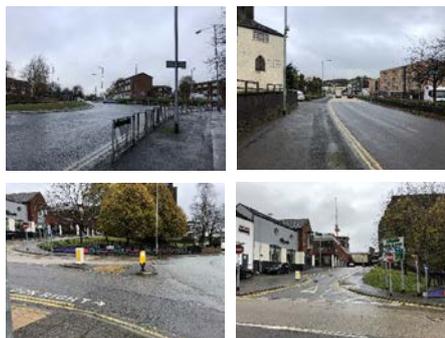
Comments	Links are unpleasant due to lack of active frontage and proximity of traffic. Subways at regular intervals (each major junction) but not pleasant.
Actions	Replace subway crossings with single stage parallel ped and cycle signalised crossings for better access to retailers and residences on outside of ring road.

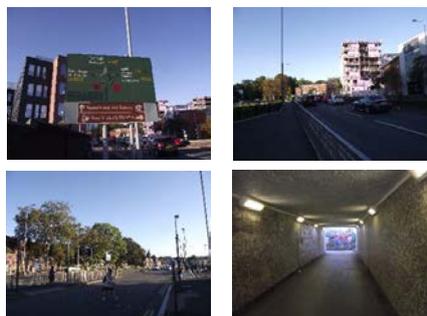
Comments	Links are unpleasant due to lack of active frontage and proximity of traffic. Subways at regular intervals (each major junction) but not pleasant.
Actions	Improve subway entrances from footways by widening, guardrail removal, planting etc. Dropped kerbs/tactiles or entry treatments to reduce crossing distance at side roads. Hassell St crossing
