Tutbury

Historic Character Assessment

Staffordshire Extensive Urban Survey

Staffordshire County Council Document No:	EC4609.R19		
Status:	Draft	Rev. No:	2

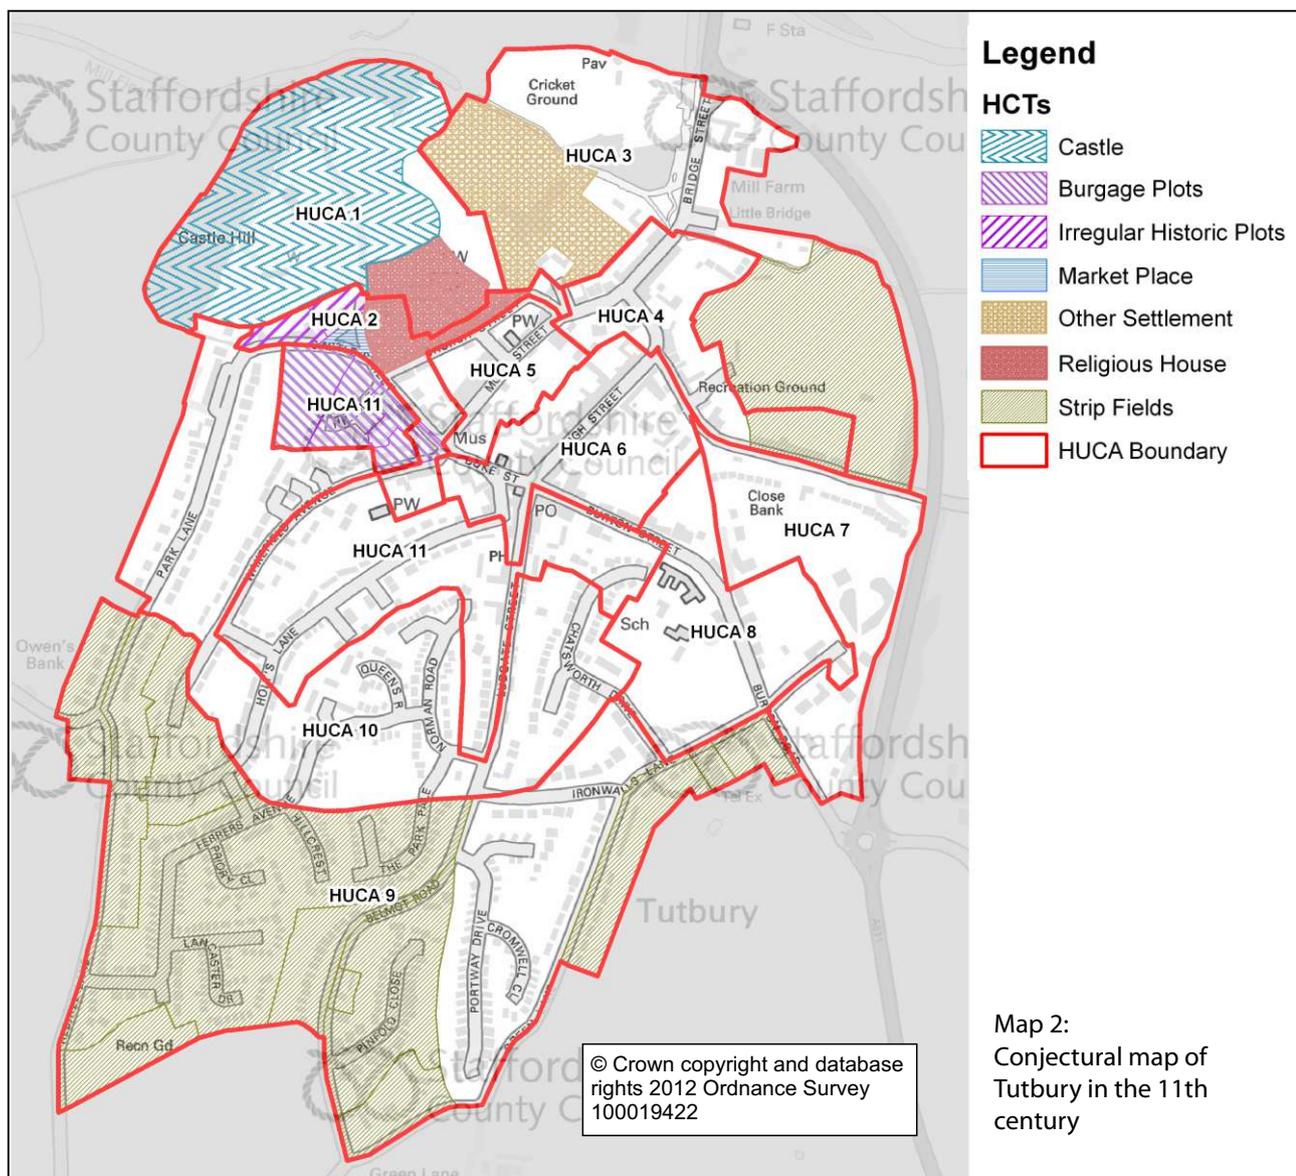
Map 2:
 Conjectural map of
 Tutbury in the 11th
 century

Tringham suggests that the village may have been located to the south east of Castle Hill, and potentially could have pre-Norman origins⁴⁴. This may have been located in the area of the later Tutbury Priory (cf. 2.4.3) and possibly stretched as far as Mill Fleam (cf. HUCA 3). Earthworks have been noted in the area of HCT 'Other Settlement' ('Paddocks and Closes' on map 15 in HUCA 3) on map 2⁴⁵. These have been described as two terraces and a hollow way possibly denoting settlement pre-dating the borough, although to date these have not been investigated⁴⁶.

Hislop et al have suggested that Domesday Book implies a planned Norman settlement and later traditions suggest it was founded in 1080³⁴. However, this work does not consider the references to Burton at Domesday. Tringham suggests that the settlement of Burton may have been located to the south east of Castle Hill (cf. 2.4.1.1 for further discussion)³⁵.

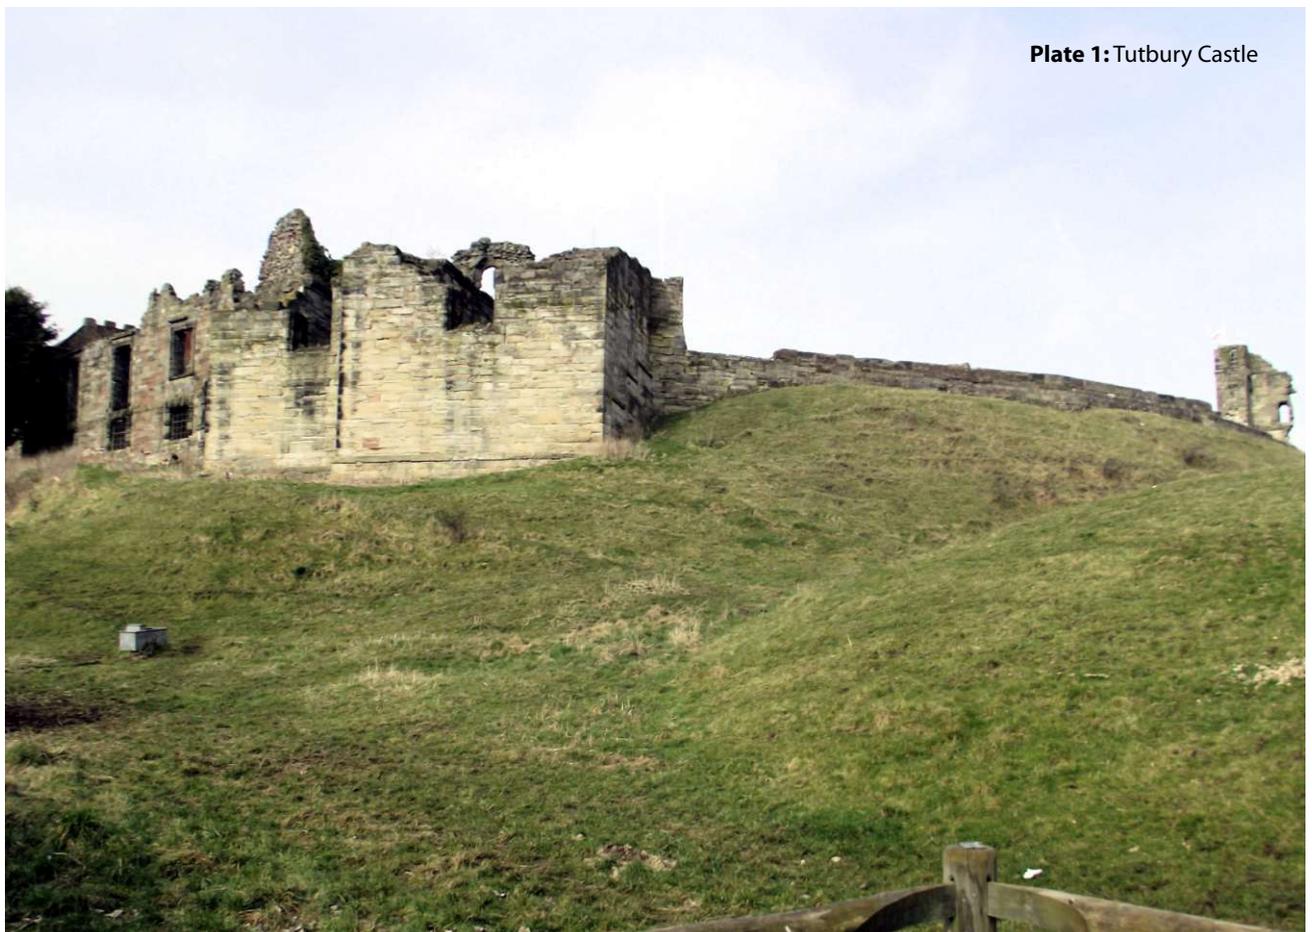
Plate 1: Tutbury Castle

Archaeological work and architectural analysis have been carried out within the castle on various occasions, but most recently in the first decade of the 21st century. This work identified the foundation of the castle in the 11th century associated with the re-working of the site followed by a major reorganisation in the 12th century⁵³. The latter was potentially associated with the destruction of the castle in 1175⁵⁴. A stone keep and a chancel to the chapel were built in the 13th century, but the majority of the upstanding remains were built in the 15th century. Hislop et al suggested that the latter works, carried out by the Crown, were probably more likely to be associated with the castle's location adjacent to Needwood Forest (cf. 2.4.2.1) which represented an important hunting ground⁵⁵.

The archaeological works at the castle included an analysis of the existing buildings (plate 1). This has emphasised the differing architectural styles and fabric and so has in part revealed the legible history of the castle. The phases include the 18th century folly which can be seen as a clear indicator of a change in the way in which the castle was viewed. From this point onwards its importance was linked to its aesthetic appeal as a romantic ruin visible across the wider landscape (cf. 2.6.1.3; plate 7). It remains an important tourist attraction in the local area for its aesthetics and its role in national history (notably as one of the prisons of Mary Queen of Scots). The castle's national importance has been recognised through its designation as a Scheduled Monument (cf. map 12)¹⁸⁹.

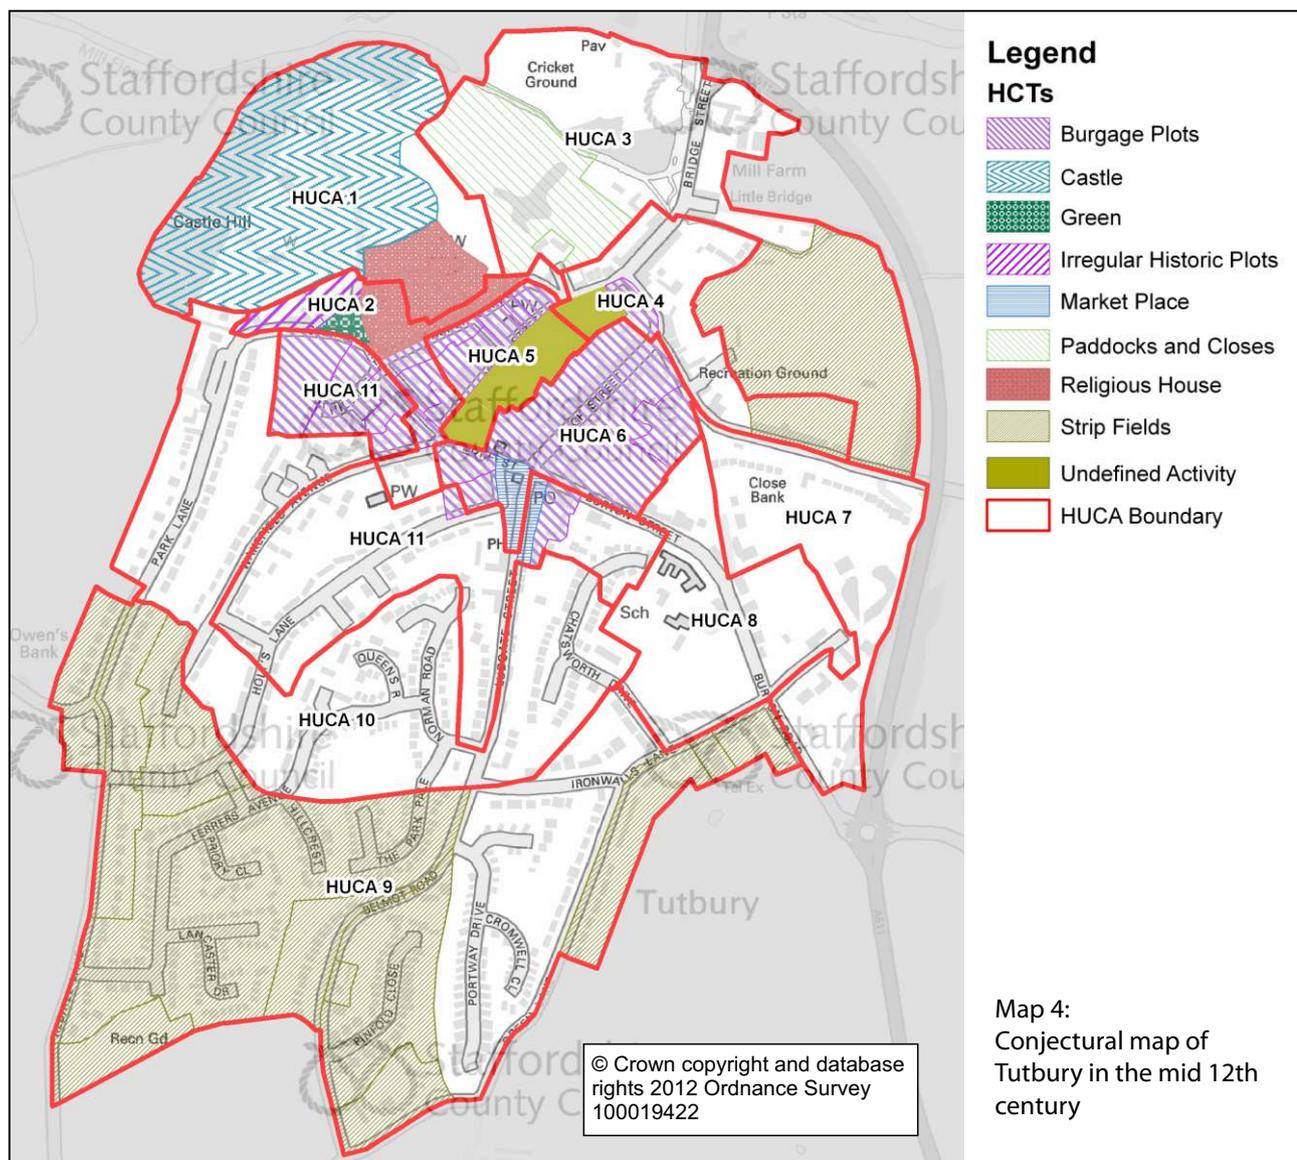
Map 4:
 Conjectural map of
 Tutbury in the mid 12th
 century

In the mid 12th century the de Ferrers granted a further 182 burgages within the borough indicating the creation of the extant grid street pattern typical of other mid 12th century towns⁶¹. In Tutbury this pattern appears to comprise two parallel streets, Monk Street and High Street, which link Lower High Street (to the north east) with Castle Street/Burton Street (to the south west). Historic maps and the conjectured plan of settlement circa 1559 (plate 4) appear to suggest that burgages had been laid out along both sides of High Street and either side of Monk

Street. The conjectural plan further indicates that the properties fronting onto High Street were divided from those fronting onto Monk Street by a 'common water-course' (cf. plate 4). This appears to have survived in a fragmentary form in circa 1810, but had been completely infilled by the end of the 19th century. However, archaeological work carried out to the south of Monk Street has suggested that the area of land lying between the 'common water-course' and the street may not have been settled in the medieval period⁶². The evidence revealed a large feature at least 3m deep on its southern side which has been interpreted as a possible fishpond, presumably belonging to the Priory lying to the north (cf. map 4). Hislop et al suggested that, as well as having a functional purpose, the location of a fishpond in this area could have been aesthetic and provided a 'physical and psychological barrier between the priory and the town'⁶³. This puts into question the existence of any burgage plots projected as lying on the northern side of Monk Street and it has even been suggested that the priory precinct could have extended as far south as this street a theory supported by the street name⁶⁴.

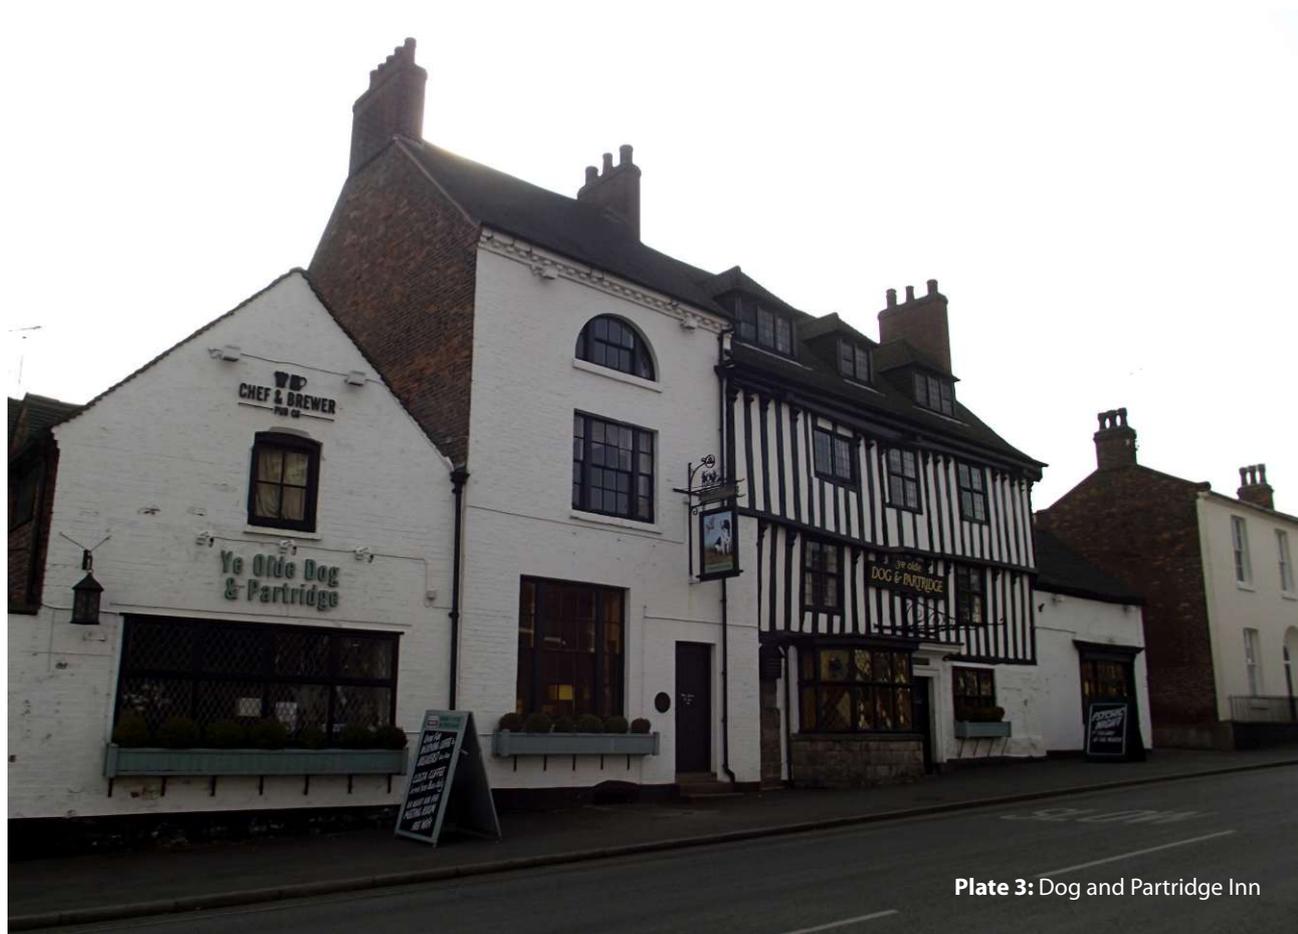
Plate 3: Dog and Partridge Inn

There are currently only four buildings known to date this to period surviving within Tutbury; two of which lie within the High Street. The earliest, and largest, of these is the Grade II* Dog and Partridge Inn which probably dates to the late 15th or early 16th century. It is also the only building within the centre of the town whose frontage retains its timber-framing (plate 3)¹³³. The other early Grade II listed property, 33 High Street, is believed to have originated in the 17th century, but was considerably altered in the early 19th century when it was given a red brick frontage¹³⁴.

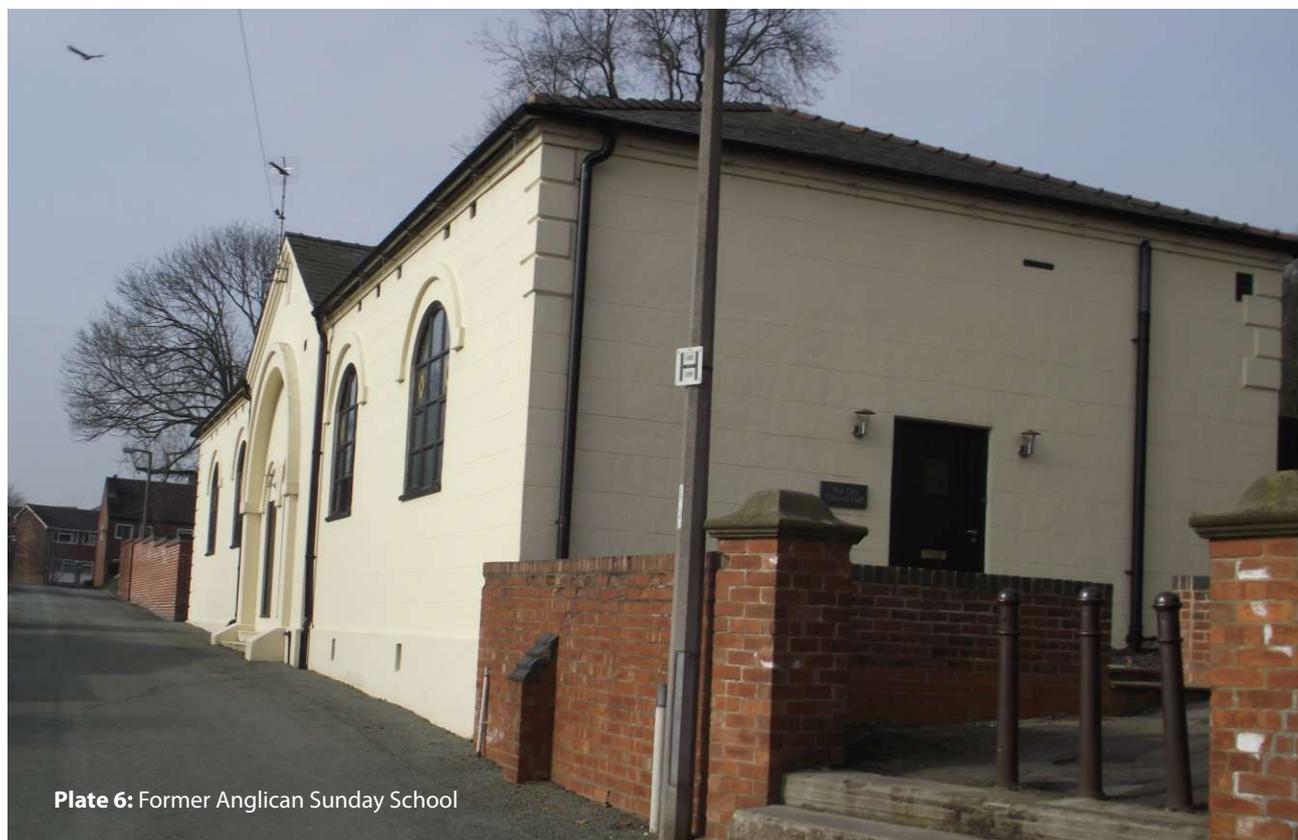
Plate 6: Former Anglican Sunday School

The extant school building on Church Street was originally built as an Anglican Sunday School in 1831; it had become part of the National school by 1888 (plate 6). New schools were built elsewhere in Tutbury in 1909 and it is likely that it was at this point that it returned to its former use as a Sunday school.

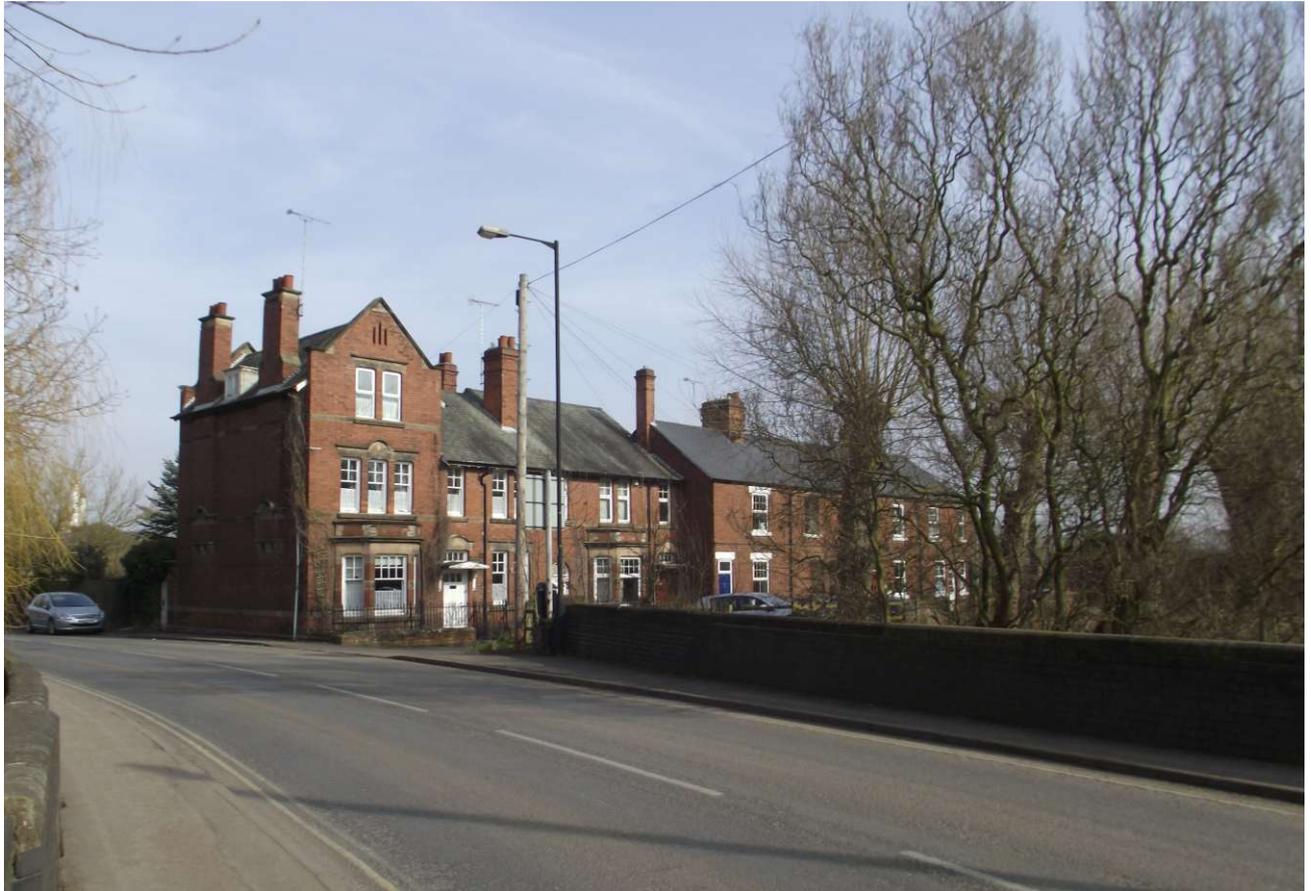
Plate 9: Terraces adjacent to site of Tutbury Mill

The historic built environment of the HUCA reflects the rural character of the wider landscape of the Dove Valley. Mill Farm, lying opposite the site of Tutbury Mill, has been identified as retaining its regular courtyard plan form which is suggestive of a late 18th century date. This would make it broadly contemporary with the mill itself; it certainly existed by circa 1810. A second farmstead lies to the south west of the HUCA in a landscape still mostly defined by fields (HCTs 'Detached Property' and 'Paddocks and Closes' on map 15). The farmstead, Manor House Farm, is associated with a Grade II Listed 17th century farmhouse, since sub-divided into two properties²¹⁰. It originated as a timber framed property, but was later re-clad in brick. The origin of its name is unknown as is any potential association with the Castle. Pear Tree Cottage lying just south of the mill fleam (HCT 'Detached Property' on map 15) was probably established in the 19th century, but only one range of the original farmstead survives.

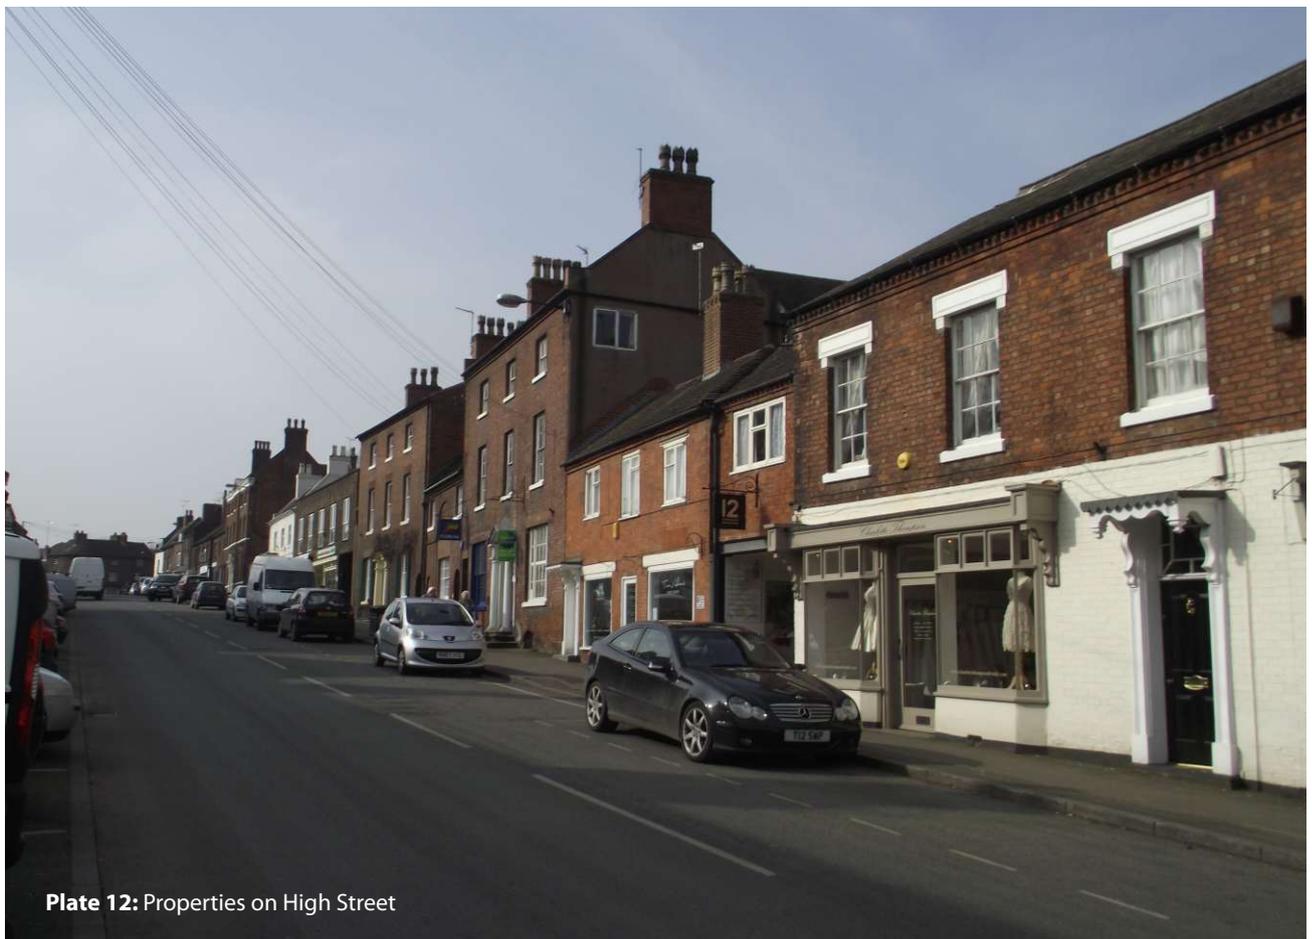
Plate 12: Properties on High Street

The historic character of the built environment within the HUCA is dominated by properties which appear to date to the late 18th and 19th century. Within the HUCA there are 23 Listed Buildings (one of which is Grade II*). The majority of these originated as two and three storey brick town houses lining High Street (cf. 2.6.1.2; plate 12). Earlier buildings are present within the HUCA; the most significant of these is the Grade II* Dog and Partridge Inn which dates to the 15th/16th century and is the only building in the town to retain its timber framed frontage (plate 3)²³². Other earlier buildings are known to survive within the HUCA (cf. map 19). There is also the potential for any of the buildings of 18th/19th century date to retain earlier fabric within their structures.

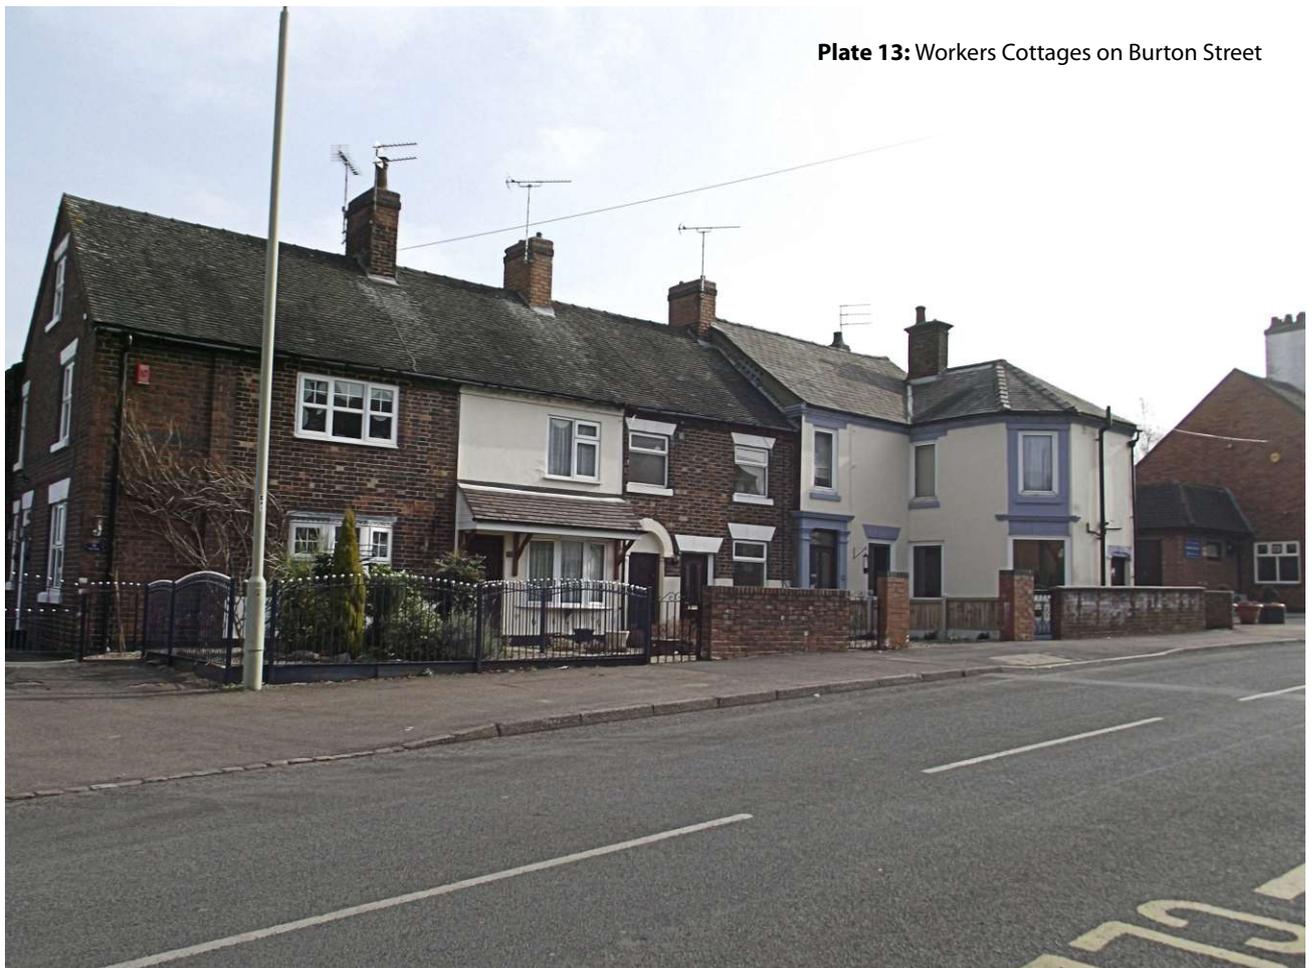
Plate 13: Workers Cottages on Burton Street

The character of the HUCA is defined by residential properties lying principally upon the northern side of Burton Street the earliest of which date to at least the late 19th century. These are two storey brick properties (many of which have been rendered) forming terraces stepped down the hill (in the area defined as HCT 'Suburb –Terraces' on map 21) as well as short terraces and semi-detached cottages (within HCT 'Workers Cottages'). Some later infilling has occurred with detached properties lying back from the road. A large late 19th century detached property lies to the south along a narrow drive known as 'The Balk'.
