## Flooding in Slindon, Staffordshire

January 2024

Investigation under Section 19  
of the Flood and Water Management Act 2010

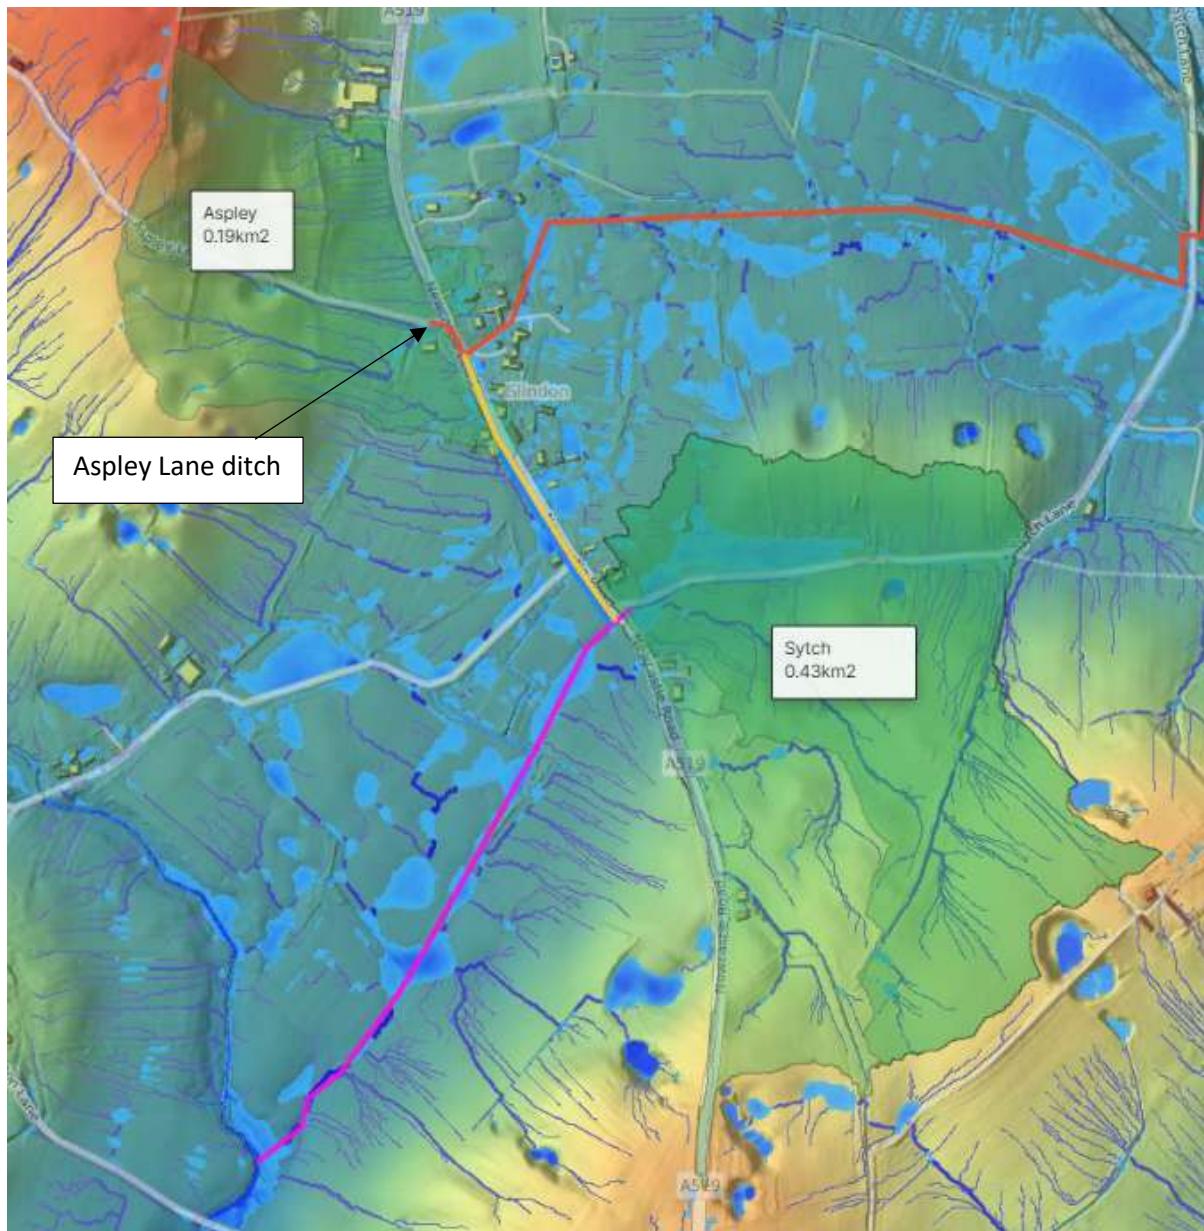
Figure 10: Engineered drainage routes

The primary drainage route for the Aspley catchment follows the red line (Figure 10). Surface water runoff from Aspley Hill drains to a roadside ditch which flows adjacent to Aspley Lane. The ditch is piped beneath the A519 in a 225mm diameter pipe with the inlet protected by a trash screen (Figure 11) which is owned and maintained by SCC highways department. The pipe follows a route along Villa Farm Lane for approximately 700m before discharging into an open ditch, and ultimately discharging into Meece Brook approximately 1km to the east.

At the junction of the A519 and Villa Farm Lane, the Aspley Lane pipe passes through a manhole chamber with a weir (Figure 12). Under high flow conditions, once the capacity of the pipe from Aspley Lane has been exceeded, water will flow over the weir and enter the highway drainage network (Figure 10, yellow drainage route) which conveys surface water flows from the A519.

The main drainage route for the Sy whole catchment follows the pink line (Figure 10). A series of land drainage ditches are located adjacent to Sy whole Lane which flow in a westerly direction towards the A519. At the junction of Sy whole Lane and the A519, the ditch is piped beneath the road through a 600mm diameter pipe. Inspection of a surface water manhole opposite Sy whole Lane, indicates that at this point, surface water flows from the highway drainage network connect into the pipe, which continues in a south westerly direction, before discharging into Brockton Brook approximately 700m to the south west.

Surface water that flows onto the highway is collected via the highway drainage network, comprising traditional highway gullies and connections into 300mm diameter clay pipes that run down the A519 (Figure 10, yellow line). The highway drains discharge into a culverted ordinary watercourse, situated at the southern end of the village opposite Sy whole Lane. This forms a 600mm diameter pipe, which continues in a south westerly direction across fields, before discharging into Brockton Brook. Staffordshire County Council highways department are responsible for the maintenance of this network of highway gullies and connections to the point at which they discharge into the culverted ordinary watercourse.

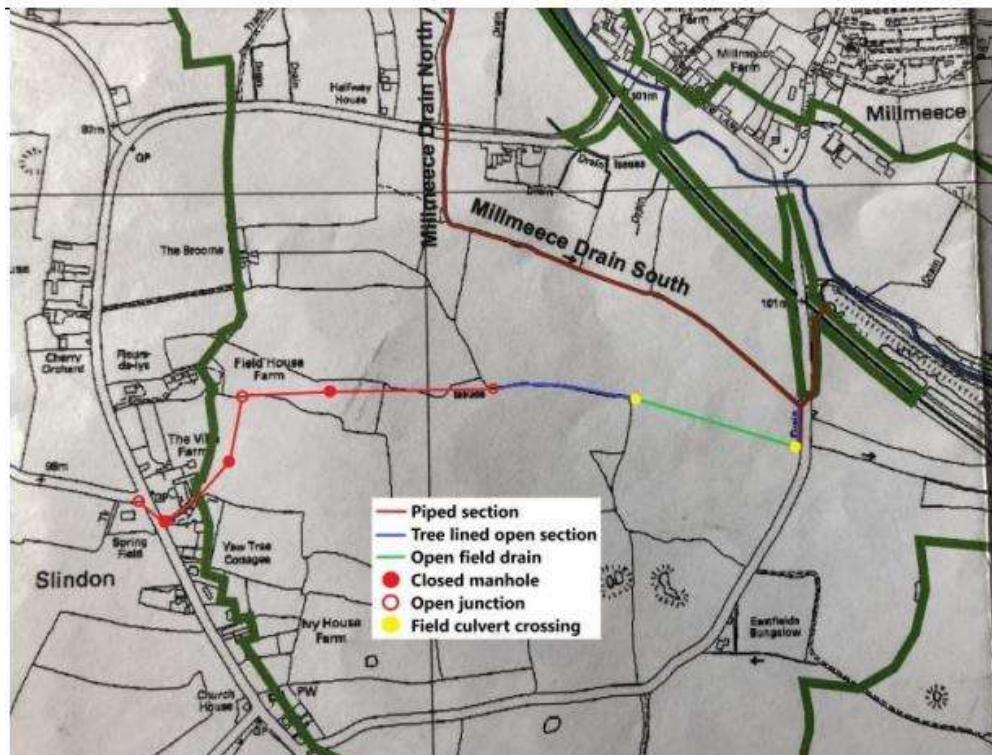
Both the pipe and downstream ditch channel fall under the ownership of the riparian landowner. Figure 13 presents the location of the piped Ordinary Watercourse (red line with manholes) and open sections of ditch as understood by the IDB from previous investigations.

Figure 13: Approximate location of piped Ordinary Watercourse (red line with manholes) and open sections of ditch as understood by the IDB from previous investigations (Source: Sow and Penk IDB)

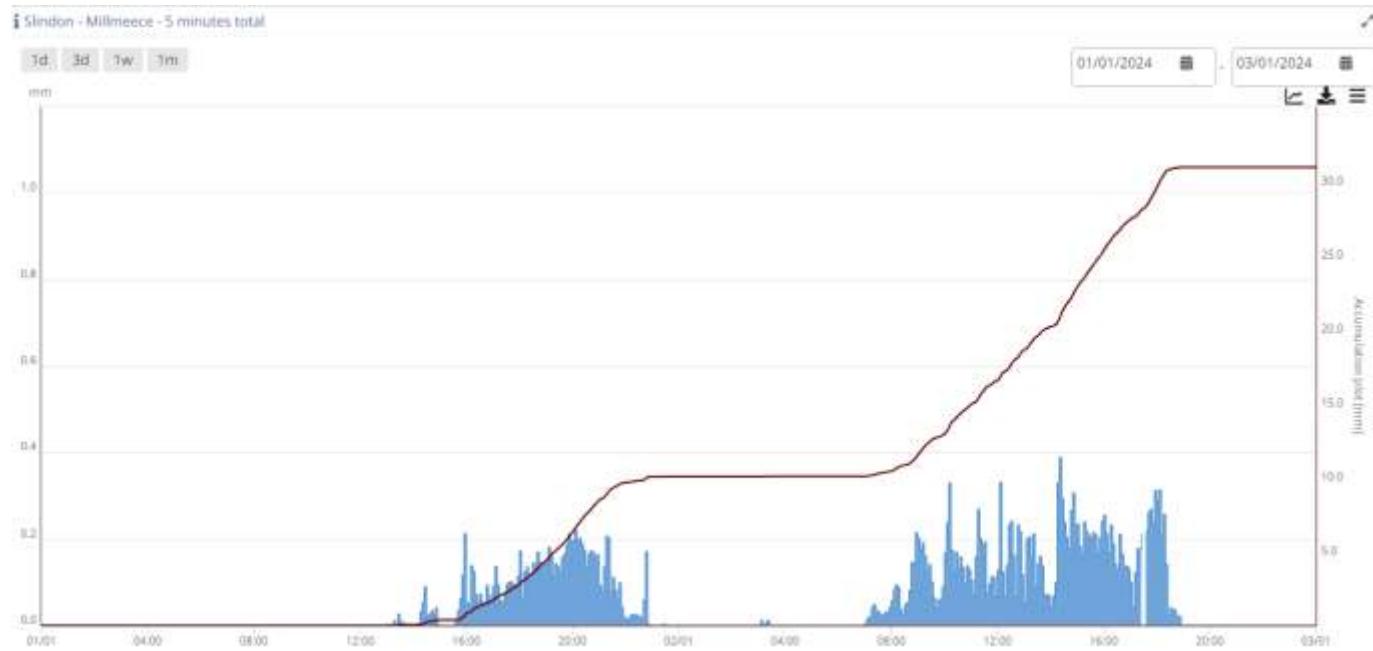
Figure 16: 5-minute recorded rainfall and accumulation for Slindon 1<sup>st</sup> to 2<sup>nd</sup> January 2024 (Source: HydroMaster)

HydroMaster rainfall data identified two distinct periods of rainfall during the January 2024 flood event. The first occurred on 01/01/2024 between 15:45 and 21:45, with 9.4mm of rainfall falling over a 6 hour period. The second occurred on 2nd January between 07:00 and 18:55, with 20.1mm of rainfall falling over a 10 hour time period. This shows a prolonged period of moderate intensity rainfall, with several periods of higher intensity rainfall from late morning and into the late afternoon. Within a 29 hour time period, HydroMaster recorded a total of 29.8mm of rainfall.

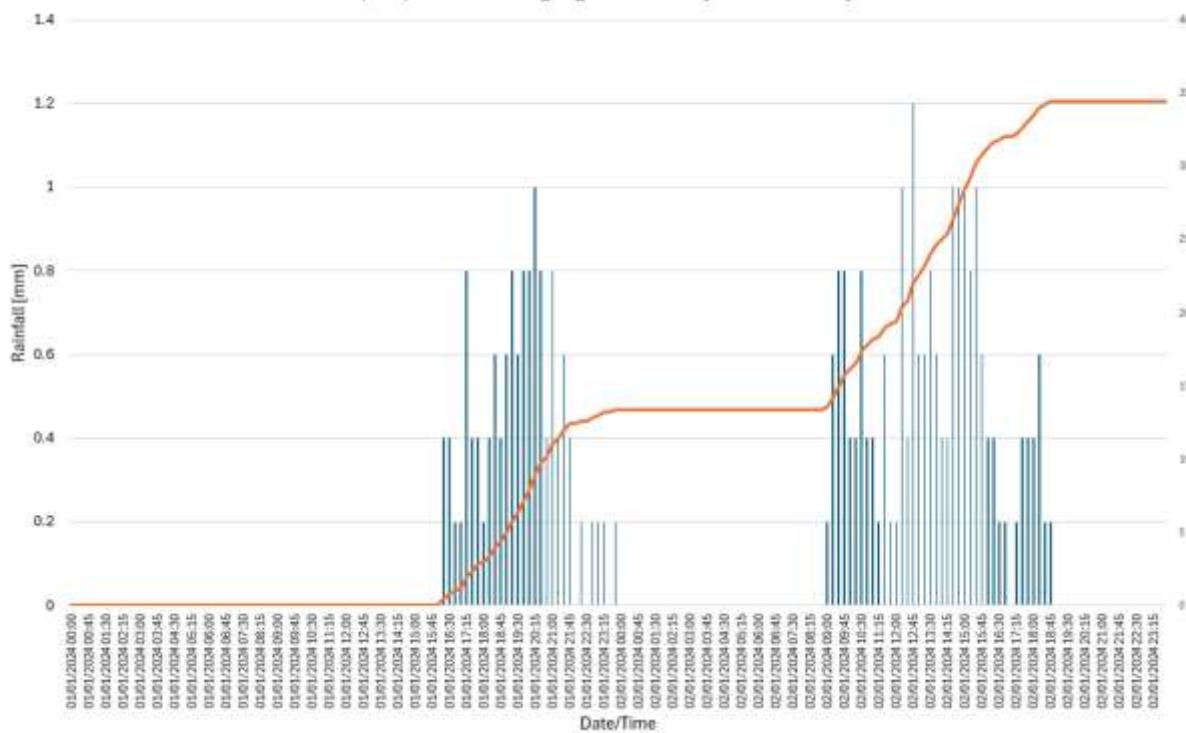
Similar rainfall totals for the same period were recorded by DEFRA Environment Agency rain gauges within the area. The closest gauge, Stone (5km from Slindon), recorded daily (24 hour) rainfall totals as 13.4mm on the 1<sup>st</sup> January 2024 and 21.0mm on 2<sup>nd</sup> January 2024, with a total of 34.4mm over the two day period (Figure 17).

Figure 17: Recorded rainfall at Stone rainfall gauge, the closest gauging station to Slindon

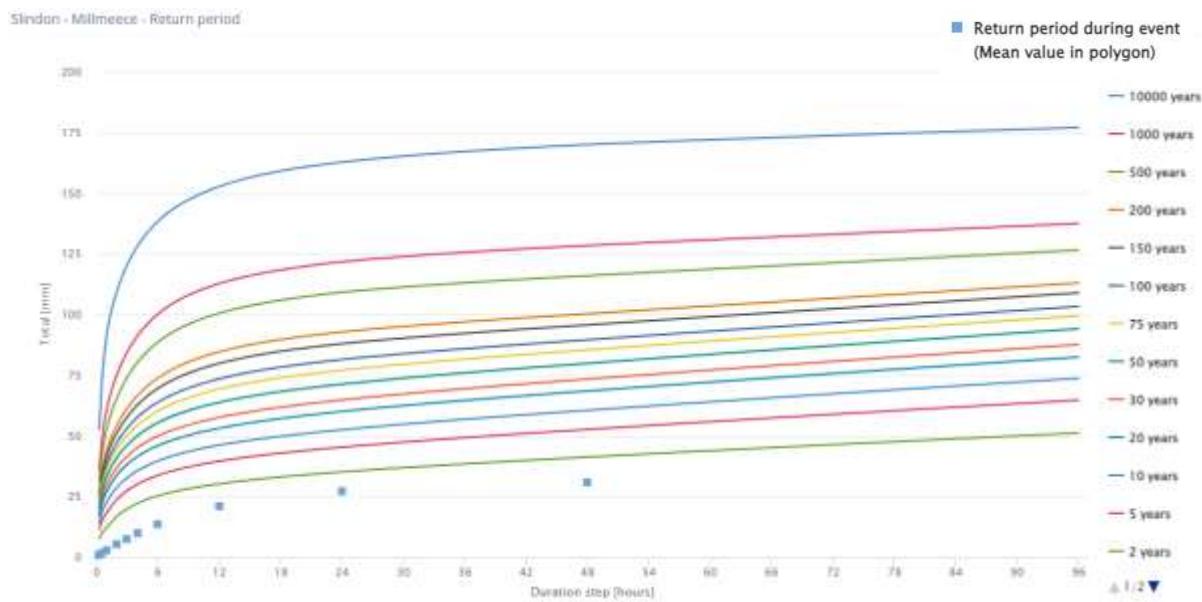
HydroMaster software has identified the rainfall return period that fell over Slindon as less than a 2-year rainfall event for the 24-hour and 48-hour storm durations (Figure 18).

Figure 18: HydroMaster return periods for different storm durations during Storm Henk in Slindon

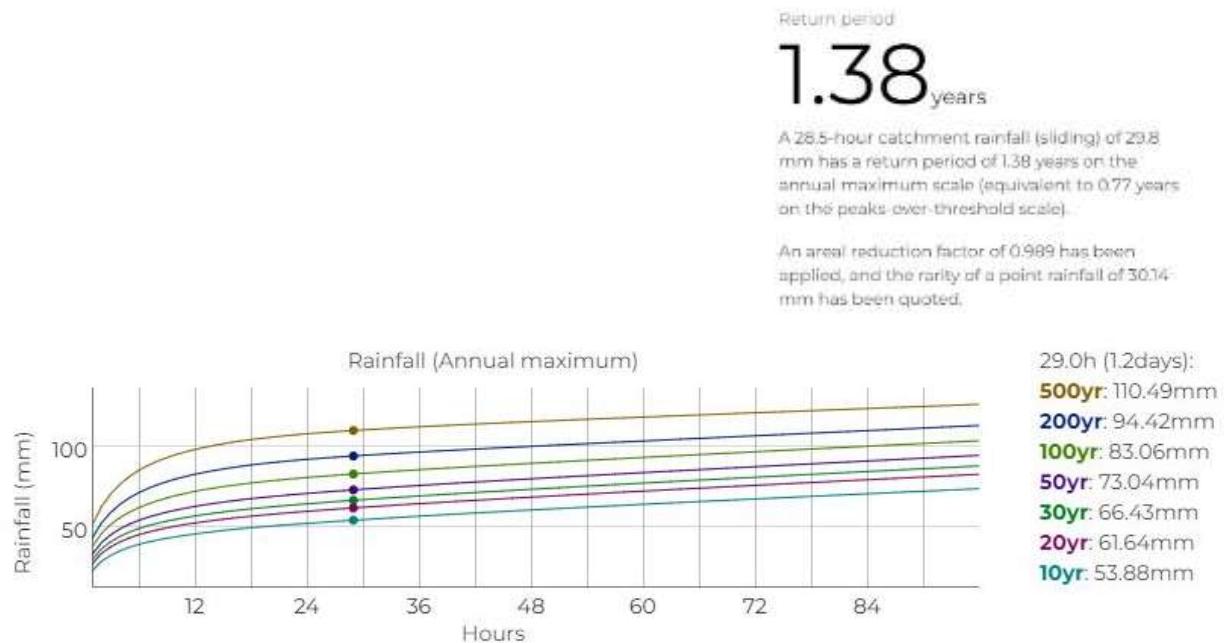
Rainfall modelling from FEH has further identified the rainfall return period as a 1.4-year rainfall event for the entire storm duration (29.8mm of rainfall during a 28.5 hour period). Figure 19 shows the amount of rainfall that correlates to specific return periods for the Slindon catchment, identifying that 29.8mm of rainfall in 28.5hours from 1<sup>st</sup> January to 2<sup>nd</sup> January 2024 is less than a 10-year return period.

Figure 19: FEH rainfall return period for the Slindon catchment estimated as 1.38 years for the 29.8mm of rainfall that was recorded during the entire event (28.5 hours). The graph indicates rainfall values for the return periods from 10-years upwards.

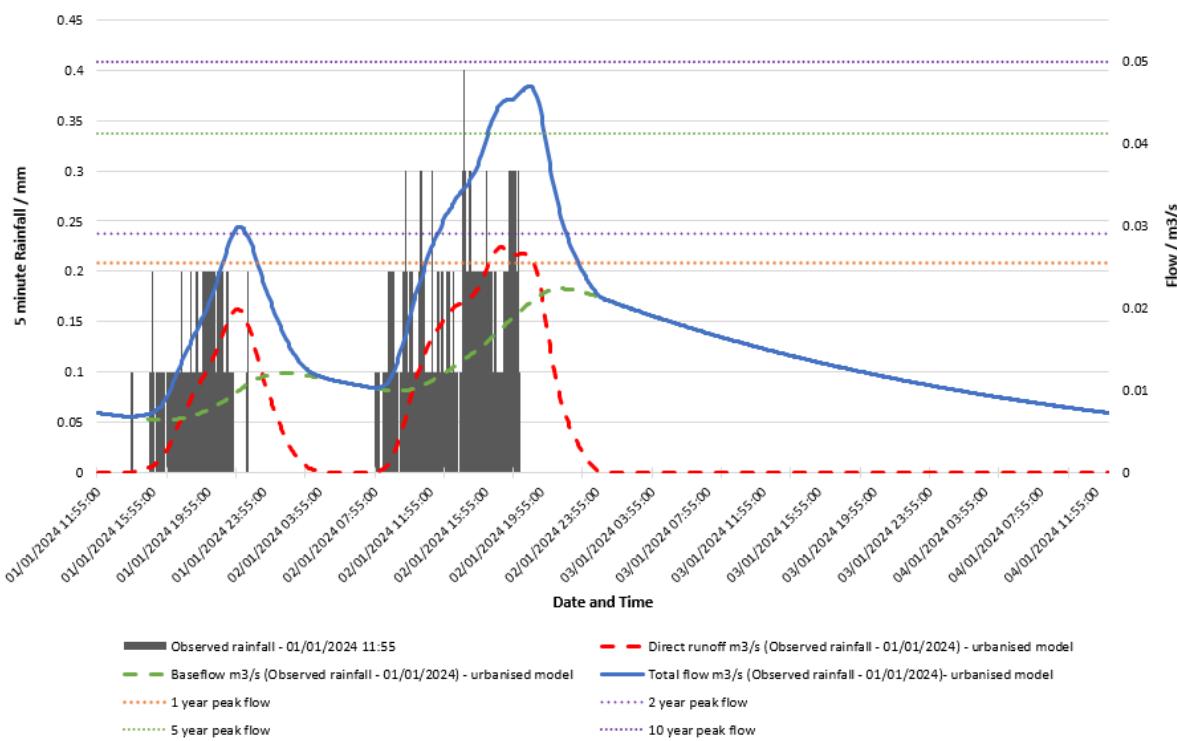
ReFH (Revitalised Flood Hydrograph) software has been used to create a hydrograph from the observed rainfall and catchment characteristics, along with a series of uncalibrated modelled hydrographs for design storms of different return periods. Comparison of the peak flows enabled the rainfall runoff return period to be estimated. Figures 20 and 21 show the modelled hydrographs for the Aspley and Sutch catchments respectively, demonstrating that for Storm Henk, the peak runoff was equivalent to an event with a return period of between a 1 in 5 and 1 in 10 years.

The higher estimated runoff return period can be explained by the ground saturation at the time of the event. Storm Henk occurred during a wetter-than-average winter, when catchments were saturated and drainage ditch networks were at elevated base-flow levels. Whilst not particularly extreme volumes of rainfall on their own, the combined total of 30.9mm, fell on already saturated ground.

Figure 20: ReFH design flood hydrograph for Aspley Catchment, Slindon following Storm Henk rainfall event on 1<sup>st</sup> and 2<sup>nd</sup> January 2024

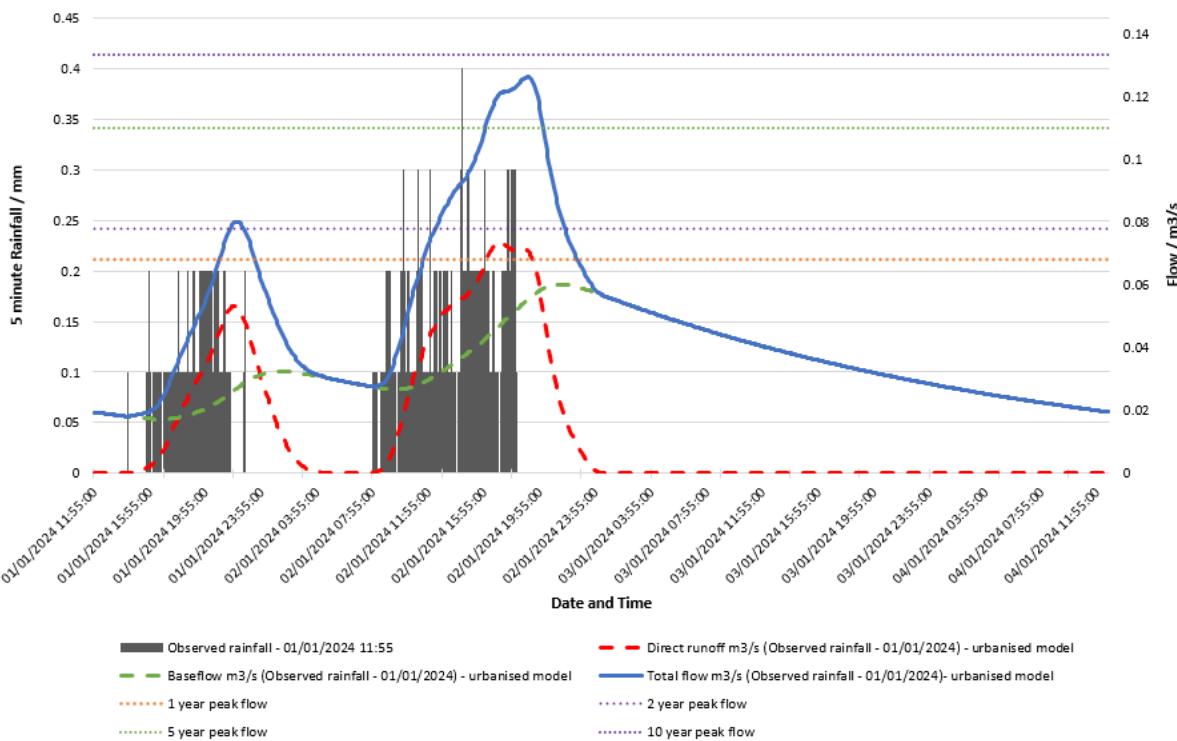
Figure 21: ReFH design flood hydrograph for Sutch Lane catchment, Slindon, following Storm Henk rainfall event on 1<sup>st</sup> and 2<sup>nd</sup> January 2024

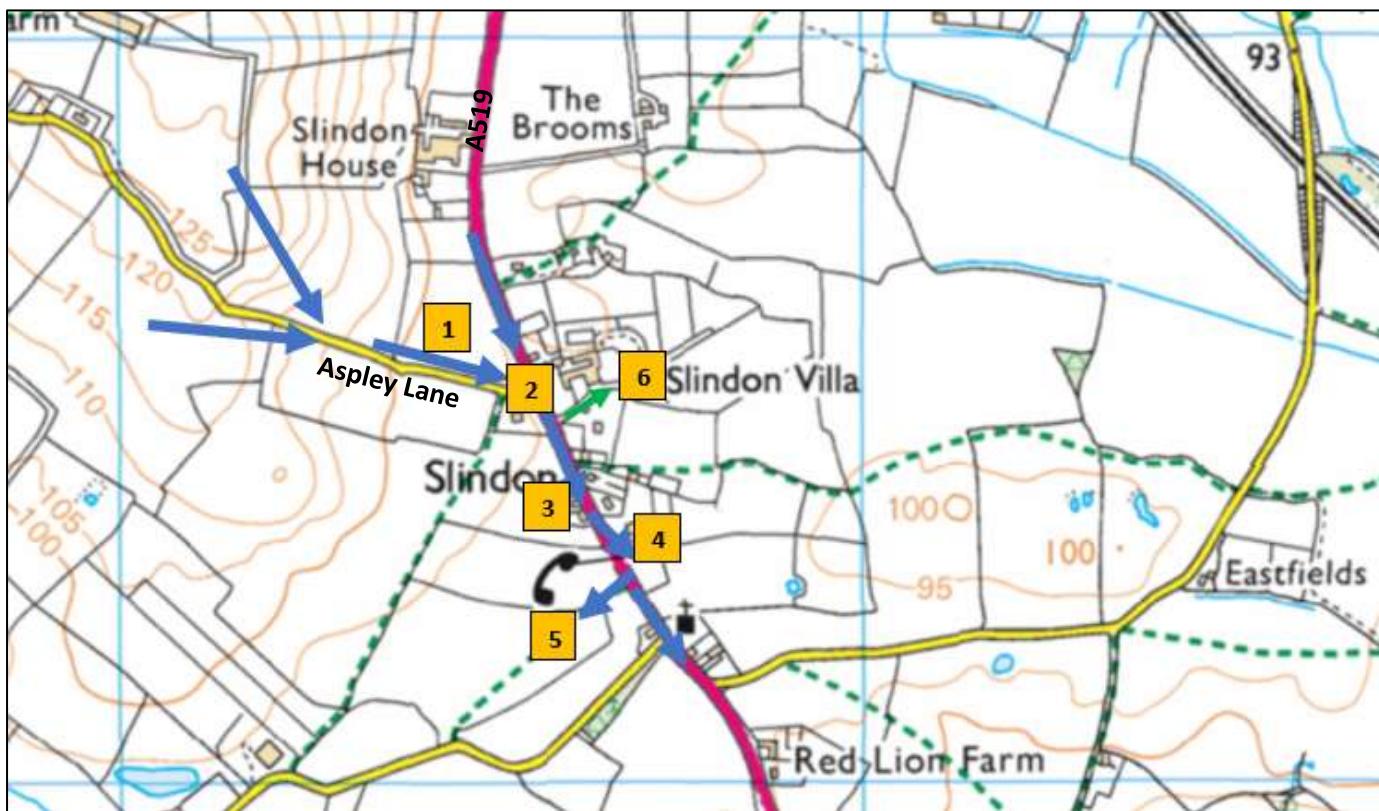
Figure 22: Surface water flow routes observed by residents on 2nd January 2024

At around 14:00 external flooding to property was reported along the western side of the highway (Location 3, Figure 22). Reports from residents describe how flood water reached a depth of approximately 1 foot, surrounding the property. On this occasion, residents managed to prevent water entering the property by pumping water back onto the highway.

Surface water flows then continued to flow down the A519, impacting properties on the eastern side of the highway at around 14:30-15:00 (Location 4, Figure 22 and Figure 26). Residents reported that the highway drainage network became overwhelmed, with water observed to be bubbling out of the drain adjacent to the old telephone box. Surface water then flowed from the highway towards properties which are situated at a lower level than the highway. The flooding was exacerbated by bow waves from passing cars pushing water towards properties. Two properties reporting internal flooding to depths of between 4 and 5 inches, in addition to significant flooding to gardens and outbuildings.

Surface water flows continued to then follow the prevailing topography along the A519 in a southerly direction and flowing across the highway into the fields on the western side of the A519 (Location 5, Figure 22; and Figure 27).

At the northern extent of the village, flooding was also experienced along Villa Farm Lane (Location 6, Figure 22). Residents described how water emerged rapidly from a manhole cover situated along the private lane. Since the lane is below the main A519 road surface level, water accumulated along the lane (Figure 28). As the volume of water on the A519 increased, this also flowed onto the lane, resulting in floodwater reaching depths of approximately 30cm. Whilst no internal flooding to property was reported, access to property was significantly restricted, with some residents also reporting issues with septic tanks and private drainage.

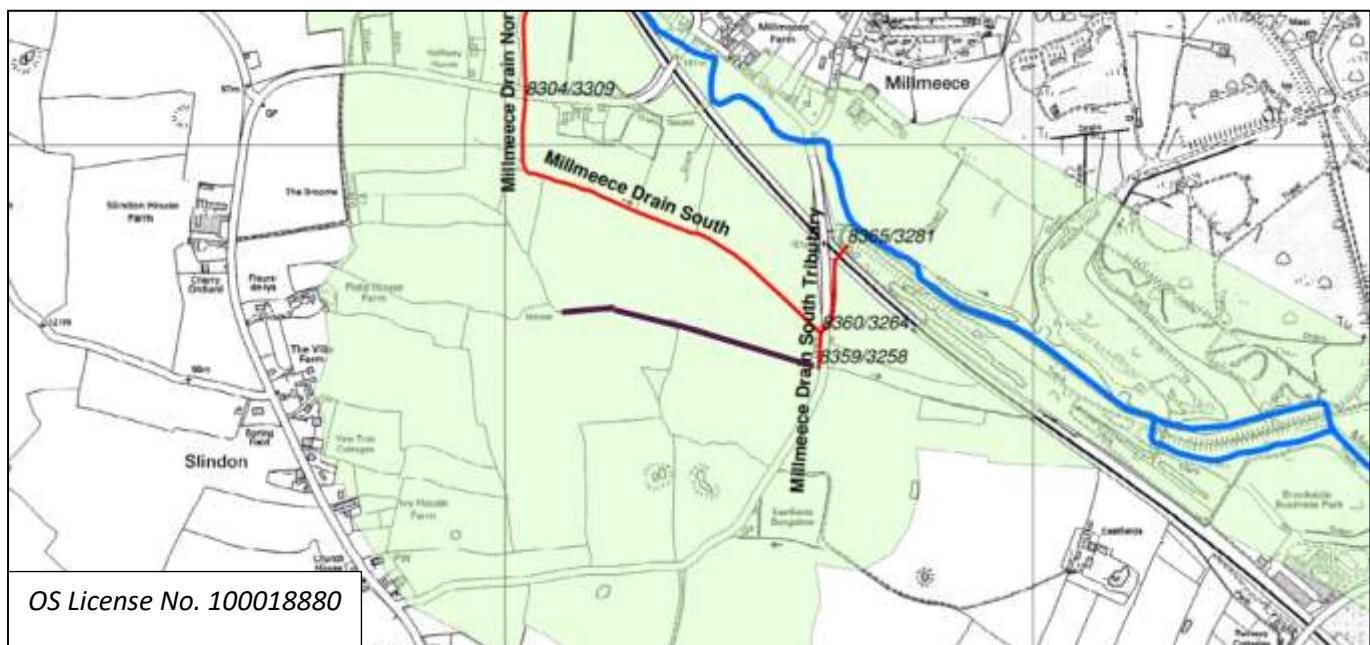
Figure 38 presents the plan of assets within the IDB area (area shaded light green) as provided by the IDB. This shows IDB maintained watercourses (red), EA Main River (blue), Aspley Lane riparian owned watercourse (purple). All other assets between Newcastle Road and Sutch Lane are the responsibility of the Riparian Owner Occupiers who own the land above or adjacent the asset and the IDB does not hold details of Riparian Assets.

Figure 38: Plan of watercourses and ownership as provided by Sow and Penk IDB
