Flooding in Cranberry, Staffordshire

January 2024

Investigation under Section 19
of the Flood and Water Management Act 2010

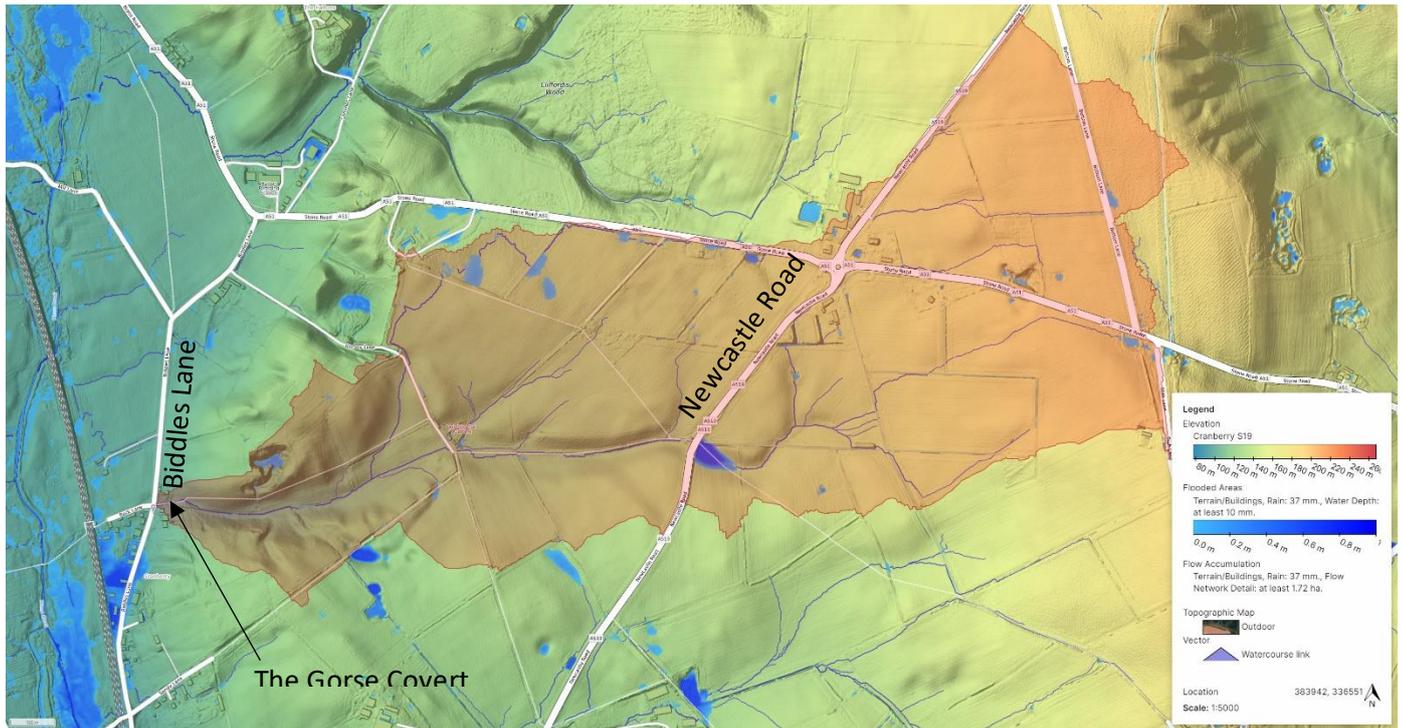
Figure 9: Cranberry surface water catchment with 37mm rainfall applied as defined by SCALGO Live

This shows that surface water flows in a westerly direction towards the village with the catchment covering an area of around 160ha. The topography is steep, ranging from 190mAOD in the upper catchment (east of Bottom Lane) to approximately 100mAOD in the lower catchment adjacent to Biddles Lane. Surface water flows follow the prevailing topography to an open ditch which runs parallel to Gorse Covert, before entering a 150mm diameter pipe just upstream of Biddles Lane. This pipe discharges into the Highway Drainage Network along Biddles Lane.

Figure 9 demonstrates that there is a natural low point to the east of Newcastle Road (A519) that holds back runoff from the catchment to the east (59ha). At this point there is a 250mm culvert in the highway, but in recent flood events the highway was overtopped, with water continuing to flow towards the village.

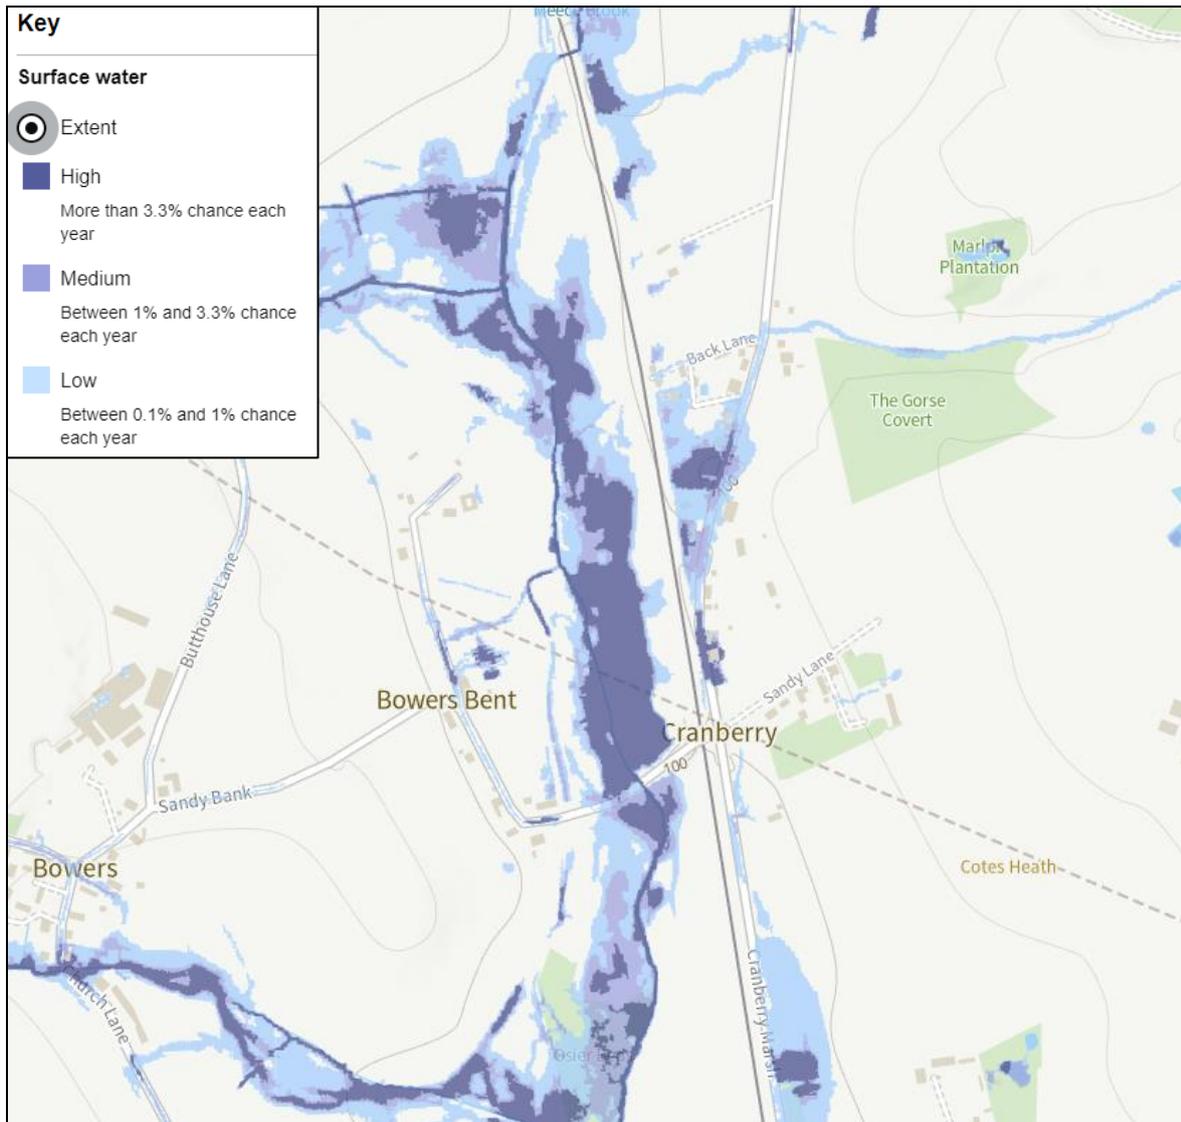
Figure 12: Environment Agency surface water risk map for Cranberry. Source: Environment Agency.

The Environment Agency defines the yearly chance of flooding from surface water as ‘Low’ throughout much of the village. This means that there is less than a 0.1% and 1% chance of flooding from the rivers or sea each year. Areas of ‘High’ surface flood risk are shown within central and southern parts of the village. At these locations, there is more than a 3.3% chance each year of surface water flooding.

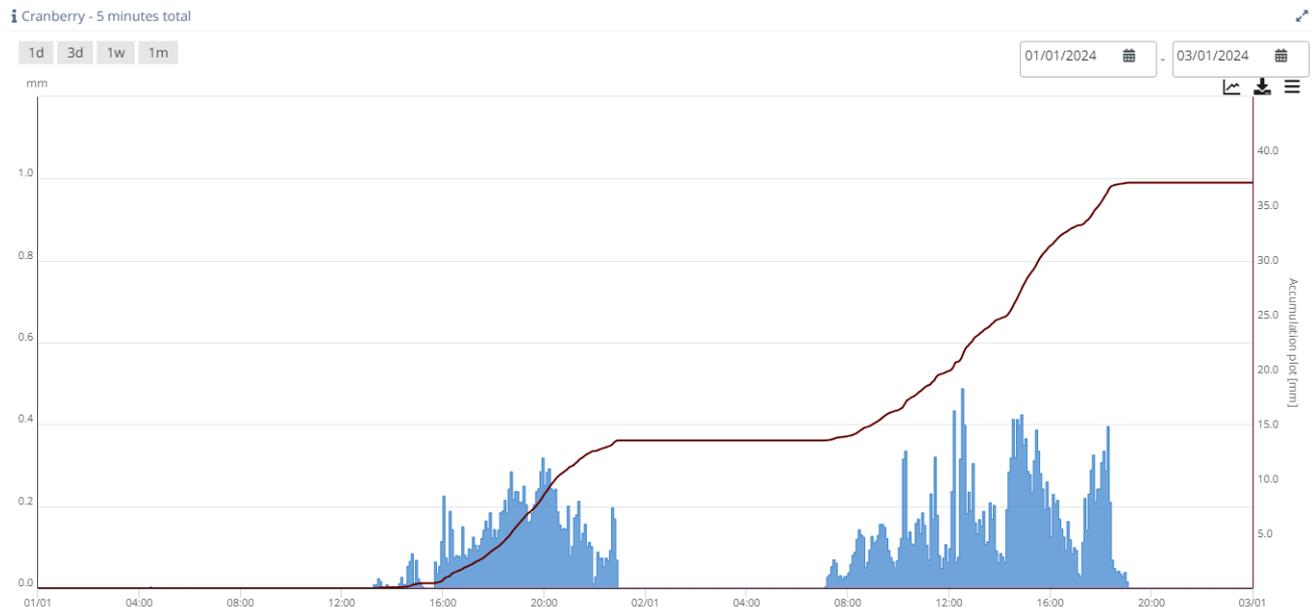
Figure 13: 5-minute recorded rainfall and accumulation for Cranberry, 1st to 3rd January 2024 (Source: HydroMaster)

Rainfall data has been obtained from various sources to obtain a better understanding of the January 2024 event. Figure 13 shows 5-minute HydroMaster rainfall data for Cranberry between 01/01/2024 and 03/01/2024. Two distinct periods of rainfall are observed. The first occurred on 01/01/2024 between 13:15 and 22:50, with 13.5mm of rainfall falling over a 9.5 hour period. The second, more prolonged period of rainfall occurred on 02/01/2024 between 07:10 and 19:00, with an additional 23.6mm of rainfall falling over a 12 hour period. This accumulates to a total of 37.1mm of rain over a 48hour period.

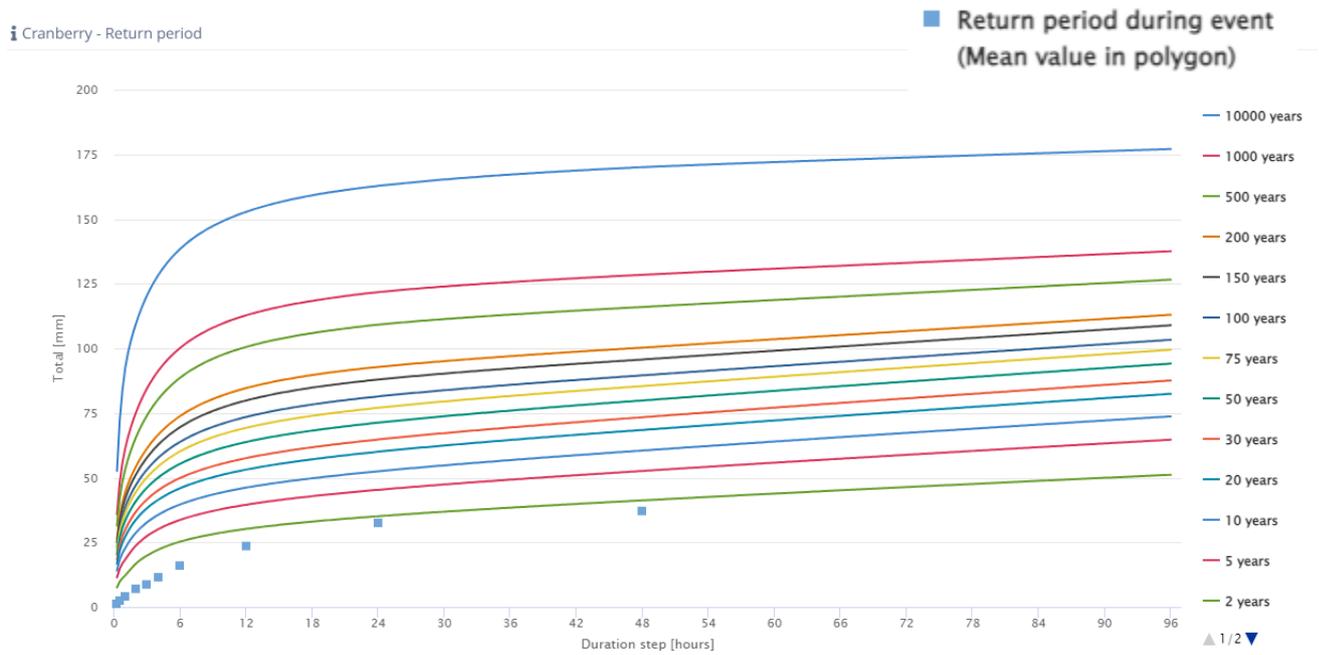
Figure 14: HydroMaster return periods for different storm durations during Storm Henk at Cranberry

HydroMaster software has identified the average rainfall return period during the event at Cranberry as less than a 2 year rainfall event for the 24-hour and 48-hour storm durations (Figure 14).

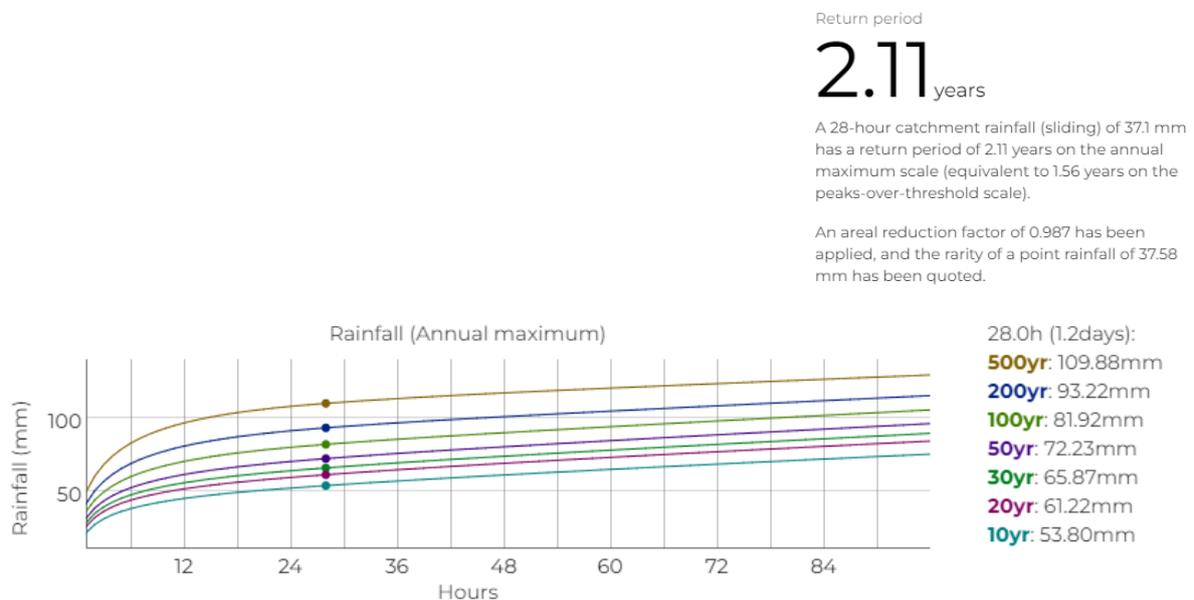
Figure 15: FEH rainfall return period for the Cranberry catchment estimated as 2.11 years for the 37.1mm of rainfall that was recorded during the entire event (28hours). The graph indicates rainfall values for the return periods from 10-years upwards.

Rainfall modelling from FEH has further identified the rainfall return period as a 2.11-year rainfall event for the entire storm duration (37.1mm rainfall during a 28 hour period). Figure 15 shows the amount of rainfall that correlates to specific return periods for the Cranberry catchment, identifying that 37.1mm of rainfall in 28 hours from 1st January to 2nd January 2024 is less than a 10-year return period.

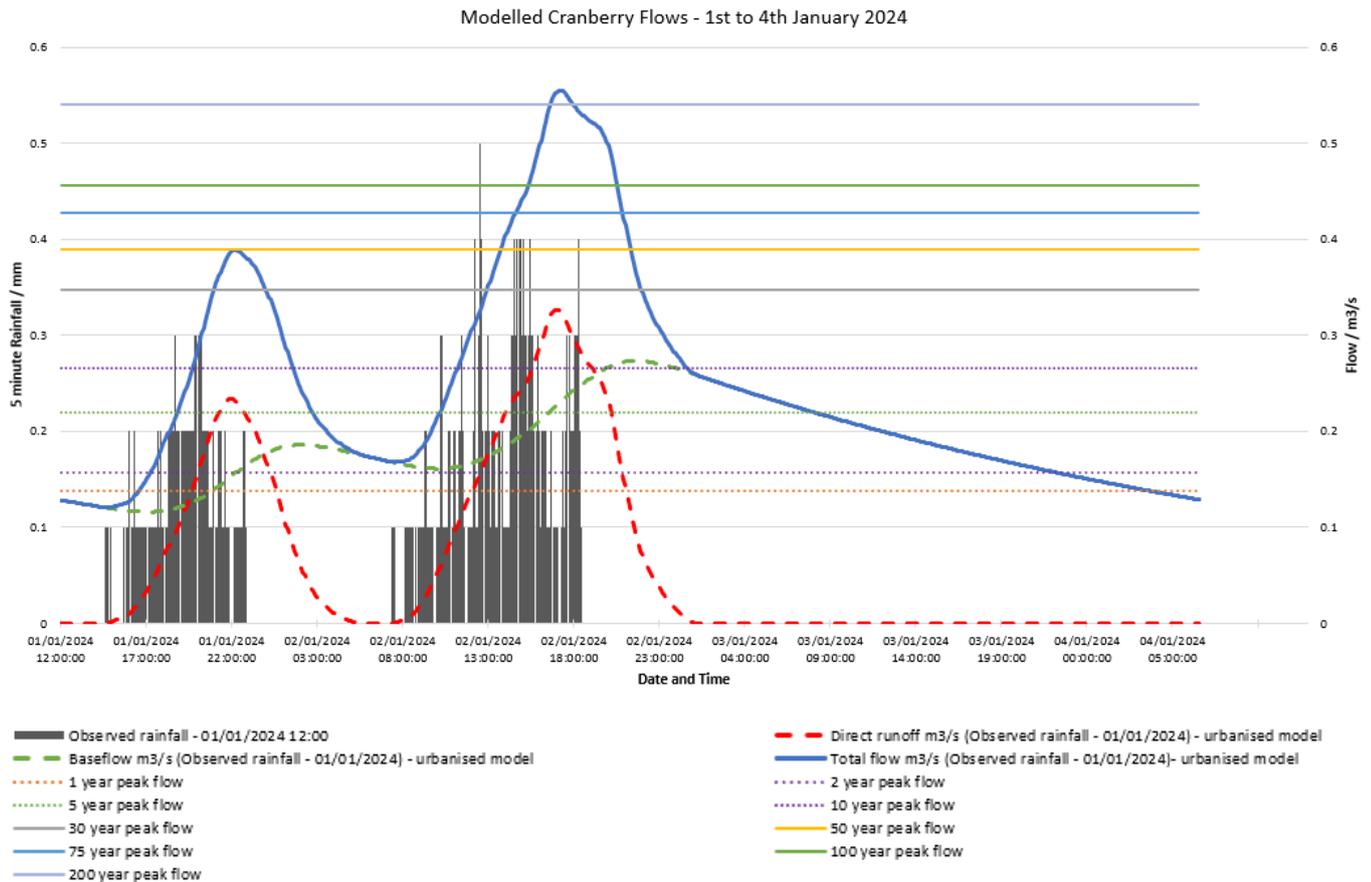
Figure 16: ReFH design flood hydrograph for Cranberry catchment following Storm Henk rainfall event on 1st and 2nd January 2024

ReFH (Revitalised Flood Hydrograph) software has been used to create a hydrograph from the observed rainfall and catchment characteristics, along with a series of uncalibrated modelled hydrographs for design storms of different return periods (Figure 16). Comparison of the peak flows enabled the rainfall runoff return period to be estimated. Figure 16 shows the modelled hydrograph for the Cranberry catchment, demonstrating that for Storm Henk, the peak runoff was equivalent to an event with a return period of a 1 in 200 year event.

Whilst the recorded rainfall totals were not particularly extreme volumes on their own, the 37.1mm of rainfall over the 28hour period fell on already saturated ground. This, combined with the steep nature of the catchment resulted in rapid runoff response.
