2020 Flood Events:  
Flood and Water Management Act  
Section 19 - Investigation  
Lichfield Road, A38, Branston

<b>Document Ref:</b>			<b>2020 Flooding: Section 19 Flood Investigation for Lichfield Road, Branston</b>		
<b>Revision</b>	<b>Date</b>	<b>Description</b>	<b>Originated</b>	<b>Checked</b>	<b>Authorised</b>
1	April 2022	Draft 1	Lucinda Capewell	Jamie Cooper	
2	May 2022	Draft for Partners	Lucinda Capewell	Chris Archer	
3	Dec 2022	Draft for Division	Lucinda Capewell	Chris Archer	Jamie Cooper

This report focuses on flooding associated with Storm Dennis that internally affected several properties on Lichfield Road, south of the village of Branston, on the 17<sup>th</sup> of February 2020. The investigation undertaken has been summarised, outlining the flood extent and flow routes reported, the most likely cause of flooding, and the relevant actions that have been completed or are to be undertaken in the future.

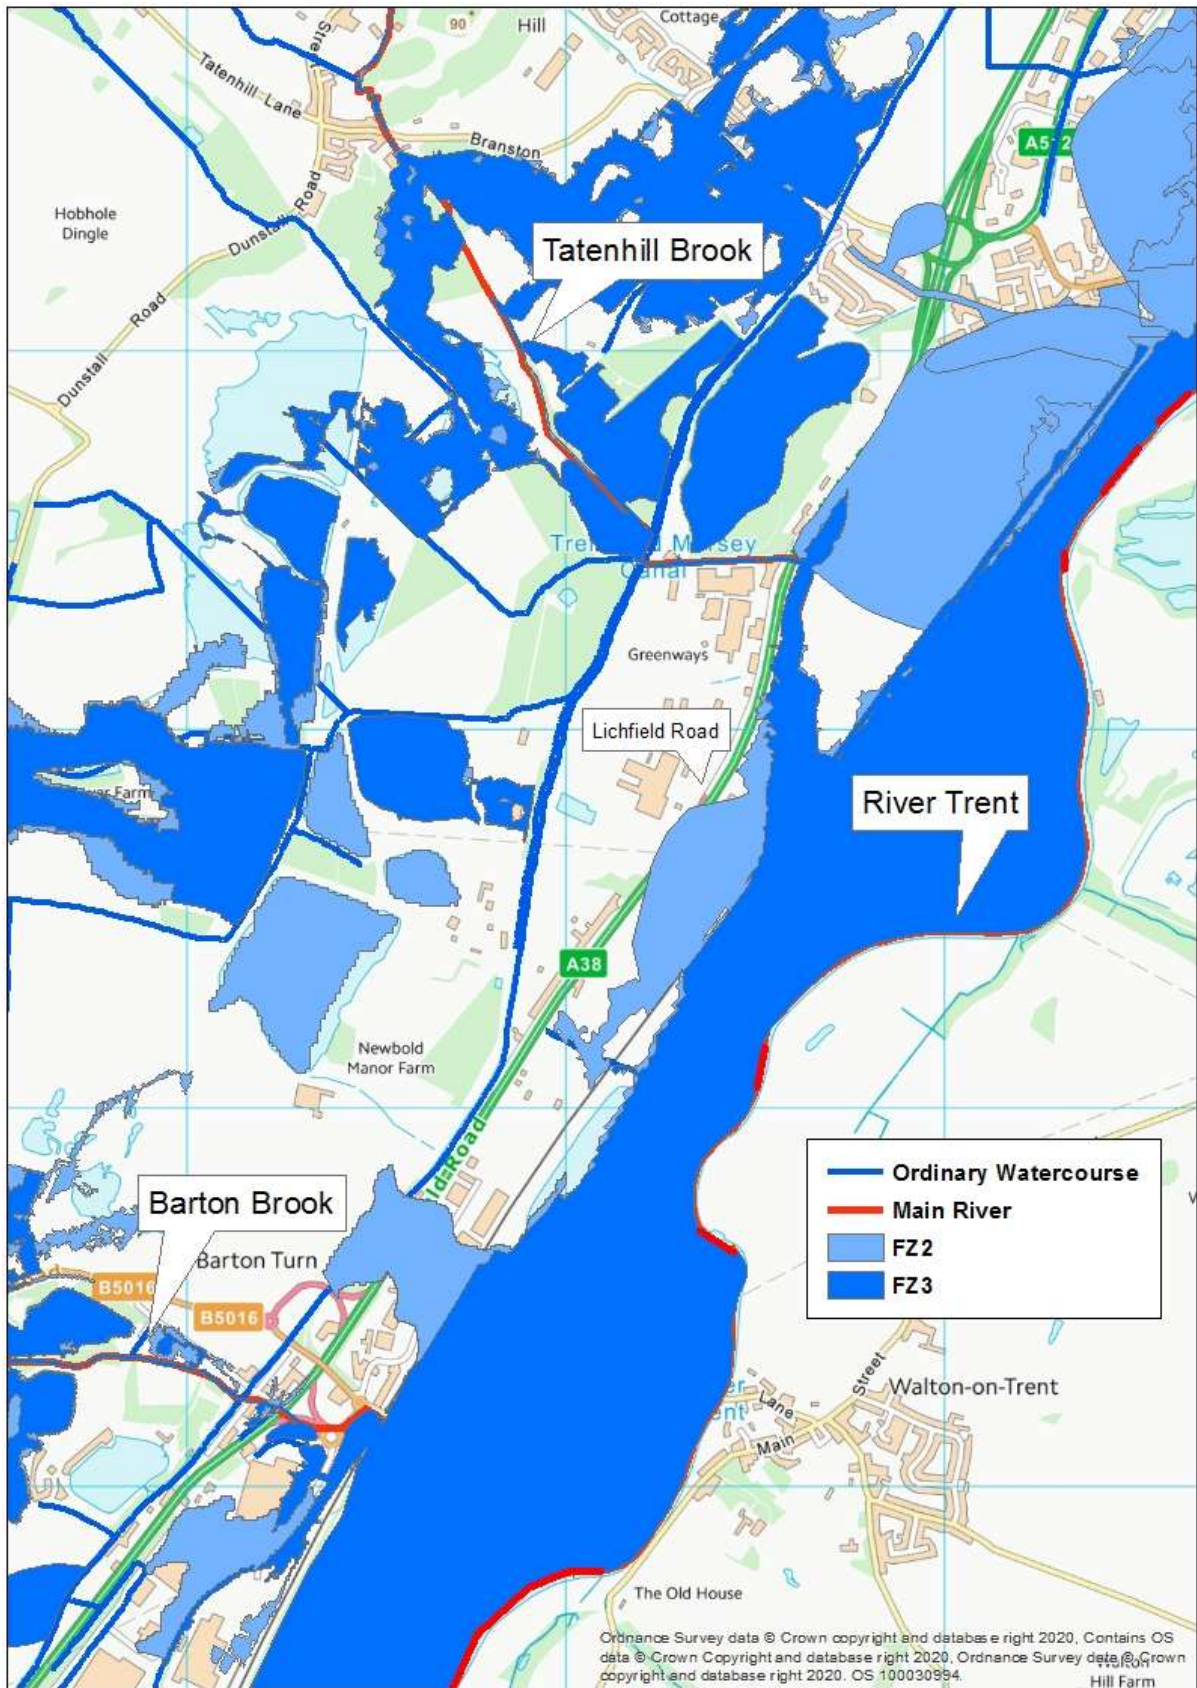
Sections of the Lichfield Road are at risk of flooding from watercourses as well as surface water flooding. **Figure 8** and **Figure 9** below display the Environment Agency Risk of Flooding from Rivers and Sea (flood zone mapping) and Risk of Flooding from Surface Water maps for the Lichfield Road. The flood zone map in Figure 3 shows parts of the Lichfield Road in Flood Zone 2 (FZ2; projected flood risk between 1% and 0.1% Annual Exceedance Probability AEP yearly) between Branston and the Tatenhill Brook culvert, around industrial and residential properties in the middle of the length of the highway, and at the south end of the highway by Barton Turn. Land with 20m of the Lichfield Road is also in Flood Zone 3 (FZ3; greater flood risk than 1% AEP yearly), particularly around the Branston Water Park and River Trent floodplain. There are also some highway sections at risk of surface water flooding, with areas falling within the 1 in 100-year (1% yearly AEP) and 1 in 1000-year (0.1% yearly AEP) Risk of Flooding from Surface Water (RoFSW) outlines.

**Figure 8:** Environment Agency Risk of Flooding from Rivers and Sea (RoFRS) map that shows the outlines of Flood Zone 2 (FZ2) and Flood Zone 3 (FZ3) for the Lichfield Road, A38, Branston

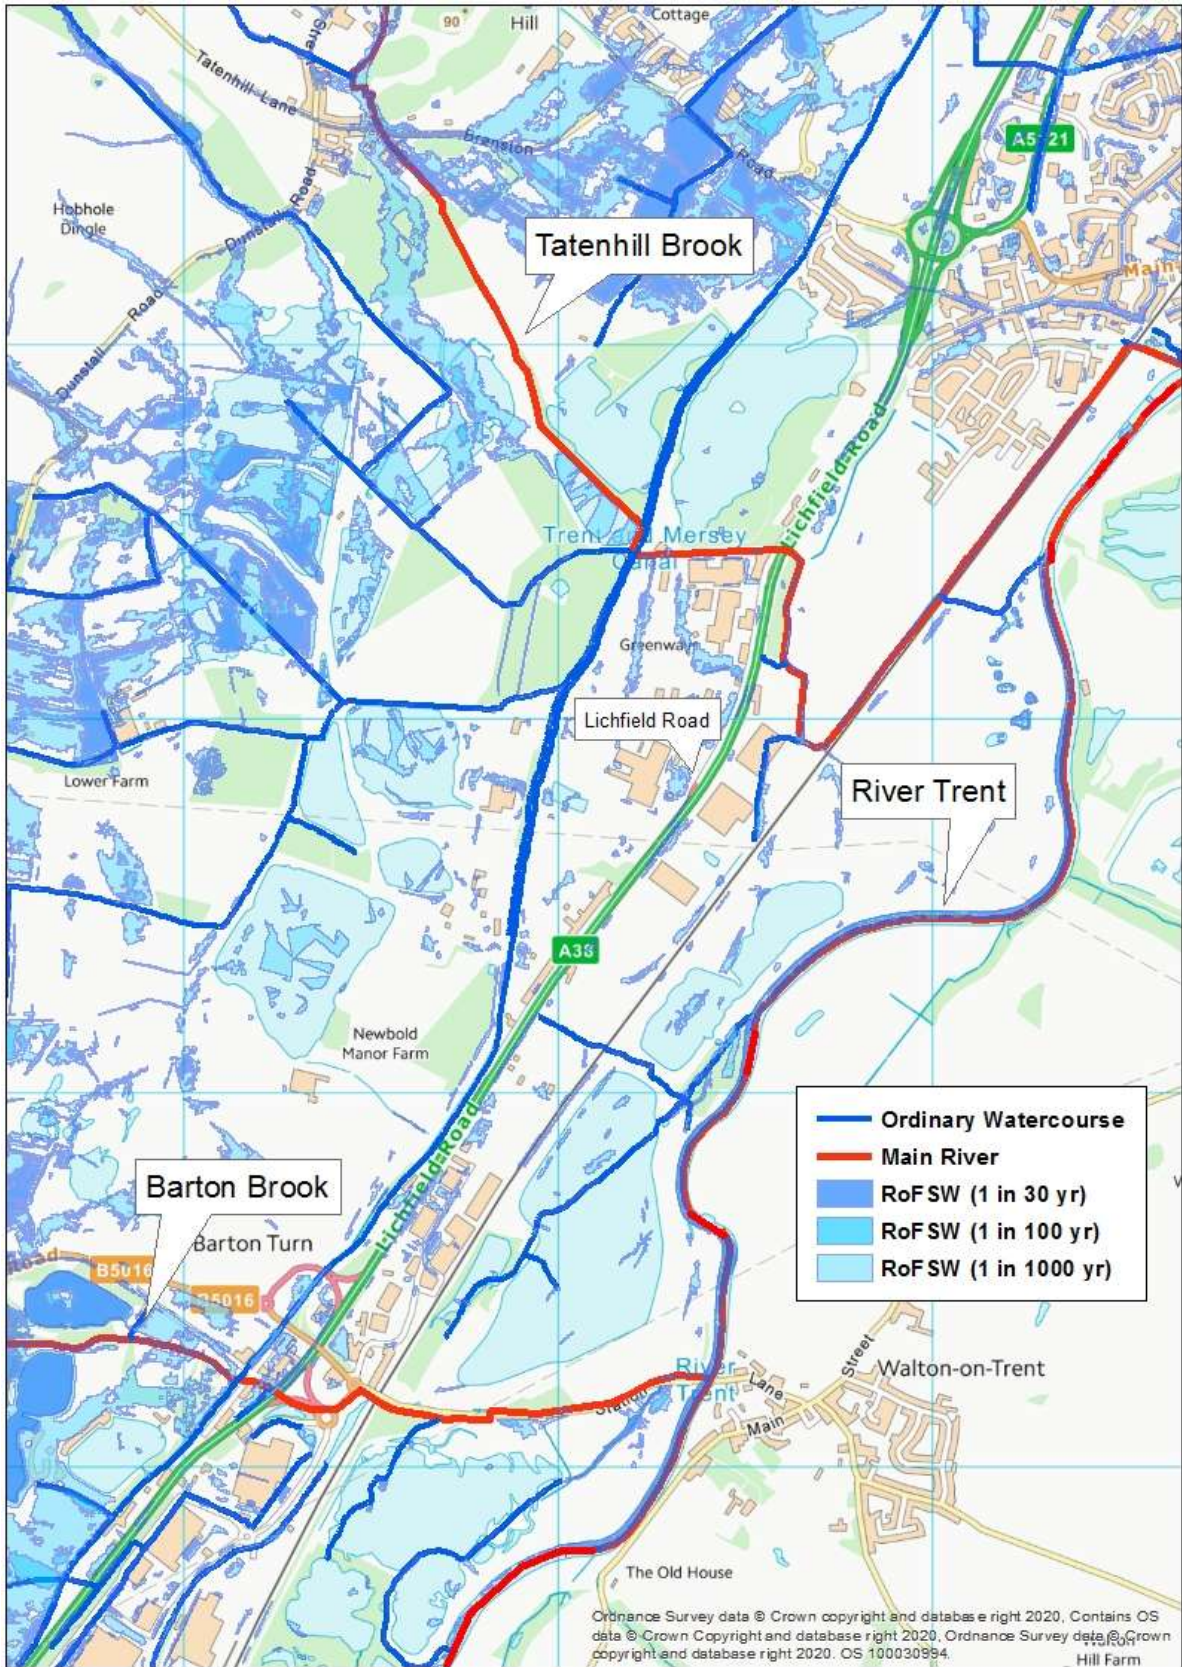
**Figure 9:** Environment Agency Risk of Flooding from Surface Water (RoFSW) map that shows the outlines for a 1 in 30-year event (% AEP), 1 in 100-year event (1% AEP) and a 1 in 1000-year event (0.1% AEP)

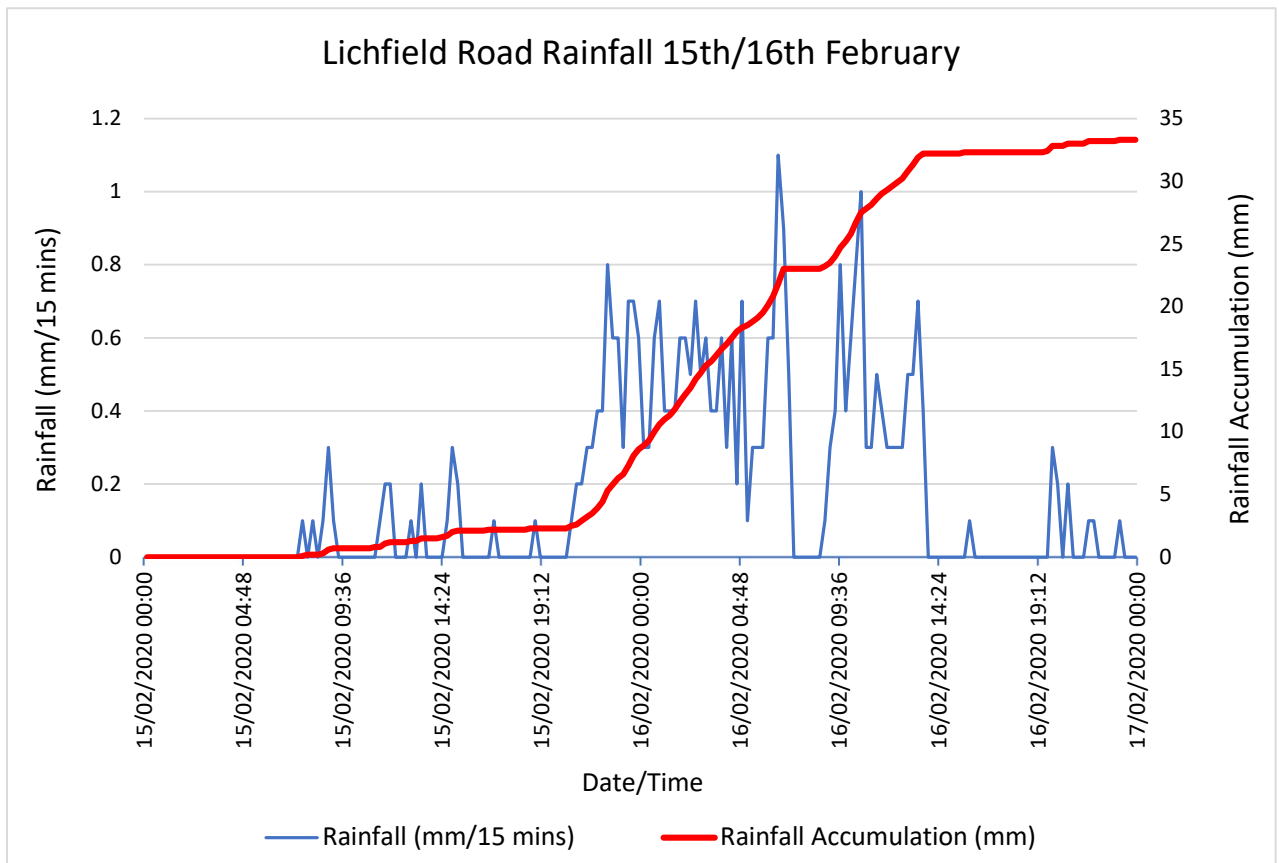
On the 15<sup>th</sup> and 16<sup>th</sup> of February, Storm Dennis generated a severe weather warning over much of the Midlands. The Storm Dennis event has been characterised as a long duration, low to moderate intensity rainfall event that spread over a large catchment and is typical with winter rainfall storm events. **Figure 10** shows the recorded 15-minute rainfall for the Lichfield Road from February 15<sup>th</sup> to 17<sup>th</sup>. A total of 33.3mm of rainfall was recorded over the two days, with 29.9mm of this total recorded during a 17-hour period between 20:45 on February 15<sup>th</sup> until 14:00 on February 16<sup>th</sup>, 2020. The return period of this event (**Table 1**) has been identified as between a 1-year and 2-year event by HydroMaster software. Although this presents the event as unexceptional, the average rainfall for February (1981-2010 baseline) for the area, recorded by the closest Staffordshire Met Office climate station in Denstone, is 62.1mm. Therefore, more than 50% of the monthly rainfall fell in the Lichfield Road, Branston, within two days making it significant to the area.

**Figure 10:** 15-minute rainfall for Lichfield Road, Branston on February 15th and 16th 2020 (Data Source: Hydromaster)

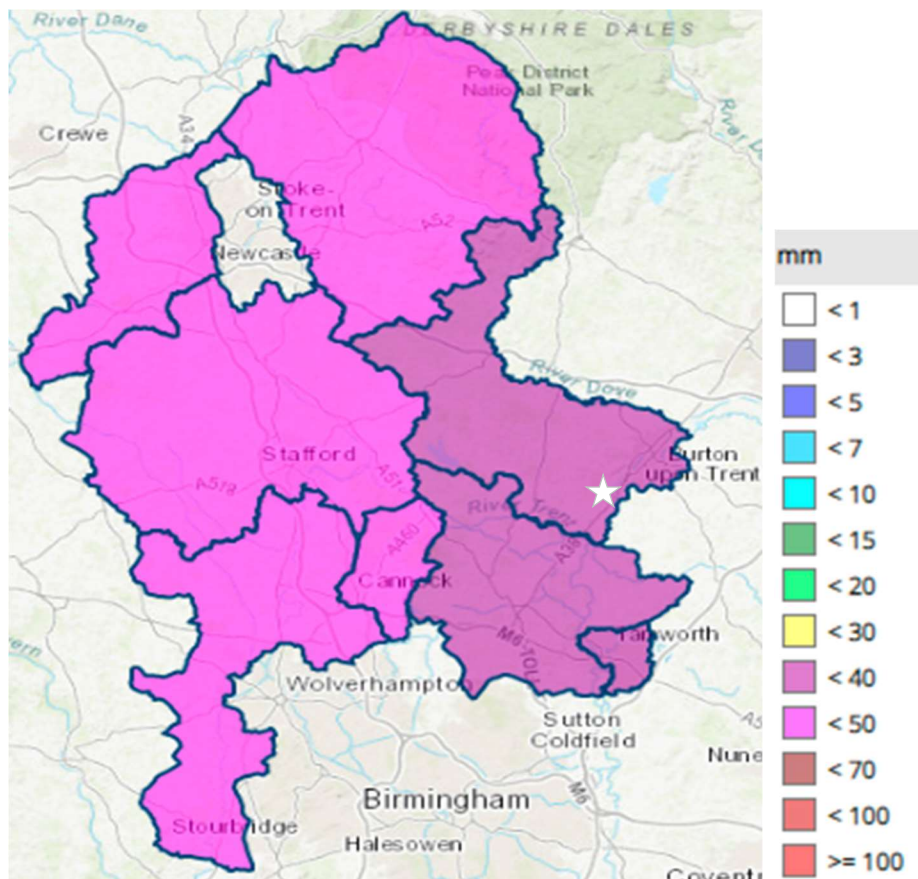
This intense rainfall was widespread across the catchment and larger area of Staffordshire (**Figure 11**). Verifying this data, similar rainfall totals for the same time-period were recorded by DEFRA Environment Agency rain gauges within the area. The closest gauge to the Lichfield Road, Byrkley Park gauge, recorded a total of 40.6mm for the two days of February 15<sup>th</sup> and 16<sup>th</sup>. Of this total, a significant 31.8mm peak rainfall was recorded between 21:30 on February 15<sup>th</sup> and 07:00 February 16<sup>th</sup>. Comparable rainfall values were also recorded at Overseal rain gauge, that recorded 42.4mm of rainfall, and Clay Mills rain gauge, that recorded 43.8mm of rainfall, for February 15<sup>th</sup> and 16<sup>th</sup>. This rainfall data for the surrounding area, including the intense period of rainfall recorded at Brykley Park at a similar time to Lichfield Road, shows an excess of 40mm of rainfall fell over the wider area surrounding Lichfield Road prior to the flood event on February 17<sup>th</sup>, whilst soils were already saturated and river levels remaining high throughout the catchment from Storm Ciara the previous week.

**Figure 11:** Rainfall totals for districts and boroughs across Staffordshire County with Lichfield Road indicated by a white star (Data Source: HydroMaster)

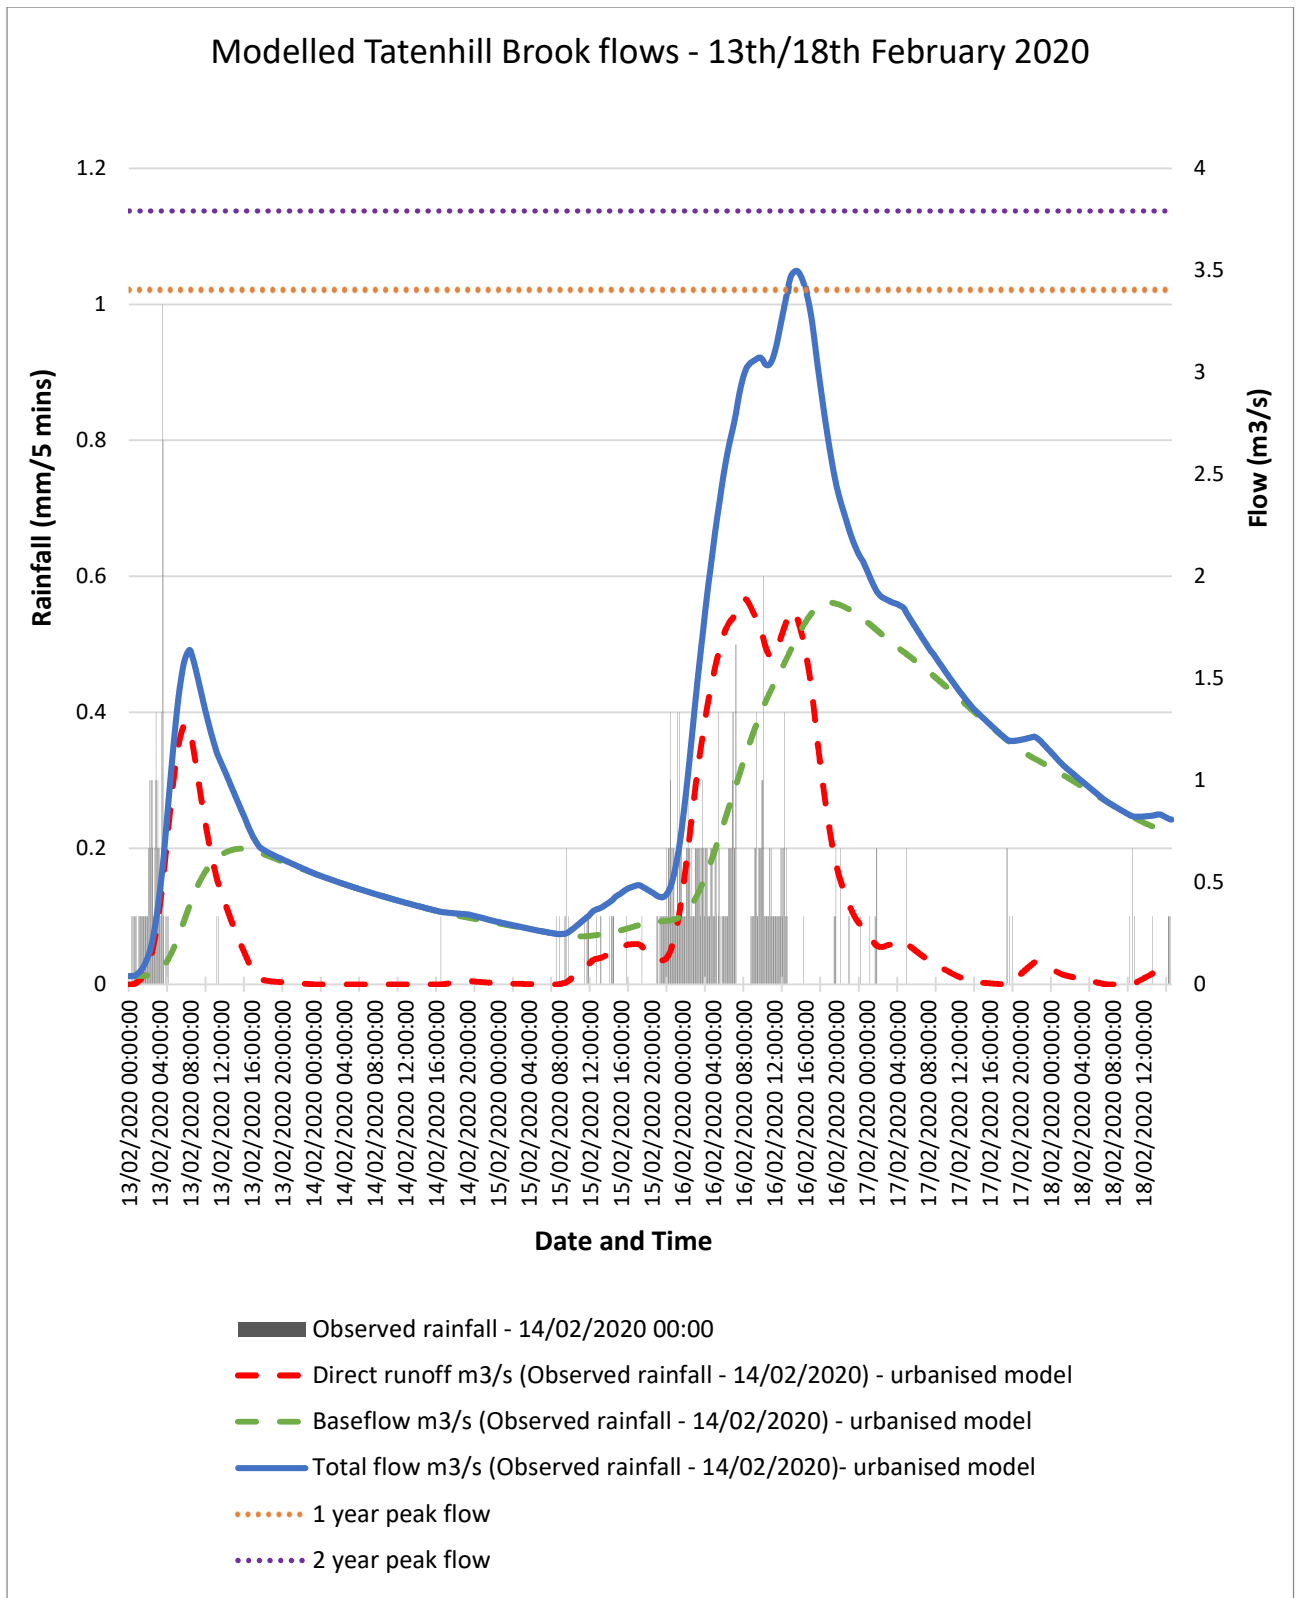
The Storm Dennis event and associated rainfall impacted watercourse levels and flows in the surrounding Branston area. The Tatenhill Brook is an ungauged watercourse, but ReFH software has been used to create a hydrograph of observed rainfall and catchment characteristics, as well as modelled hydrographs for design storms of different return periods. The hydrograph shows rainfall from February 13<sup>th</sup> to 19<sup>th</sup> 2020, and identifies an intense, earlier but smaller rainfall event on the 13<sup>th</sup> that had a fast response on Tatenhill Brook levels increasing to  $>1.6\text{m}^3/\text{s}$ . Total flow reduced following this event but remained moderate in channel before the occurrence of Storm Dennis rainfall on the 15<sup>th</sup> and 16<sup>th</sup>. Peak rainfall at 10:30 on February 16<sup>th</sup> resulted in fast responding levels with peak discharge of  $3.5\text{m}^3/\text{s}$  around 15:00 on February 16<sup>th</sup>. Comparison of peak flows has enabled the return period of this peak Tatenhill Brook discharge to be calculated as an event with a return period between 1 and 2-years. The resulting hydrograph is available as **Figure 12**.

**Figure 12:** ReFH design flood hydrograph for Tatenhill Brook overtopping event on February 17th following the Storm Dennis rainfall event on 15th/16<sup>th</sup>. The modelled return period of flows has been calculated as between a 1 and 2-year peak event (Data Source: Hydromaster and ReFH)

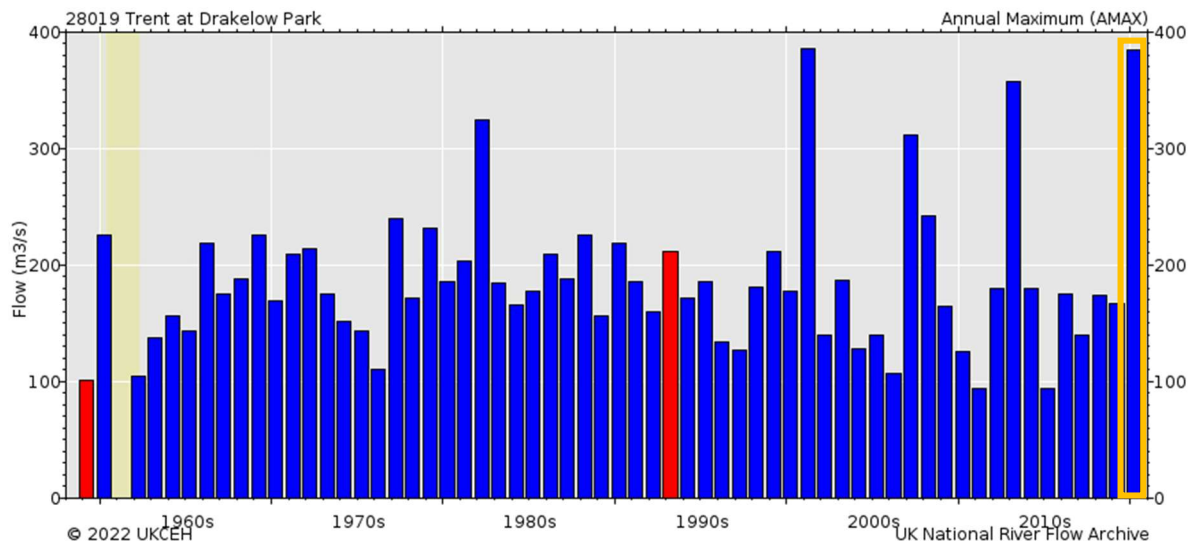
On February 17<sup>th</sup> 2020 at 23:00 the River Trent gauge at Drakelow Park, the nearest River Trent gauge to Lichfield Road, Branston, by Branston Golf and Country Club (**Figure 13**), recorded a river level of 3.8m and a discharge of  $384.2\text{ m}^3/\text{s}$  (**Figure 14**). This is the joint highest recorded level of the River Trent at Drakelow Park gauge station since records started in 1959, coinciding with levels from November 7<sup>th</sup> 2020 that had a slightly higher flow rate of  $385.3\text{ m}^3/\text{s}$  but a lower river level of 3.79m. Data available from the National River Flow Archive (NRFA) under an open licence.

**Figure 14:** River Trent flow from 1959 to 2020. February 17<sup>th</sup> 2020 (outlined in orange) has the joint highest recorded flow levels for the River Trent at Drakelow gauge (Data Source: NFRA)
