**2020 Flood Events:**

**Section 19 - Investigation**

**Mead Crescent & Manor Crescent,  
Stapenhill, Burton-Upon-Trent**

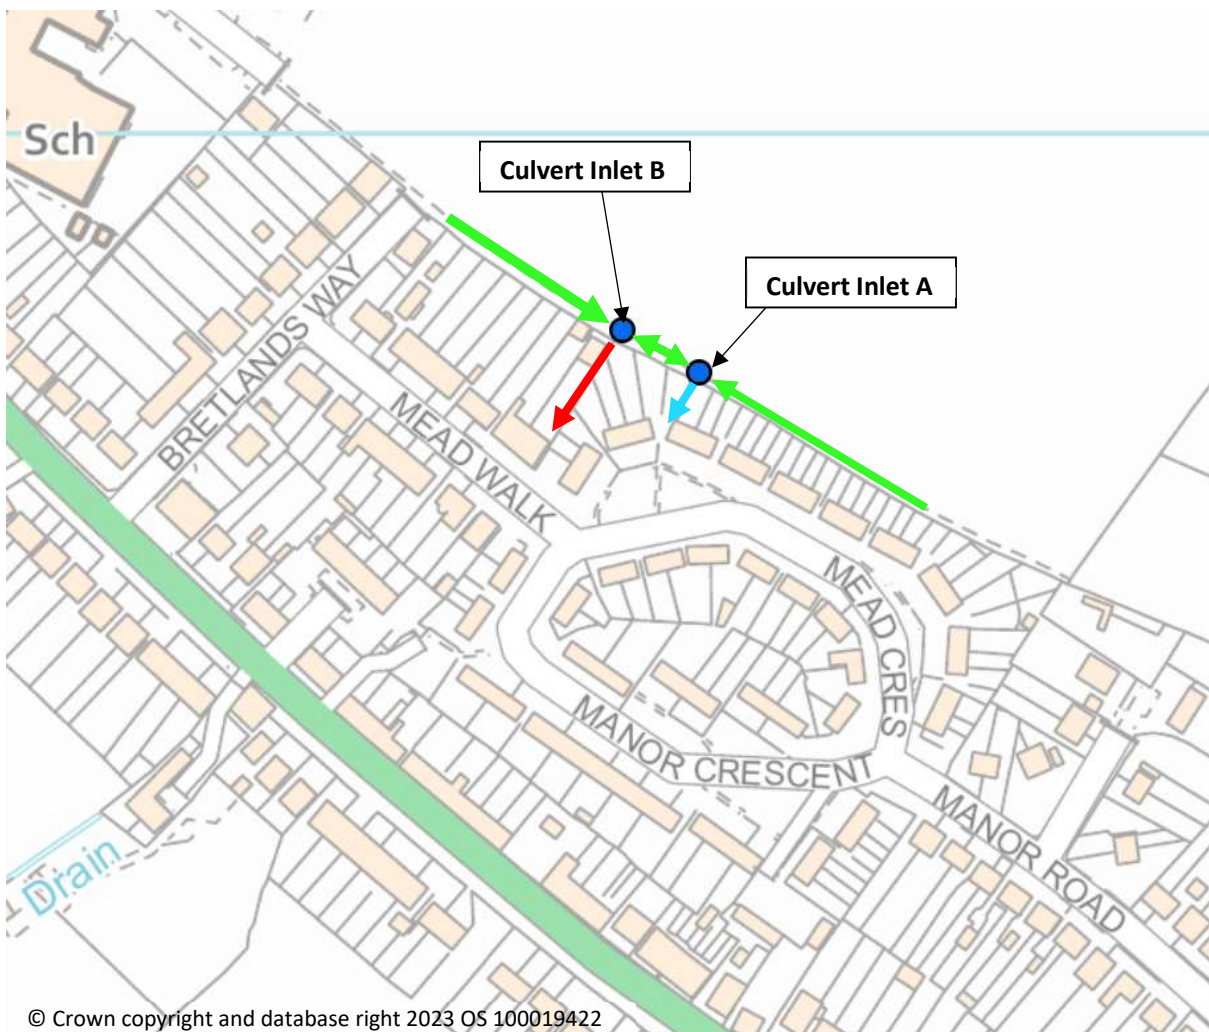
**Figure 8:** Location of drainage ditch and bund (green line), culvert inlet A and outlet pipe (blue line) and culvert inlet B and outlet pipe (red line).

A drainage ditch and bund run along the northern edge of the gardens between Mead Crescent and Mead Walk and the agricultural land to the north (Figure 8). The ditch intercepts surface water runoff from the field to the north which flows towards a culvert inlet situated at a low spot approximately halfway along the field boundary (Culvert Inlet A). Review of OS Mapping and contour data indicates that approximately 0.2km<sup>2</sup> of the field to the north of the flood location drains into the drainage ditch (Figure 9). The outlet pipe from the field conveys surface water runoff through a 150mm diameter pipe in a southerly direction. A grille with approximate spacing of 90mm is situated above the pipe inlet. Site investigations have confirmed that Pipe A discharges into the Severn Trent Water surface water sewer situated in Mead Crescent, approximately 38m to the south.

Approximately 30m to the west of Pipe A an additional culvert inlet has been observed within the ditch (Culvert B, Figure 8). This pipe also conveys surface water runoff from the field ditch, however, it is not clear whether this pipe acts as an overflow pipe from Pipe A or whether it conveys a proportion of the surface water runoff from the western part of the field. Two pipes from the western and eastern sides of the drainage ditch connect into Pipe B, both of which have a grille on the upstream end. Site investigations have confirmed that Pipe B flows in a southerly direction for approximately 70m through a private garden, before connecting into a 300mm diameter Severn Trent Water Surface Water sewer that runs in an easterly direction along Mead Walk.

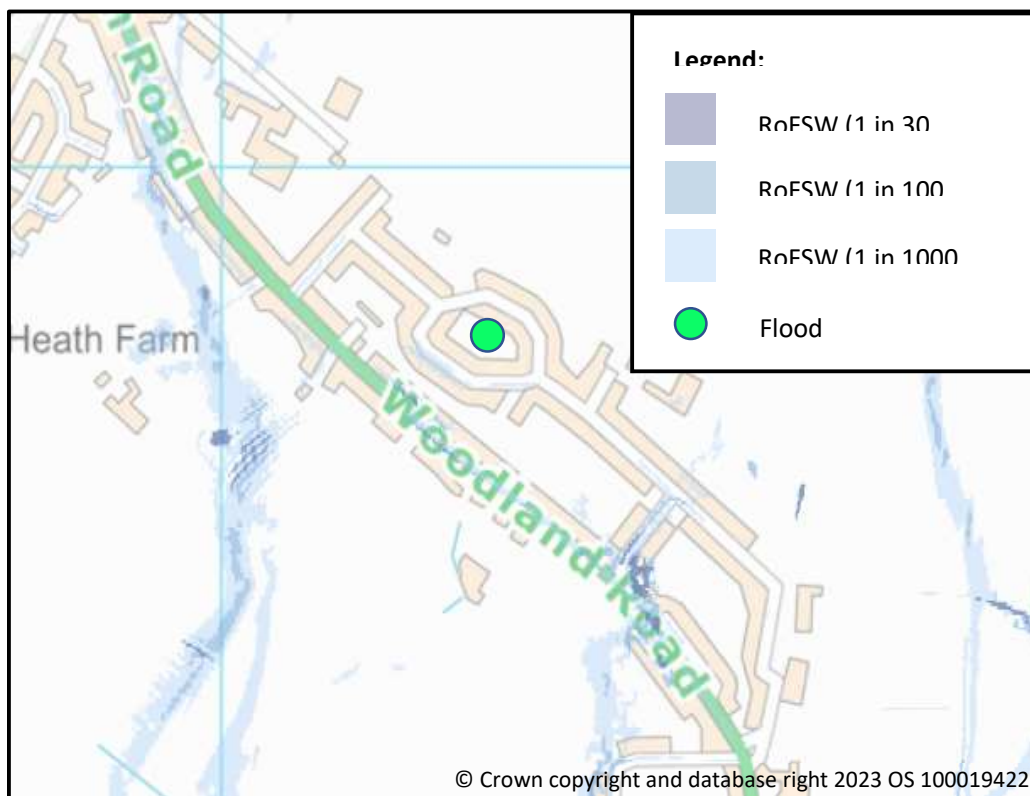
Figure 10: Environment Agency Risk of Flooding from Surface Water (RoFSW)

The Environment Agency's Risk of Flooding from Surface Water (RoFSW) map shows a small area of ponding along Manor Crescent, with several properties shown to be located within the 1 in 1000 year RoFSW map (Figure 10). This means that flooding occurring as a result of rainfall with less than 1 in 1000 (or 0.1%) chance in any given year.

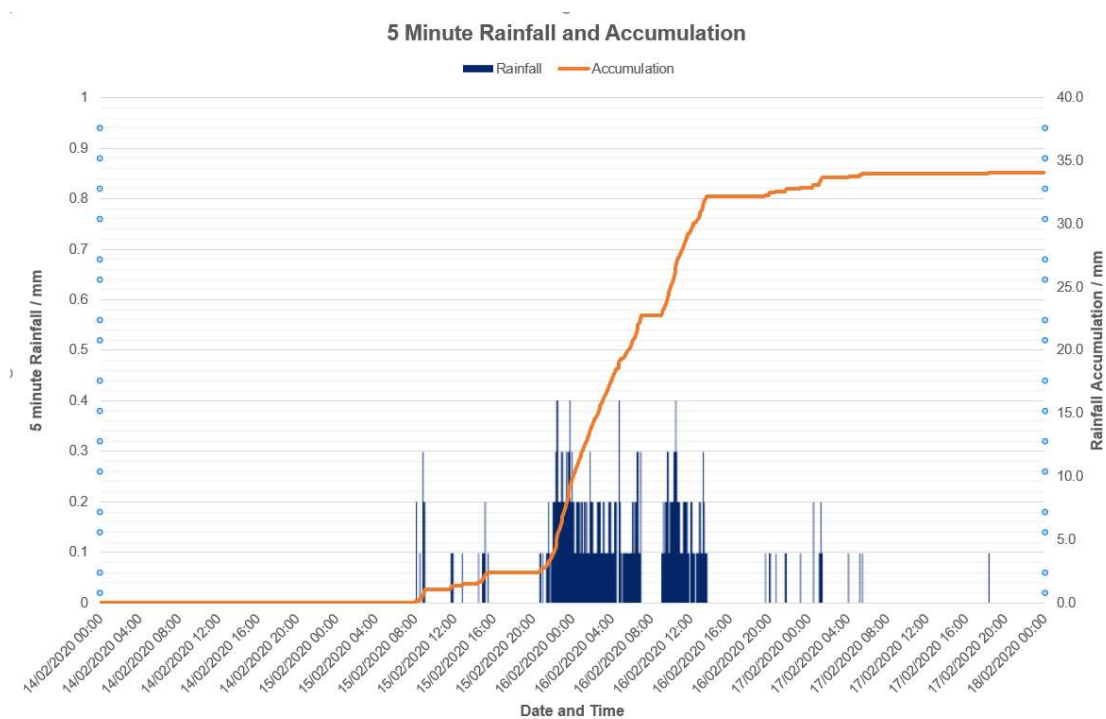
**Figure 12:** 5-minute Rainfall data for Mead Crescent and Manor Crescent, Stapenhill, from Hydromaster data for February 14<sup>th</sup> to February 18<sup>th</sup> 2020 (Source: Hydromaster)

Figure 12 shows the recorded 5-minute HydroMaster rainfall data for Mead Crescent and Manor Crescent. A total of 32.9mm of rainfall was recorded over the 24 hour time period 15<sup>th</sup> February 2020 to 16<sup>th</sup> February 2020. Of this total, 29.8mm was recorded during a 17-hour period between 20:40 on February 15<sup>th</sup> and 13:40 on 16<sup>th</sup> February 2020 demonstrating that the storm was intense with rainfall falling continuously throughout the duration of the storm.

This intense periods of rainfall prior to the flooding incidents that occurred across the County resulted in significant volumes of surface water flowing over what was already saturated ground.

The rainfall return period of the February 2020 event has been estimated as between a 1-year and 2-year event (Table 1). Whilst the magnitude of the rainfall event alone was not exceptional, when combined with the preceding conditions and extremely saturated ground it resulted in a more extreme, lower probability flooding event.
