# 2020 Flood Events:

# Flood and Water Management Act

# Section 19 - Investigation

# The District of South Staffordshire

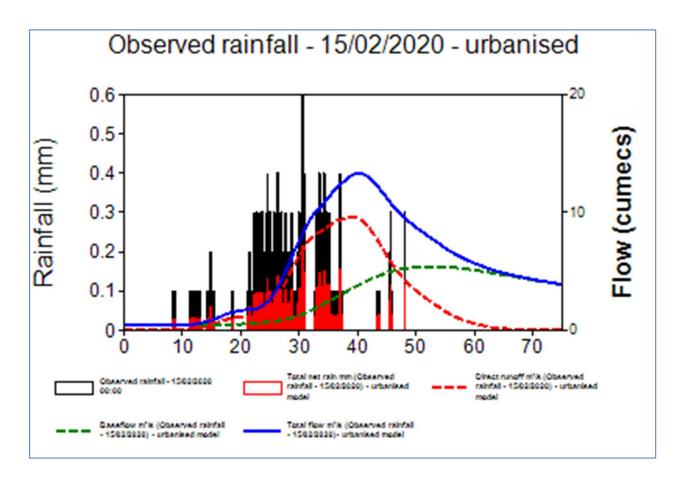
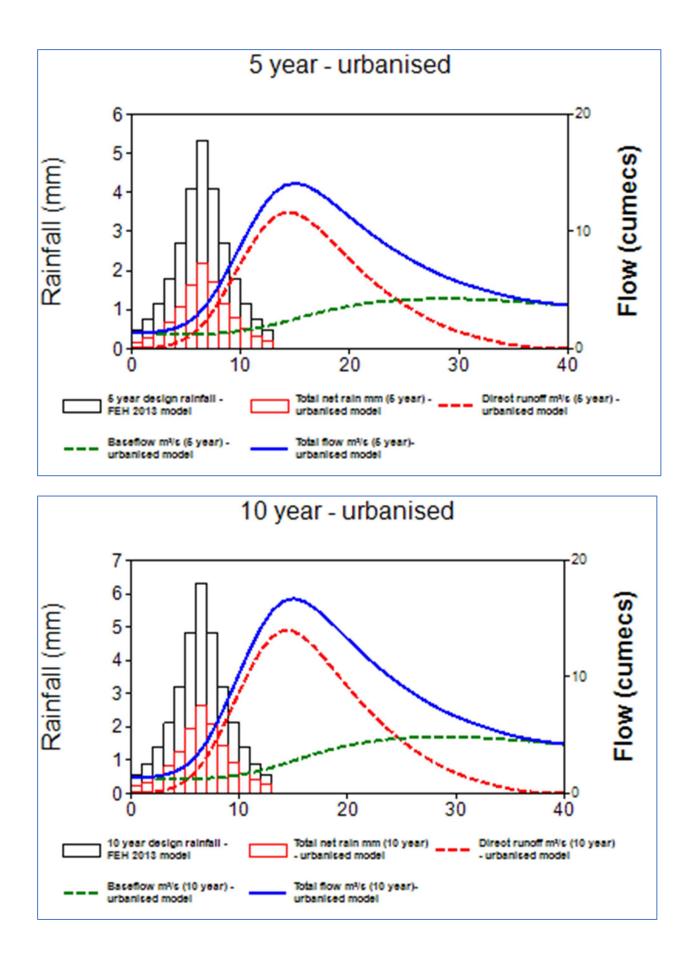
In performing a hydrological analysis utilising Flood Estimation Handbook (FEH) Webservice catchment data and rainfall data sourced through Hydromaster software, the return period for the storm Dennis on this particular watercourse (the Saredon Brook), can be estimated. An analysis was performed utilising the Revitalised Flood Hydrograph method in ReFH2 hydrological modelling software.

The observed flow event at this location had a peak rate of 13.32 m3/s. The 'design' 1 in 5 year return period peak flow (that which has a probability of occurring of 20 % in any year), is estimated at 14.13 m3/s The 1 in 10 year 'design flow' is estimated as approximately 16.73 m3/s. Therefore, we can have a degree of confidence that the actual return period of this flow event on the Shropshire Brook in Storm Dennis is between 1 in 5 years and 1 in 10 years and therefore a significant flow event so had between a 10 % and 20% probability of occurring in that (or any), year.

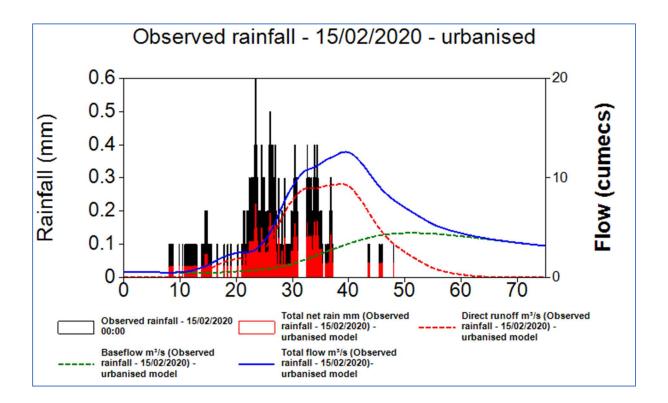
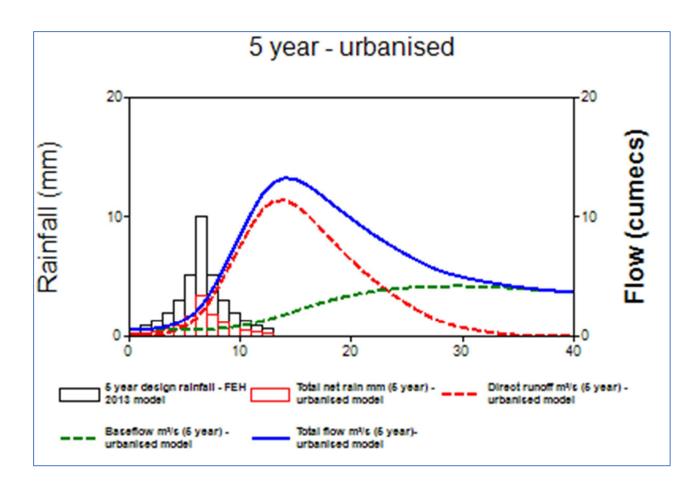
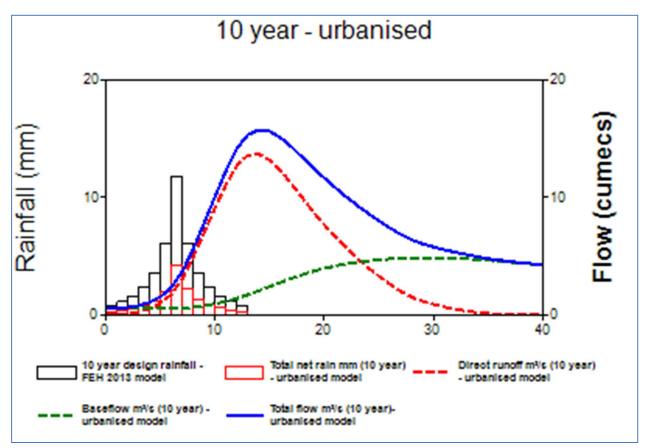
## The Beeches, Ebstree Road, Seisdon

In performing a hydrological analysis utilising Flood Estimation Handbook (FEH) Webservice catchment data and rainfall data sourced through Hydromaster software, the return period for the storm Dennis on this particular watercourse (the Smestow Brook), can be estimated. An analysis was performed utilising the Revitalised Flood Hydrograph method in ReFH2 hydrological modelling software.

The observed flow event at this location had a peak rate of 10.60 m3/s. The 'design' 1 in 5 year return period peak flow (that which has a probability of occurring of 20 % in any year), is estimated at 9.61 m3/s The 1 in 10 year 'design flow' is estimated as approximately 11.44 m3/s. Therefore, we can have a degree of confidence that the actual return period of this flow event on the Shropshire Brook in Storm Dennis is between 1 in 5 years and 1 in 10 years and therefore a significant flow event so had between a 10 % and 20% probability of occurring in that (or any), year.

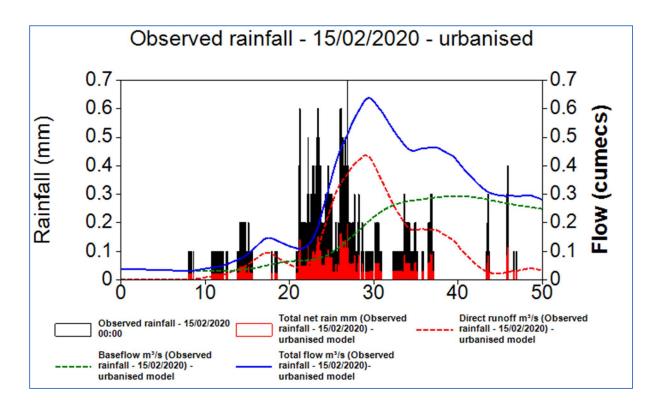
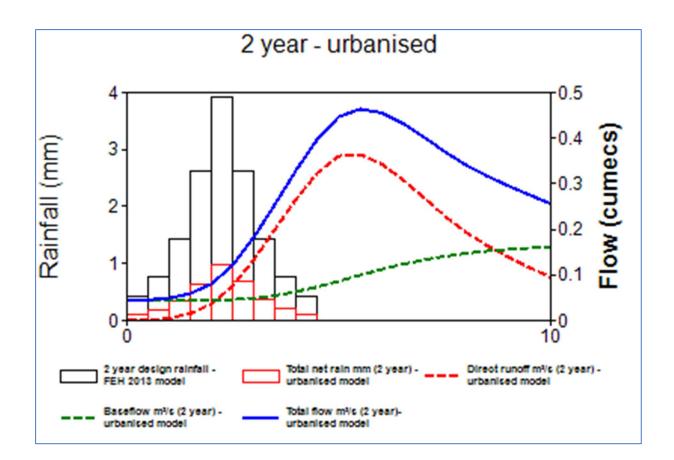
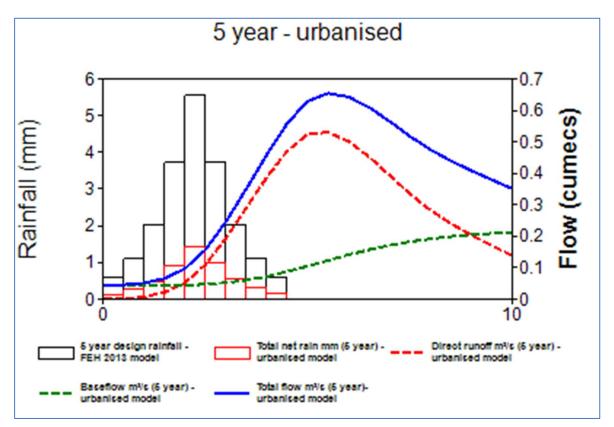
## Six Ashes Road, Bobbington

In performing a hydrological analysis utilising Flood Estimation Handbook (FEH) Webservice catchment data and rainfall data sourced through Hydromaster software, the return period for the storm Dennis on this particular watercourse can be estimated. An analysis was performed utilising the Revitalised Flood Hydrograph method in ReFH2 hydrological modelling software.

The observed flow event at this location had a peak rate of 0.64 m3/s. The 'design' 1 in 2 year return period peak flow (that which has a probability of occurring of 50 % in any year), is estimated at 0.46 m3/s The 1 in 5 year 'design flow' is estimated as approximately 0.65 m3/s. Therefore, we can have a degree of confidence that the actual return period of this flow event on the watercourse in Storm Dennis is between 1 in 2 years and 1 in 5 years and therefore a significant flow event so had between a 20 % and 50% probability of occurring in that (or any), year.

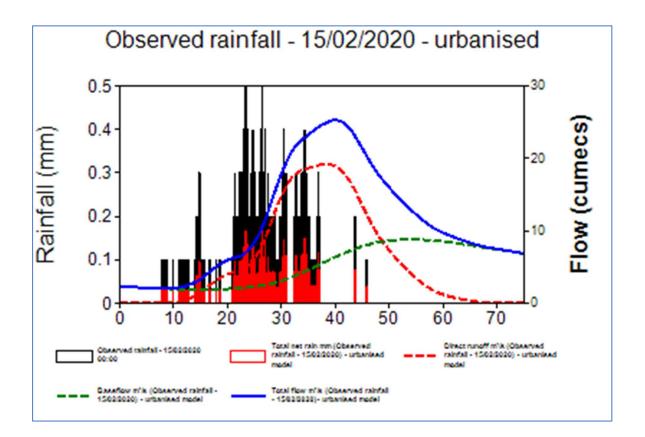
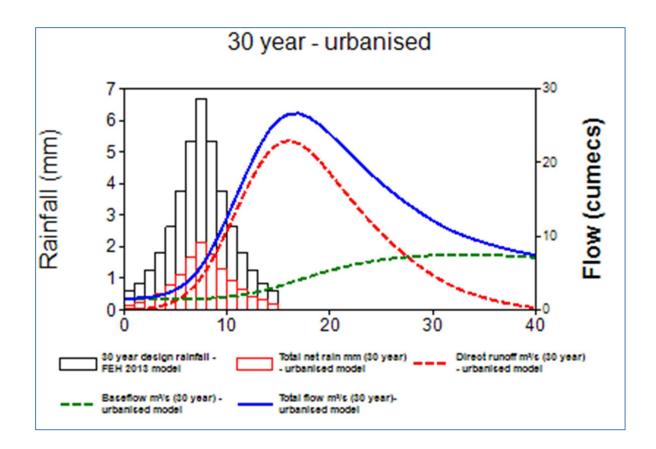
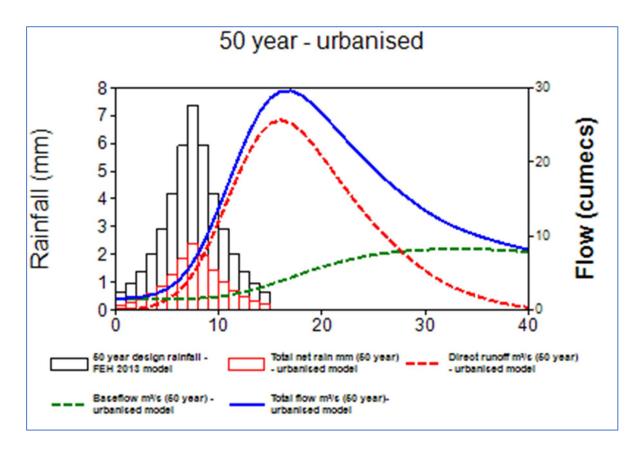
## Hinksford Caravan Park

In performing a hydrological analysis utilising Flood Estimation Handbook (FEH) Webservice catchment data and rainfall data sourced through Hydromaster software, the return period for the storm Dennis on this particular watercourse (the Smestow Brook), can be estimated. An analysis was performed utilising the Revitalised Flood Hydrograph method in ReFH2 hydrological modelling software.

The observed flow event at this location had a peak rate of 21.58 m3/s. The 'design' 1 in 30 year return period peak flow (that which has a probability of occurring of 3.33 % in any year), is estimated at 20.36 m3/s The 1 in 50 year 'design flow' is estimated as approximately 22.70 m3/s. Therefore, we can have a degree of confidence that the actual return period of this flow event on the watercourse in Storm Dennis is between 1 in 30 years and 1 in 50 years and therefore a significant flow event so had between a 2 % and 3.33% probability of occurring in that (or any), year.
