Flooding in Slindon, Staffordshire

January 2024

Investigation under Section 19
of the Flood and Water Management Act 2010

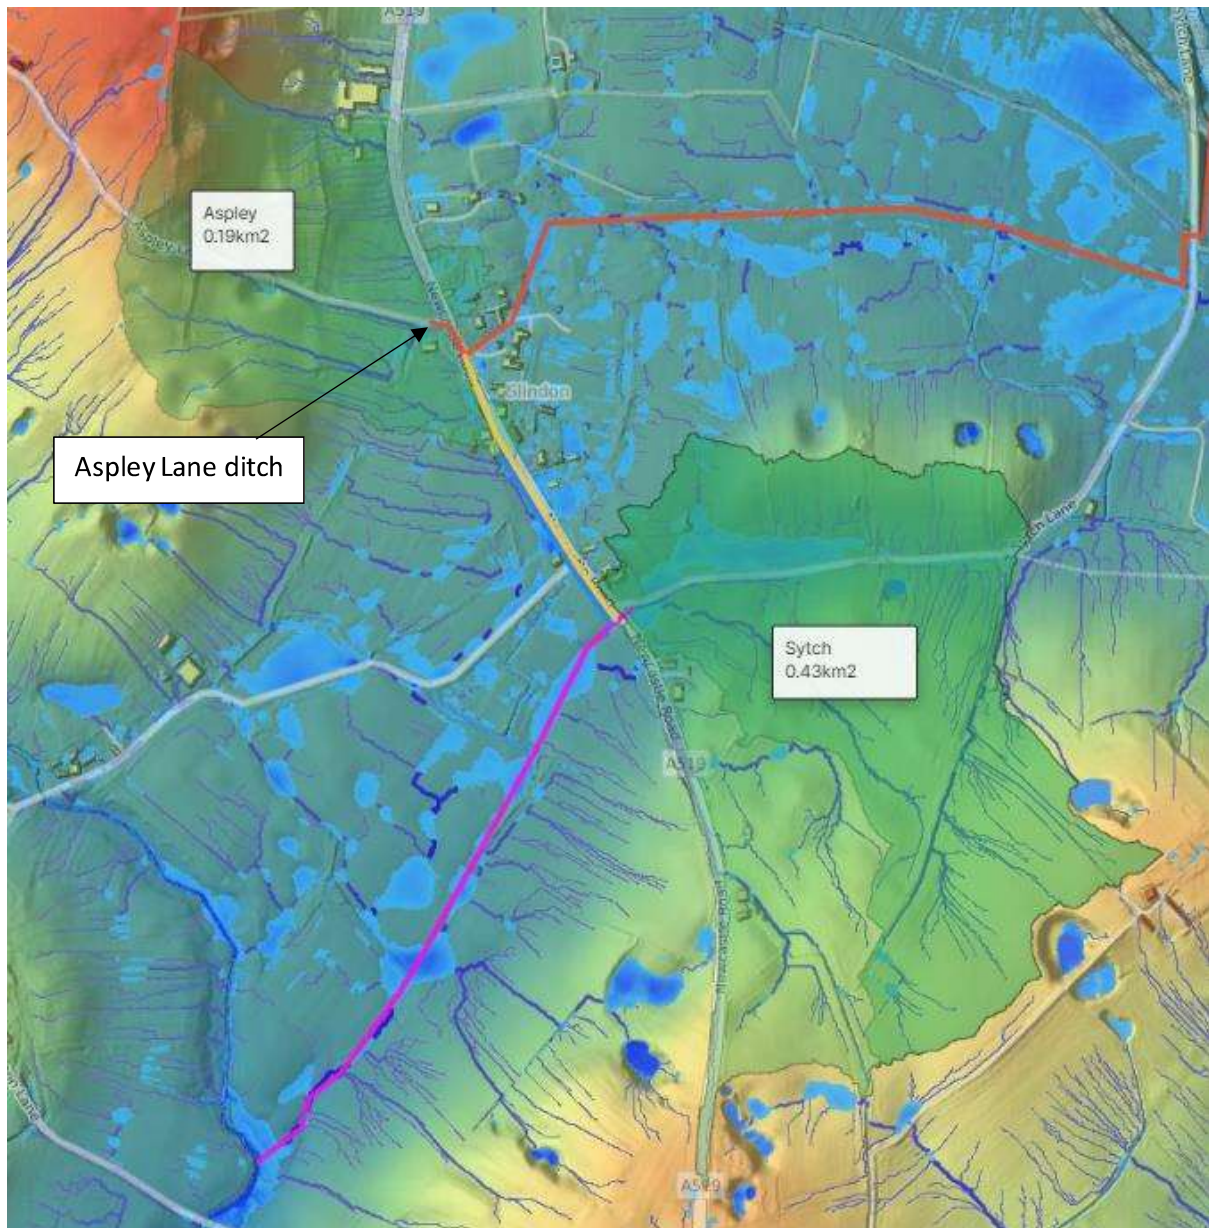
Figure 10: Engineered drainage routes

The primary drainage route for the Aspley catchment follows the red line (Figure 10). Surface water runoff from Aspley Hill drains to a roadside ditch which flows adjacent to Aspley Lane. The ditch is piped beneath the A519 in a 225mm diameter pipe with the inlet protected by a trash screen (Figure 11) which is owned and maintained by SCC highways department. The pipe follows a route along Villa Farm Lane for approximately 700m before discharging into an open ditch, and ultimately discharging into Meece Brook approximately 1km to the east.

At the junction of the A519 and Villa Farm Lane, the Aspley Lane pipe passes through a manhole chamber with a weir (Figure 12). Under high flow conditions, once the capacity of the pipe from Aspley Lane has been exceeded, water will flow over the weir and enter the highway drainage network (Figure 10, yellow drainage route) which conveys surface water flows from the A519.

The main drainage route for the Sytch catchment follows the pink line (Figure 10). A series of land drainage ditches are located adjacent to Sytch Lane which flow in a westerly direction towards the A519. At the junction of Sytch Lane and the A519, the ditch is piped beneath the road through a 600mm diameter pipe. Inspection of a surface water manhole opposite Sytch Lane, indicates that at this point, surface water flows from the highway drainage network connect into the pipe, which continues in a south westerly direction, before discharging into Brockton Brook approximately 700m to the south west.

Surface water that flows onto the highway is collected via the highway drainage network, comprising traditional highway gullies and connections into 300mm diameter clay pipes that run down the A519 (Figure 10, yellow line). The highway drains discharge into a culverted ordinary watercourse, situated at the southern end of the village opposite Sytch Lane. This forms a 600mm diameter pipe, which continues in a south westerly direction across fields, before discharging into Brockton Brook. Staffordshire County Council highways department are responsible for the maintenance of this network of highway gullies and connections to the point at which they discharge into the culverted ordinary watercourse.

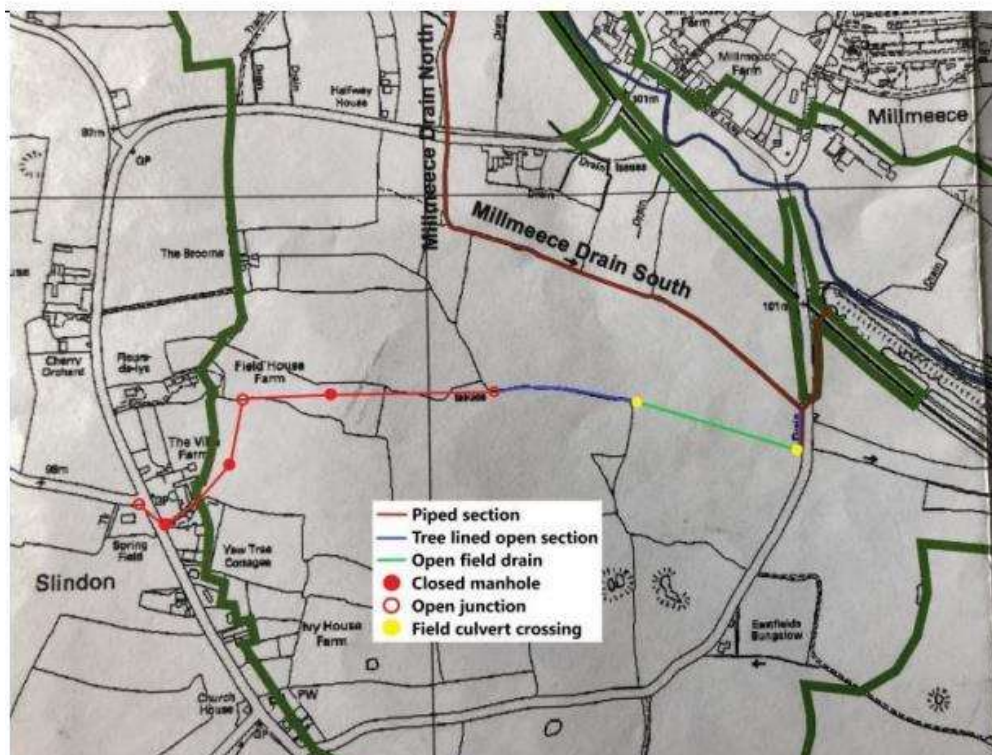
Both the pipe and downstream ditch channel fall under the ownership of the riparian landowner. Figure 13 presents the location of the piped Ordinary Watercourse (red line with manholes) and open sections of ditch as understood by the IDB from previous investigations.

Figure 13: Approximate location of piped Ordinary Watercourse (red line with manholes) and open sections of ditch as understood by the IDB from previous investigations (Source: Sow and Penk IDB)

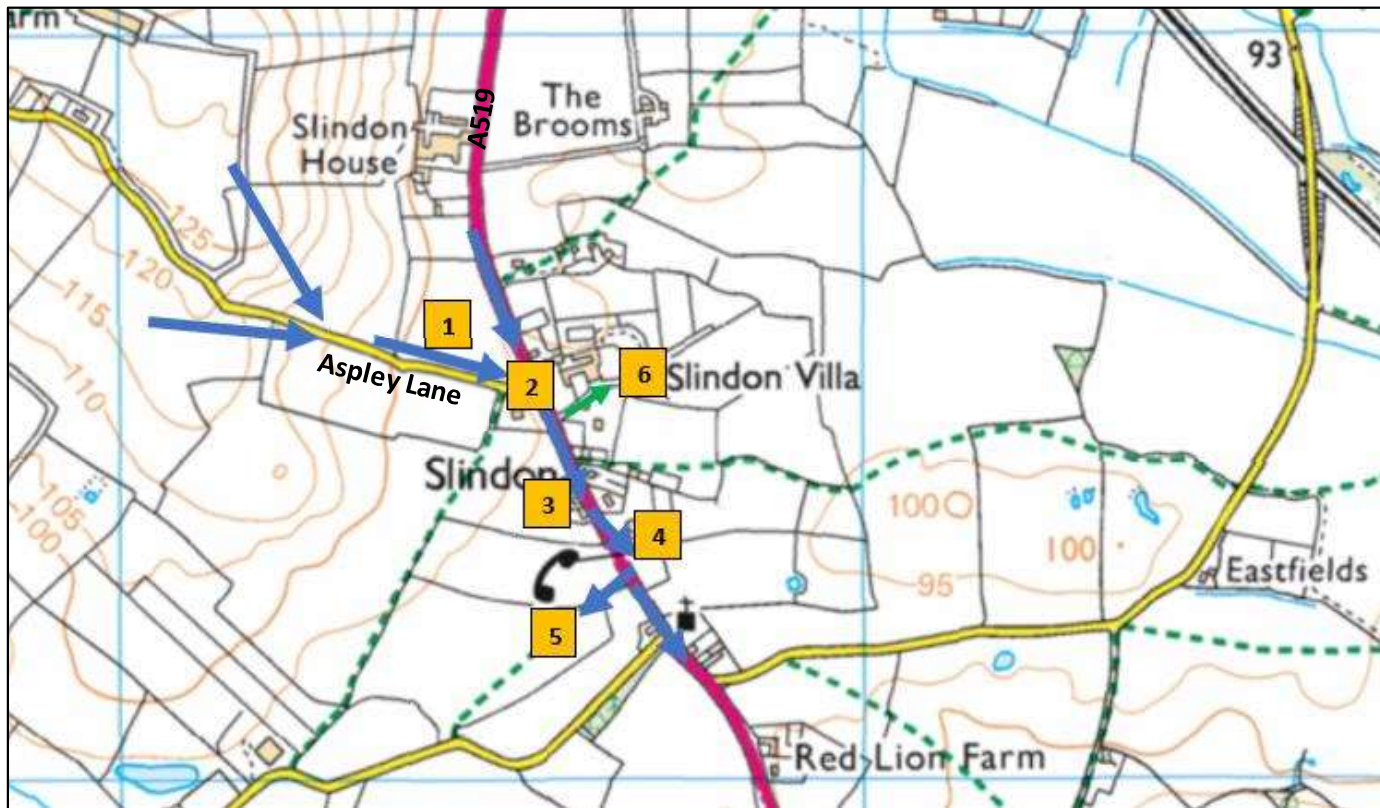
The flooding mechanism reported on 2nd January was similar to that experienced in previous flood events. Figure 22 presents the predominant flow routes observed by residents.

Figure 22: Surface water flow routes observed by residents on 2nd January 2024

At around 14:00 external flooding to property was reported along the western side of the highway (Location 3, Figure 22). Reports from residents describe how flood water reached a depth of approximately 1 foot, surrounding the property. On this occasion, residents managed to prevent water entering the property by pumping water back onto the highway.

Surface water flows then continued to flow down the A519, impacting properties on the eastern side of the highway at around 14:30-15:00 (Location 4, Figure 22 and Figure 26). Residents reported that the highway drainage network became overwhelmed, with water observed to be bubbling out of the drain adjacent to the old telephone box. Surface water then flowed from the highway towards properties which are situated at a lower level than the highway. The flooding was exacerbated by bow waves from passing cars pushing water towards properties. Two properties reporting internal flooding to depths of between 4 and 5 inches, in addition to significant flooding to gardens and outbuildings.

Surface water flows continued to then follow the prevailing topography along the A519 in a southerly direction and flowing across the highway into the fields on the western side of the A519 (Location 5, Figure 22; and Figure 27).

At the northern extent of the village, flooding was also experienced along Villa Farm Lane (Location 6, Figure 22). Residents described how water emerged rapidly from a manhole cover situated along the private lane. Since the lane is below the main A519 road surface level, water accumulated along the lane (Figure 28). As the volume of water on the A519 increased, this also flowed onto the lane, resulting in floodwater reaching depths of approximately 30cm. Whilst no internal flooding to property was reported, access to property was significantly restricted, with some residents also reporting issues with septic tanks and private drainage.

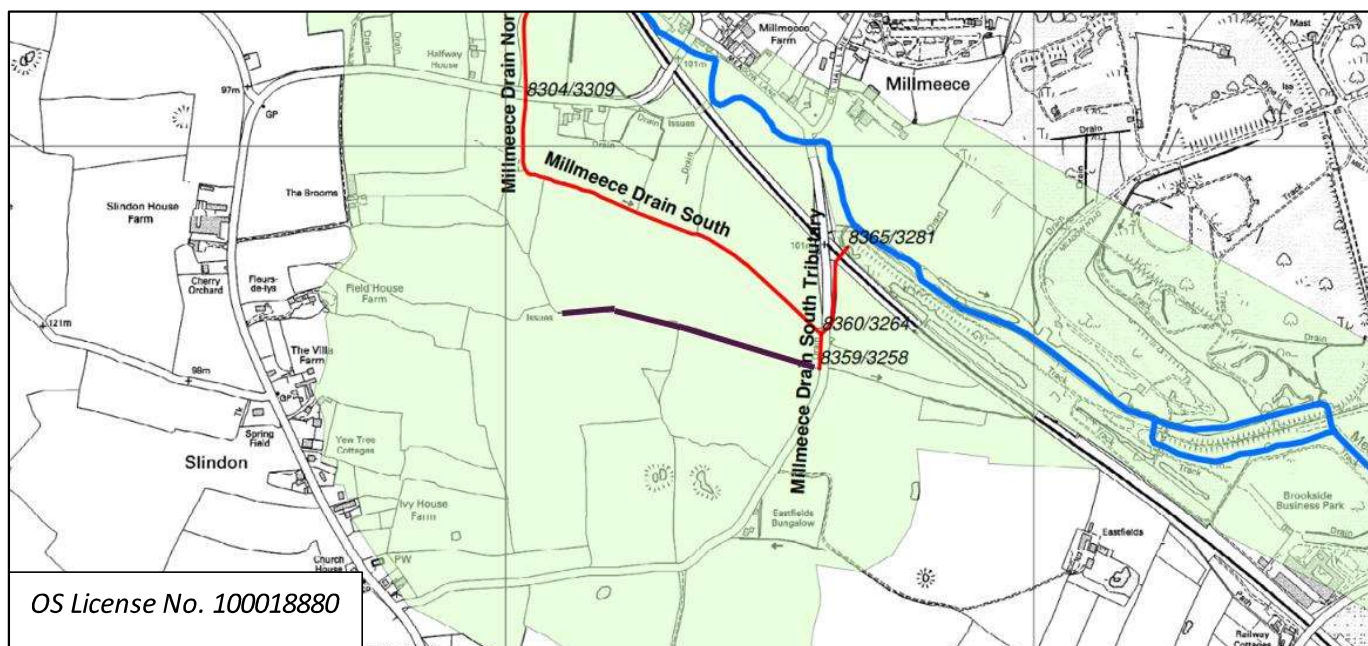
Figure 38 presents the plan of assets within the IDB area (area shaded light green) as provided by the IDB. This shows IDB maintained watercourses (red), EA Main River (blue), Aspley Lane riparian owned watercourse (purple). All other assets between Newcastle Road and Sytch Lane are the responsibility of the Riparian Owner Occupiers who own the land above or adjacent the asset and the IDB does not hold details of Riparian Assets.

Figure 38: Plan of watercourses and ownership as provided by Sow and Penk IDB
