2nd January 2024 Flood Event
Floods and Water Management Act
2010 Section 19 - Investigation
Main Road/Sill Green Wigginton
Lichfield District

This report summarises the completed and ongoing investigations carried out into the flooding which occurred on 2nd January 2024 in Main Road/Sill Green Wigginton, Lichfield

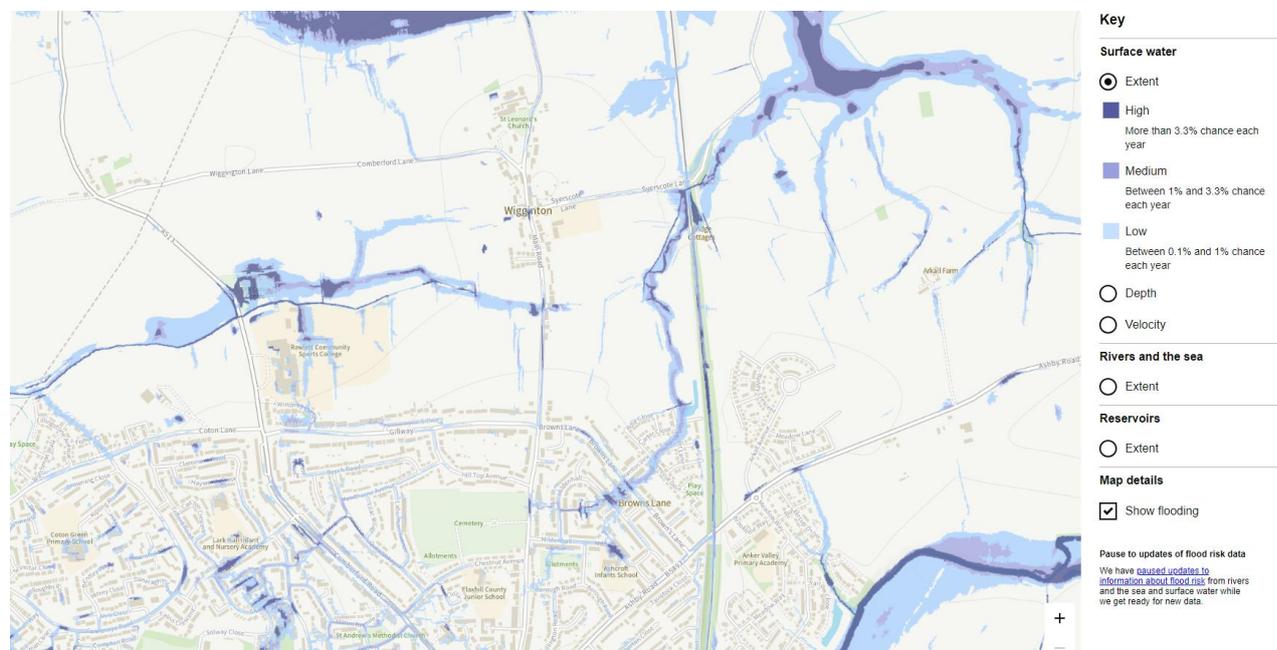
Figure 1 Extent of Surface Water Flooding, Source Environment Agency

It should be noted that this mapping has been produced at national scale with a number of assumptions and therefore there are some limitations at a local scale and is not appropriate for identifying individual property level flood risk. This mapping is publicly available for use and is available online.
