2020 Flood Events:
Flood and Water Management Act
Section 19 - Investigation
Cannock Chase District- Staffordshire

Document Ref:			2020 Flooding: Section 19 Flood Investigation for Cannock Chase District		
Revision	Date	Description	Originated	Checked	Authorised
0		Draft for Partners	A Bushnell		
1		ISSUE		A J Brett	
2	27/05/2022	Hydrology added	A Bushnell	J Cooper	J Cooper

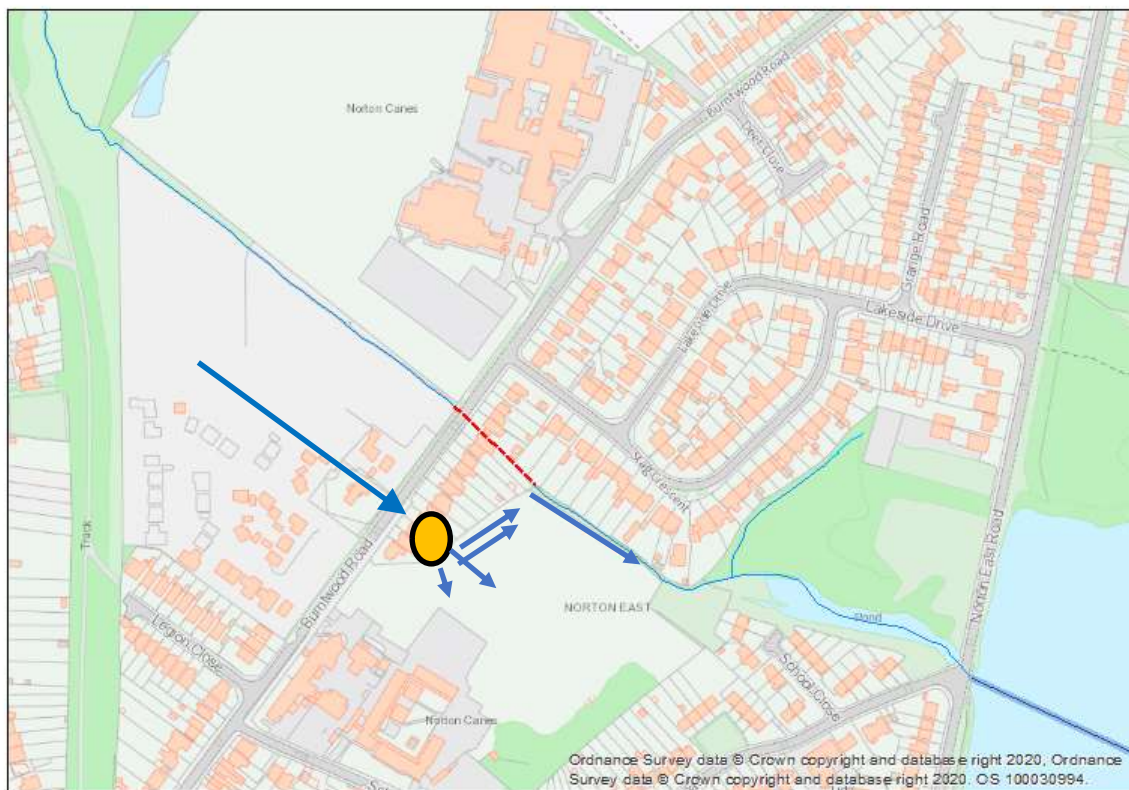
Figure 4: Flow Directions (Blue) and Debris Screen (Orange).

The flooding in this area has been identified to be because of an overflowing Ordinary Watercourse. A debris screen protecting a culvert on this Ordinary Watercourse became blocked with debris, therefore preventing flow from being conveyed through the culvert under the Burntwood Road. The water then spilled out on to the Burntwood Road and inundated properties in the vicinity and that of Stag Crescent also.

Recommended Actions	Identified Party / RMA
Debris screen to be upgraded to meet new guidelines – currently being installed	Highways (SCC)
New debris screen to be regularly inspected and maintained by owners (SCC Highways)	Highways (SCC)
Letters to Riparian Land Owners to be sent – detailing their duties	LLFA (SCC)

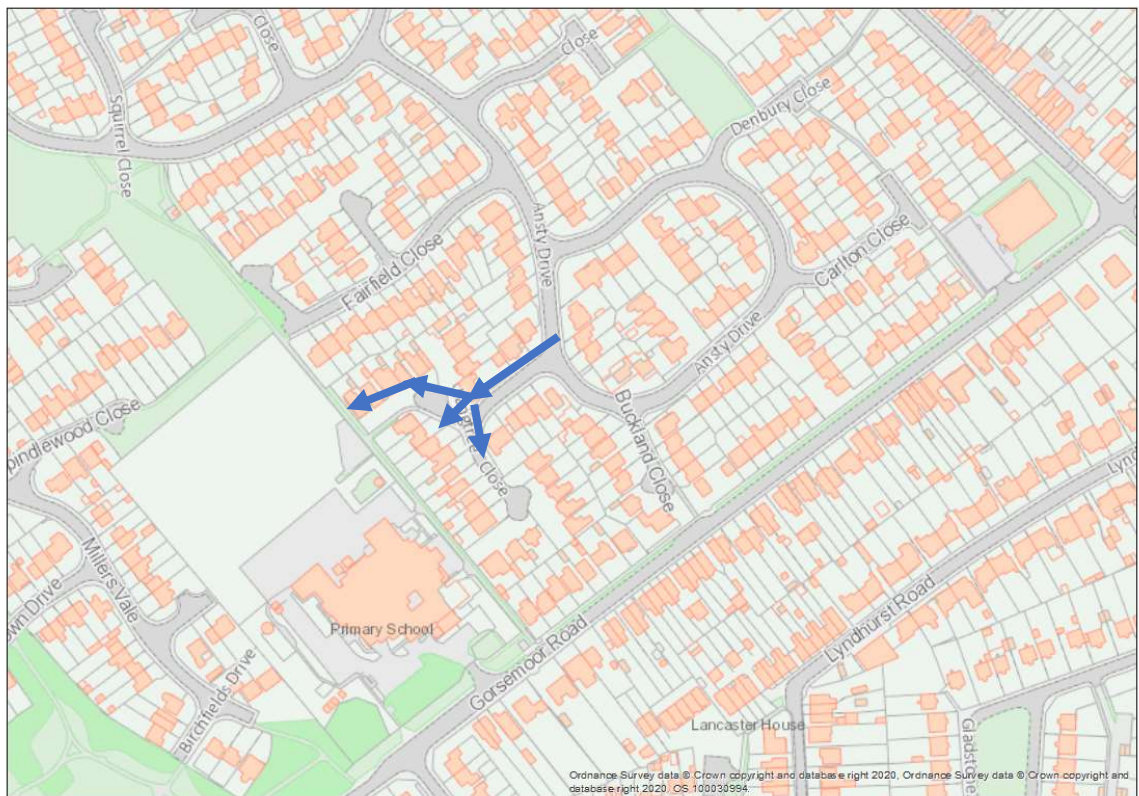
Figure 6- Surface water flow routes (blue arrows)

It was noted the main surface sewer operated by Severn Trent discharged into a local watercourse off Hayes Way. Following inspection it was noted the outfall had subsidence. This was reported to Severn Trent and Local Landowners Cannock Chase District Council for immediate attention.

Staffordshire County Council (LLFA) has recommended that Severn Trent Water undertake a CCTV (Camera Condition Survey), of the sewers in the location. From Langtree Close through to Hayes Way.

Recommended Actions	Identified Party / RMA
Severn Trent to carry out a CCTV survey to ensure sewers are functioning correctly	STW
CCDC to ensure debris from hedgerows does not enter the gullies, thus minimising the potential for blockages.	CCDC
Staffordshire County Council (Highways) to consider channel drainage.	SCC (Highways).
Downstream Outlet on Hayes way collapse – STW to undertake required repairs	STW
Downstream embankment slippage – Reported to CCDC to undertake repairs	CCDC

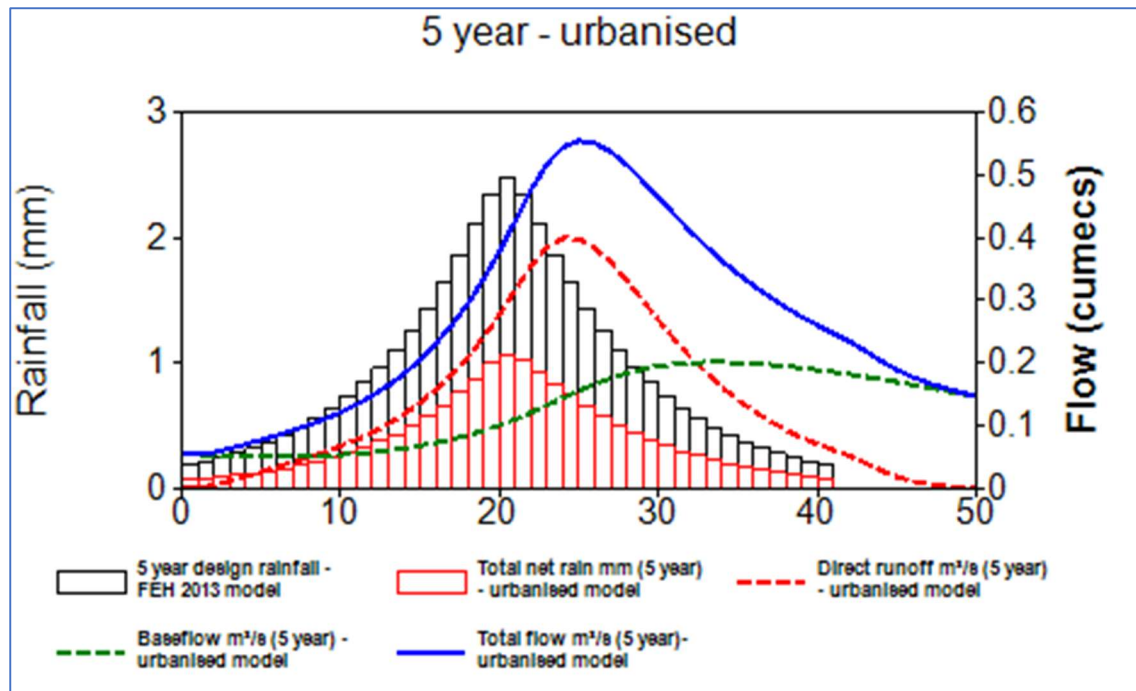
Figure 10: ReFH2 Generated Hydrographs for the 1 in 5 year return period – indicating peak flow rates of 0.56 m³/s – read from the blue line the right hand vertical axis.
