2020 Flood Events:  
Flood and Water Management Act  
Section 19 - Investigation  
Lichfield District- Staffordshire

| <b>Document Ref:</b> | | | <b>2020 Flooding: Section 19 Flood Investigation for Lichfield District</b> | | |

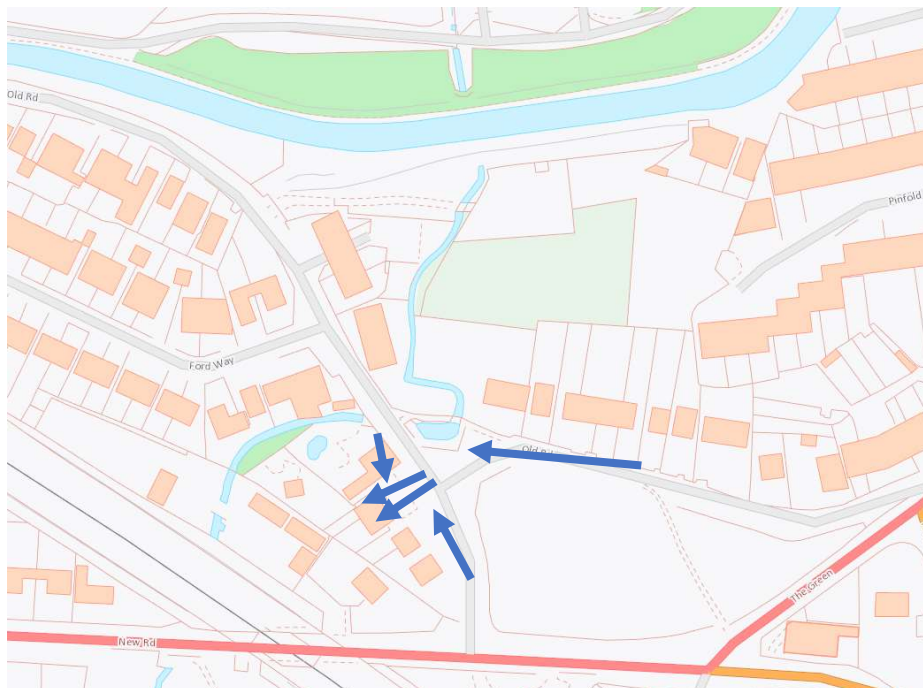
The flooding in this area has been identified as being as a result of surface water flows. Surface water from the highway could not reach the watercourse due to various obstructions and blockages.

Speaking to local Residents, councillors and Lichfield District Council, it was determined during the storm event, urban debris caused a blockage under a bridge. When this blockage was removed water did start to recede.

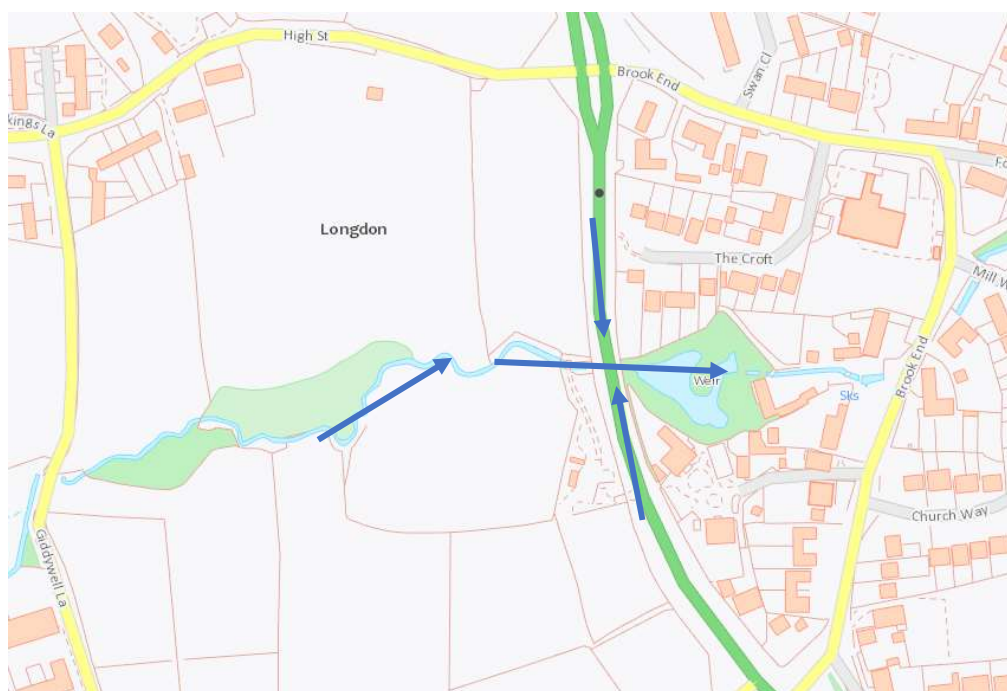
A surcharging of water from the watercourse to the west of the A51 (The Shropshire Brook), upstream of the affected properties, propagated downstream, caused a weir and other drainage features in the vicinity to be breached. These were topped with excess flows from the highway causing multiple properties to be flooded internally.

Figure 5: Brook End, Longdon- flow paths (blue arrows)

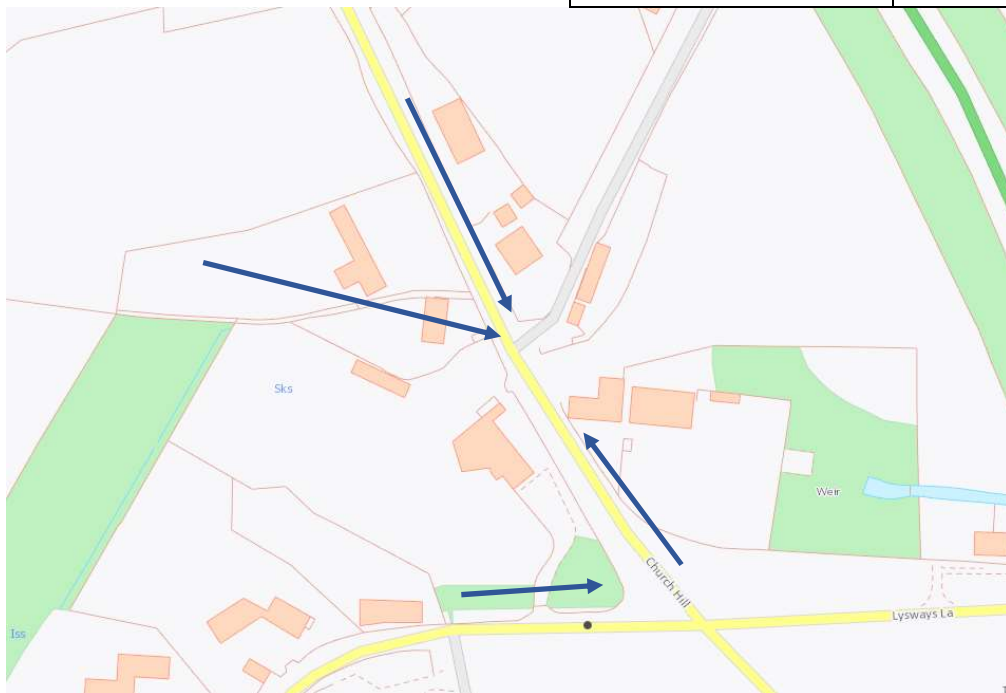
The source of flooding has been identified to be originating from surface water flows and a possible breach of the brook.

Figure 6: Longdon Green - flow paths (blue arrows)
